# Development of Best Practices for Inspection of PT Bridges in Minnesota

Minnesota  
Department of  
Transportation

Andrea Schokker, Principal Investigator  
Department of Civil Engineering  
University of Minnesota Duluth

Research Project  
Final Report 2012-09

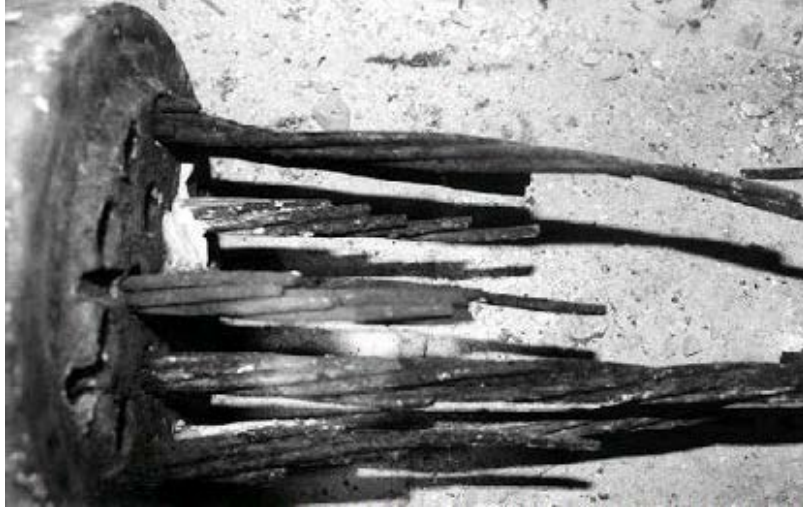
After full inspection, it was found that one of the six tendons in each span had failed. The boot connecting the steel pipe and the duct was opened for further investigation and active corrosion was found. Investigation of the removed tendon showed voids in the grout around the tendon, and pitting on the prestressing strands at the anchor head as shown in figure 2.2. The failed tendons were removed and replaced.

**Figure 2.2. Strands corroded at anchor (Corven Engineering, 2002)**

There was initial concern that this corrosion at the voids was due to corrosive bleed water from the grout, although continued examination concluded that the corrosion was due to saltwater ocean spray. It was believed that the wind carried ocean spray and came into contact with the tendons through a void in the anchor head. Seeping between the segments at the expansion joints the chloride enriched water entered the anchor and provided the conditions for active corrosion to occur. Figure 2.3 shows the staining around the anchor where the tendon corroded. While the bleed water itself did not corrode the strands, the void left by the bleed water provided a void where chlorides, moisture and oxygen could congregate and cause severe corrosion.

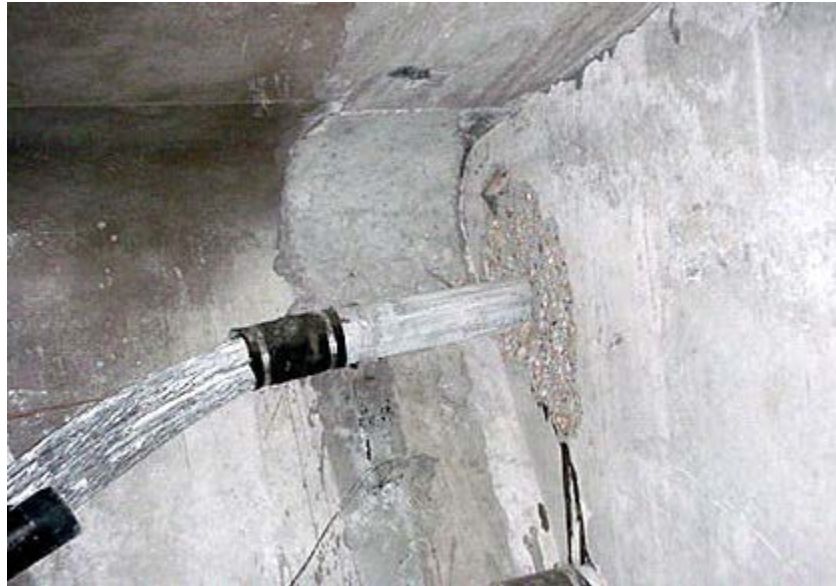
28, 2000 it was discovered that two tendons had failed. One of the failures was similar to that seen in the Niles Channel Bridge with corrosion concentrated at the anchor head. Figure 2.4 shows the tendon pullout at the expansion joint.

**Figure 2.4. Tendon at expansion joint were failure occurred (Corven Engineering, 2002)**

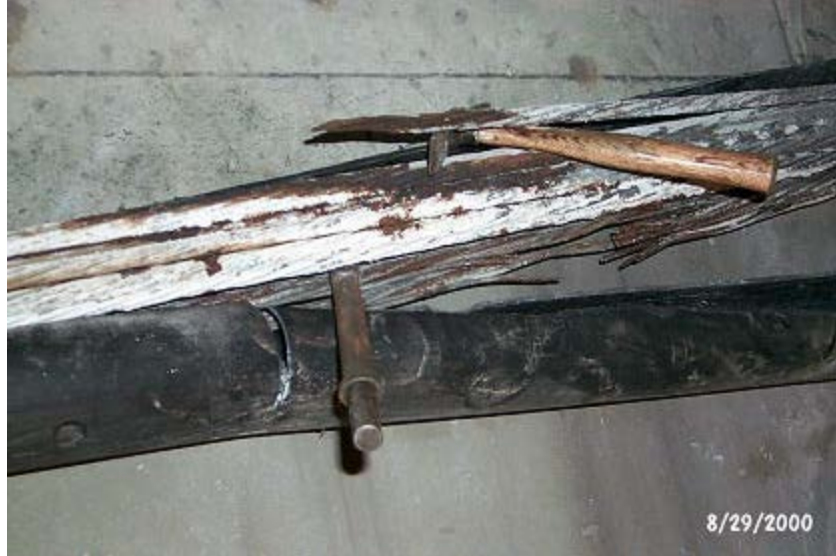
The second tendon that had failed was due to a breach in the duct that allowed ingress of moisture and oxygen. Further examination of breached ducts was performed, and a correspondence was found between the occurrence of cracked ducts, and voids in the grout (Hartt and Venugopalan 2002). Figure 2.5 shows the failed tendon in the free length of the duct. The duct cracking was the result of the use of a brittle duct material that met the required specification, but that was inappropriate for post-tensioning. Additional requirements have now been added for post-tensioning duct material (Post-Tensioning Institute, 2003).

**Figure 2.5. Corroded tendons at breached duct (Corven Engineering, 2002)**

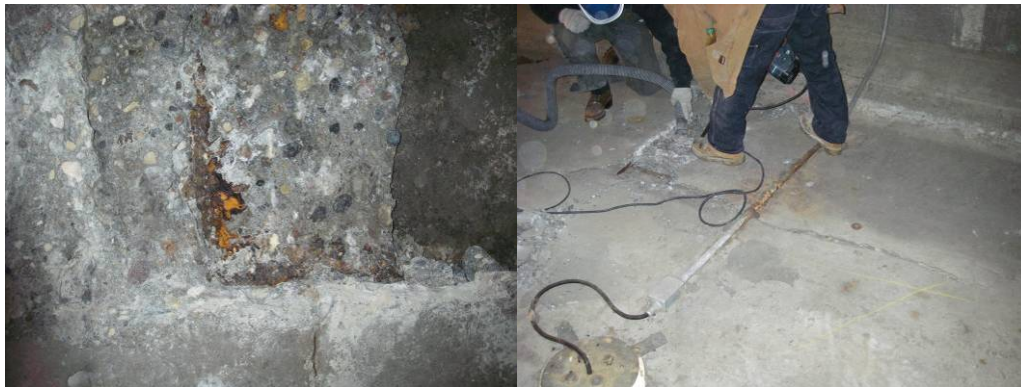
**Figure 6.19. (Left) Corrosion product under spalling area at mid span**

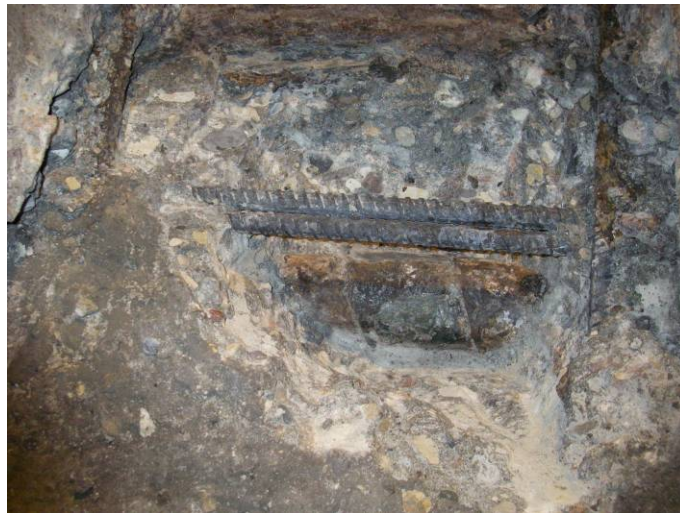
**Figure 6.24. Shows tendon 16 with corroded duct**

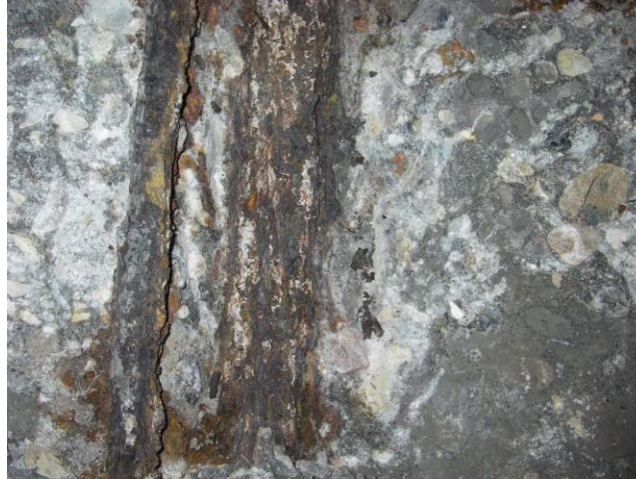
**Figure 6.32. Corrosion on tendon B28**

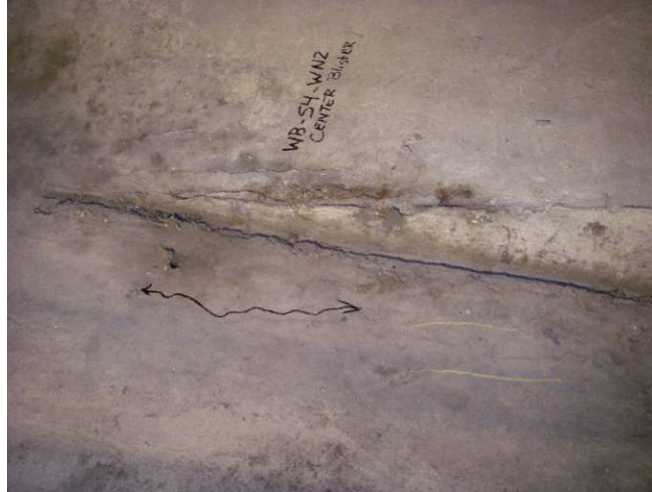
**Figure 6.36. Cracking along anchorage blister in span 4**

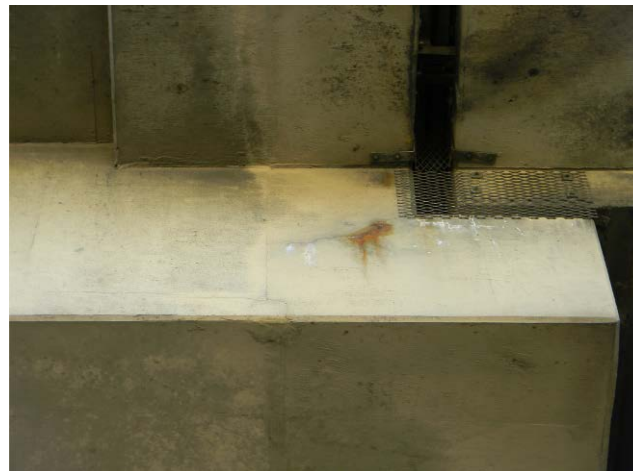
**Figure 7.7. Cracking at connection of structural units**

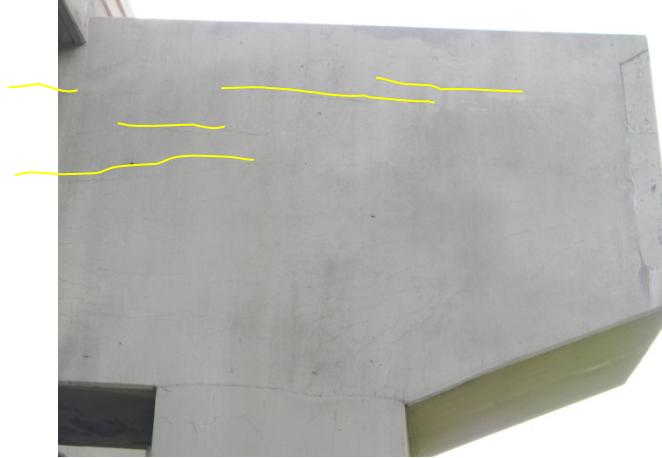
**Figure 10.2. Cracking along straddle bent**
