# Evaluation of Corrugated HDPE Pipes Manufactured with Recycled Content

**August 2025**

Final Report 2025-32

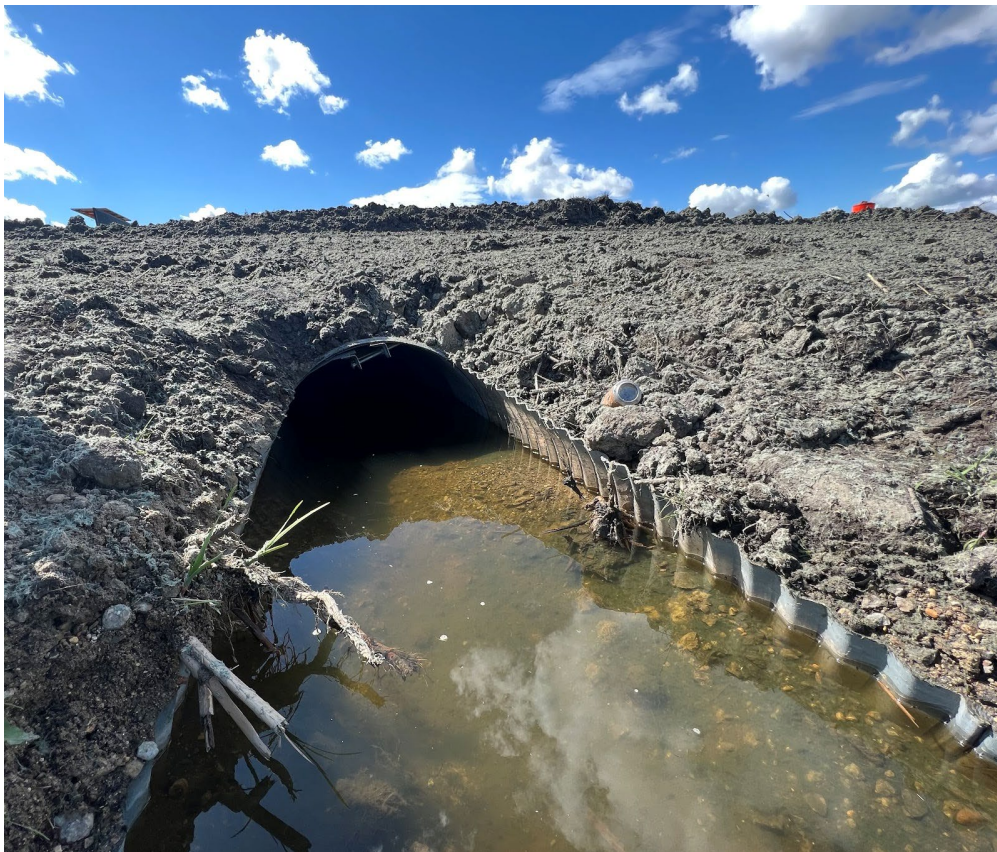
**Figure 2.24 Photograph of culvert taken 30 days after installation**

Ultimately due to severe flooding of the Fosston area abruptly after installation, interior water levels were too high to initiate deflection measurements within thirty days due to hazardous working conditions (Figure 2.24). This was a deviation from MnDOT standard 2501 C.4.

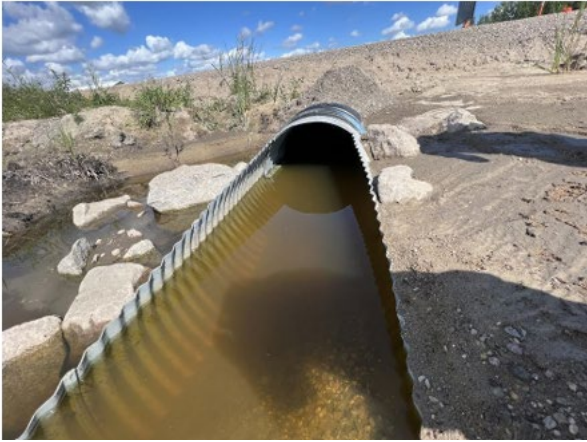
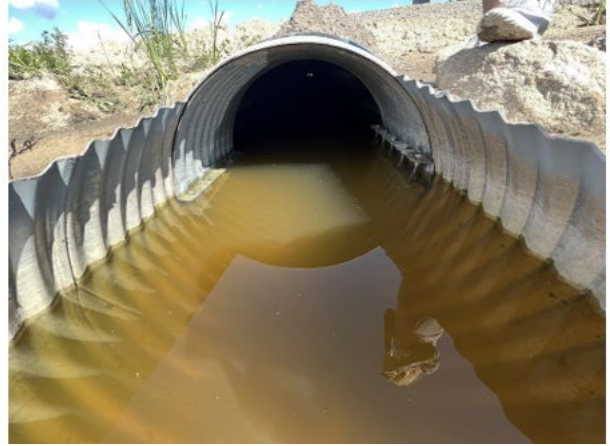
**Figure 3.2: September 10, 2022 water level**

Throughout the fall of 2022 and the spring and summer and 2023, the culvert's water table was frequently monitored for a safer depth to enter. Figures 3.2 – 3.6 show images of the culvert throughout this timeframe. As indicated in these images, the water depth was too high to safely enter the culvert for inspection. We discussed some dewatering options for the culvert, but we had difficulty identifying a contractor capable of that work, and we did not want to disrupt traffic on the roadway.

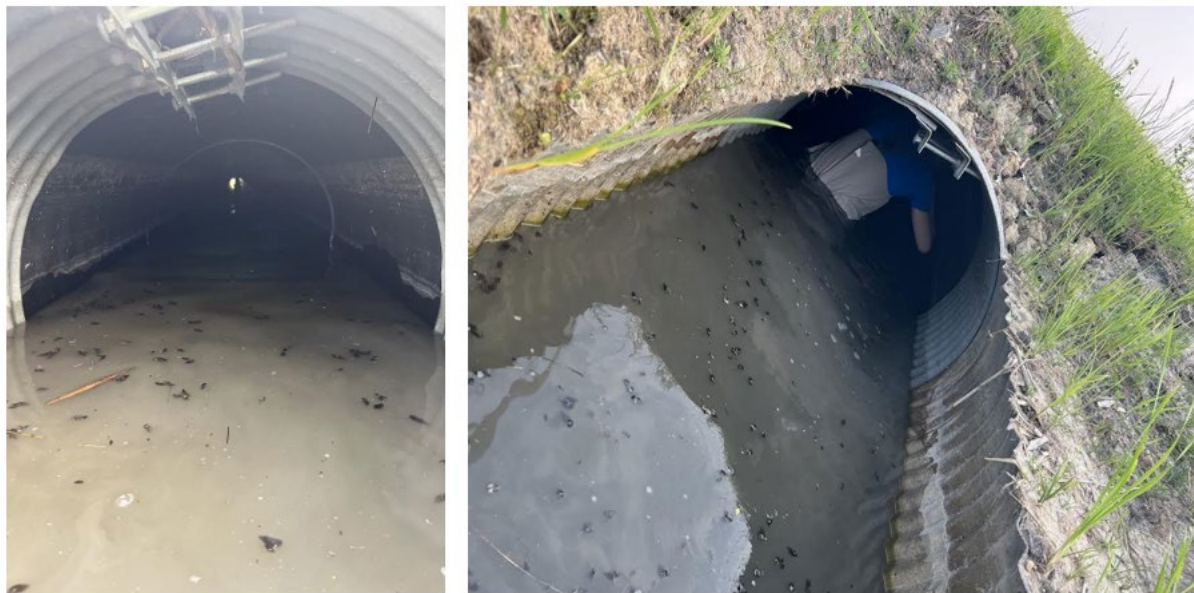
**Figure 3.7 June 12, 2023, water levels and inspection**

On June 12, 2023, the water level had finally receded enough to enter the culvert to take some measurements and inspect the instrumentation. Figure 3.7 shows some images of the culvert at this

time, indicating that the water level was just below the springline of the pipe, leaving approximately 18 inches of air space above the water to the top of the pipe. While these water levels were still quite high, entry into the culvert was possible, and we were able to inspect the strain gauges, string potentiometers, and joints. Upon inspection, the strain gauges appeared to still be intact, with the two-part polysulfide liquid polymer M-Coat® sealant and adhesive strips holding. However, we were not able to test the electrical function of the gauges as the water levels were too high to safely test. Additionally, due to the continuously high water levels and the subsequent freezing and thawing of the ice over the winter and spring, the string potentiometers were seized up. Specifically, the spring coils attached to the retractable wires in all of the string potentiometers had seized. Therefore, if live-load data is to be eventually collected, the string potentiometers will have to be replaced or a different measurement method employed.

We were able to take some physical measurements of the pipe at this time. A tape measure was used for these measurements, but it was not the most accurate method, especially given the high water depths and sediment at the invert of the culvert. The measurements are shown in Table 3.1.

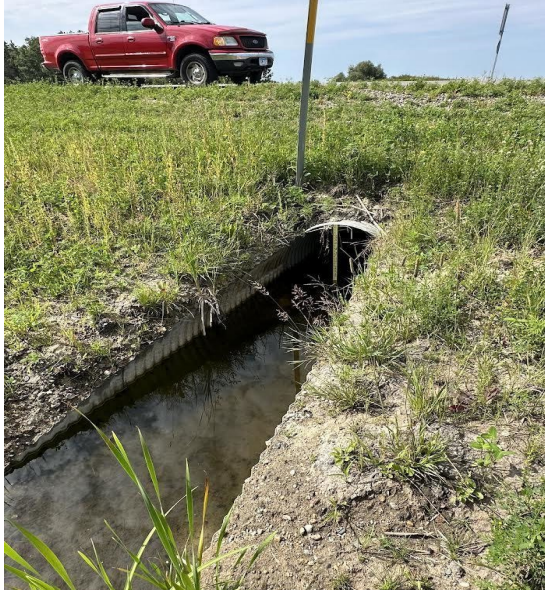
**Figure 3.8 July 19, 2023 water level**

The pipes were again inspected on July 19, 2023. Figure 3.8 shows an image of the pipe inlet at the time of inspection. Again, the water levels were very high, but the pipes were deemed marginally safe enough to enter. Due to the previously-mentioned issues with the instrumentation, physical measurements were taken using a Lufkin wooden ruler with brass extensions, allowing a more accurate measurement than the tape measure used on the June 12 inspection. Figures 3.9 and 3.10 show the process used to measure the horizontal and vertical diameters, respectively. A summary of the data is shown in Table 3.1.

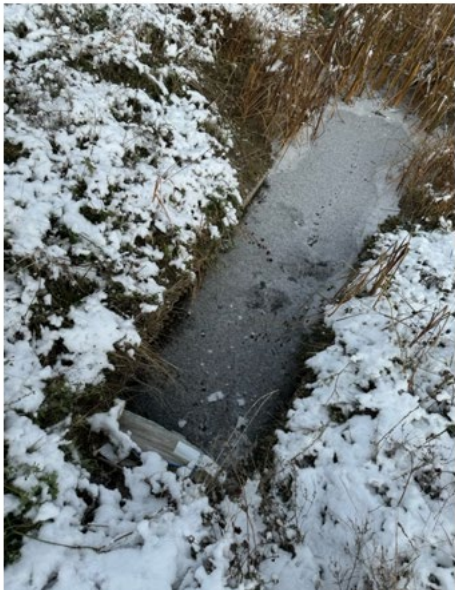
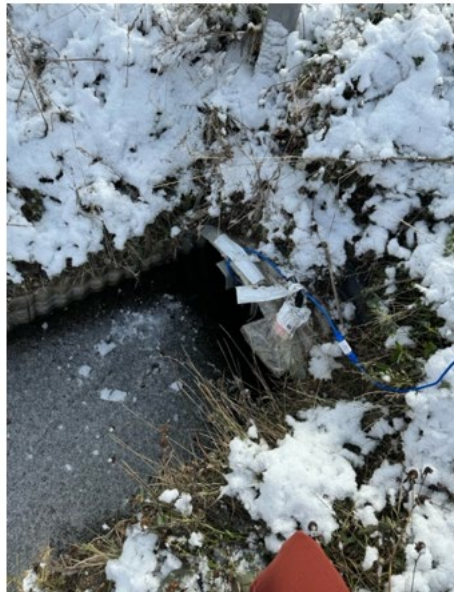
Several additional site visits were conducted between July 2023 and April 2024, and some images are shown in Figures 3.11 – 3.13. Due to high water levels and frozen conditions, the pipes were unable to be adequately inspected during this timeframe.

**Figure 3.11 Inspection; 2 in. of ice was estimated, and the culverts were not accessible**

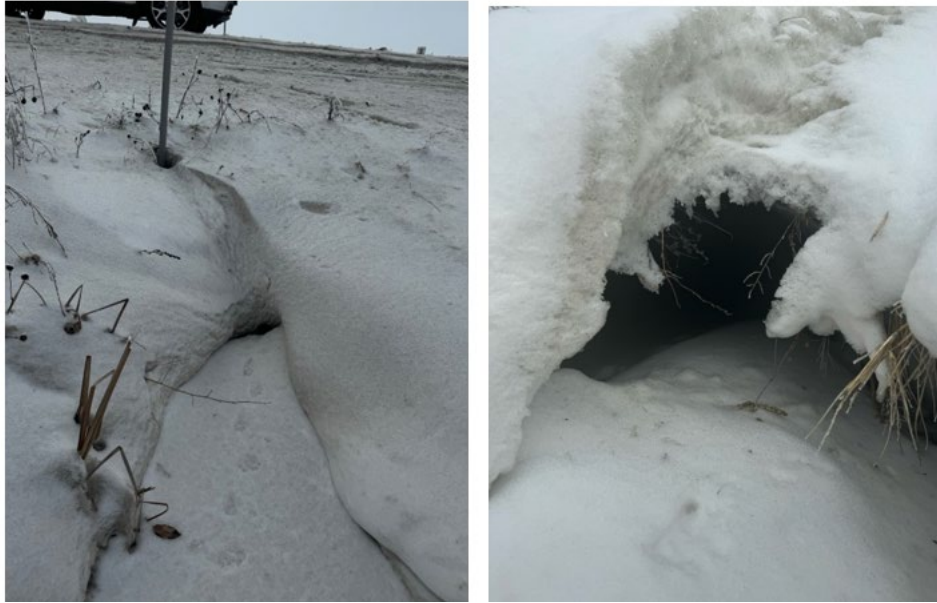
**Figure 3.12 January 27, 2024, photos - pipes were deemed unsafe to enter**

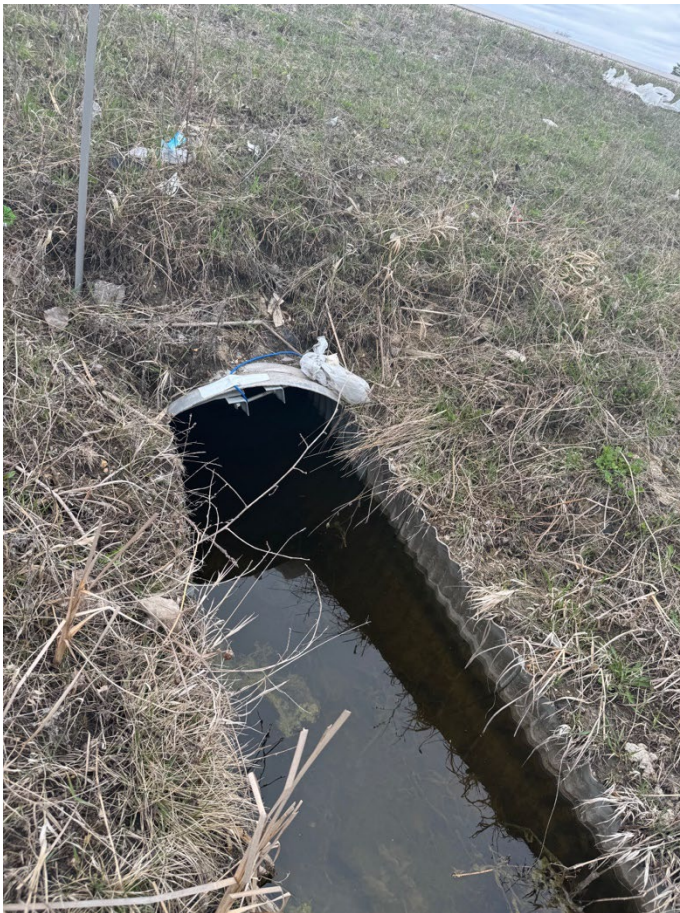
**Figure 3.13 April 28, 2024, site visit - water level was over 60% full, and the pipes were deemed unsafe to enter**

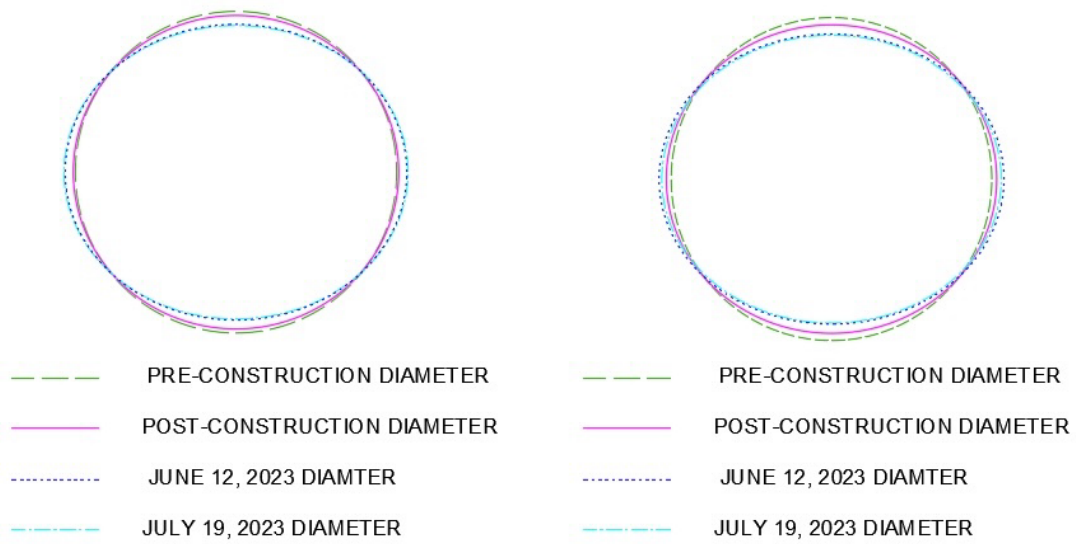
**Figure 3.3.14: Illustration of culvert deflection from prior to construction to July 19, 2023**

Though accurate measurements of the pipe deflections were not possible due to high water levels and unsafe conditions, a summary of the roughly measured pipe diameters and percent deflections for both the M 294V and M 294R pipes is shown in Table 3.1 and a graphical depiction of the culverts is shown in Figure 3.14. As evident from the measurements, the deflections of both the M 294V and M 294R pipes have apparently exceeded MnDOT's 5% maximum requirements. This could be due to a number of different factors, summarized below.

First, this could be related to the installation of the pipes. The pipes installed underneath the eastbound lanes were monitored by both Michael Pluimer (PI) and MnDOT personnel. It was noted that the backfill around the pipes was compacted in larger lifts than typically recommended. The contractor deemed that this was acceptable for the type of backfill being used. However, soil samples were retained and could be further tested to determine the strength of the materials and validate this assessment if desired by MnDOT. Due to the scheduling of the project, Michael Pluimer was not available for the installation of the pipes underneath the westbound lanes. The installation was monitored and documented by graduate student, Katie Padden, and reported in Task 5. It may be worthwhile to inspect the deflections of the pipes underneath the eastbound lanes to see if there are any differences from those underneath the westbound lanes.

It should be noted that while the pipes have apparently exceeded the maximum MnDOT deflection requirements, the pipes did not continue to increase in deflection from the June 12, 2023 to April 28, 2024 measurements. Additionally, visual inspection of the pipes did not show any significant distortions or damage. Finally, there does not appear to be any significant difference in performance between the virgin and recycled pipes. If anything, the recycled pipes are performing slightly better than the virgin pipes, though the deflections are very comparable.

Based on this research project, it is recommended that MnDOT consider the allowance of corrugated HDPE pipes manufactured with recycled content in accordance with AASHTO M 294R for their culvert and storm drainage applications. The AASHTO M 294R pipes performed comparably to the AASHTO M 294V pipes, and the pipes are still performing well in the 3rd year of service. While both the M 294V and M 294R pipes appear to have slightly exceeded MnDOT deflection requirements, it is deemed that this was likely due to a failure to follow MnDOT installation guidelines as well as measurement errors due to

sediment and water in the pipes. Additionally, since the water levels in the pipes made it difficult to accurately measure deflections and monitor the pipes over time, it is recommended to identify an additional test site for further analysis. An LCA showed significant environmental benefits to using corrugated HDPE pipes manufactured with recycled content, and an LCCA showed some potential economic savings.

Finally, due to the issues in installing and monitoring these test pipes, it is our recommendation to identify an additional test site where new test pipes could be installed. Ideally, this test site would not be as wet as the Fosston site, and the pipes could be more easily monitored over time. It is also recommended that the pipes are installed properly and in accordance with MnDOT installation standards. While the current pipes appear to be performing satisfactorily and do not show any difference in performance between the virgin and recycled pipes, we were unable to obtain the live load data that was desired for this project, and we feel that could be better obtained at a more suitable test site.
