# Vehicle Speed Impacts of Occasional Hazard (Playground) Warning Signs

Minnesota  
Department of  
Transportation

John Hourdos, Principal Investigator  
Department of Civil Engineering  
University of Minnesota

Research Project  
Final Report 2012-06

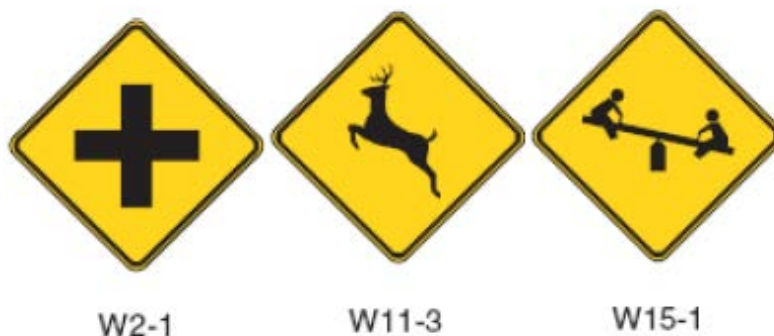
**Figure 1.1. Examples of Occasional Hazard Warning Signs**

Warning signs are installed along roadways to provide information to vehicle drivers about hazards that may impact their decision-making. In general, these signs are located and designed to elicit one or more driver responses (e.g., more awareness, speed reduction). They are also sometimes supplemented with advisory speed limit signs. Some hazards identified by warning signs are relatively static (e.g., the existence of a horizontal curve), whereas other warning signs are installed for hazards that may occur on a more sporadic basis. These occasional hazard warning signs can be used to raise awareness of the potential for hazards at particular locations (e.g., playground or intersection ahead) or along an entire roadway segment (e.g., deer crossing). Examples of occasional hazard warning signs include the non-standard “children-at-play” sign and the Manual on Uniform Traffic Control Devices (MUTCD) [1] compliant signs shown in Figure 1.1.

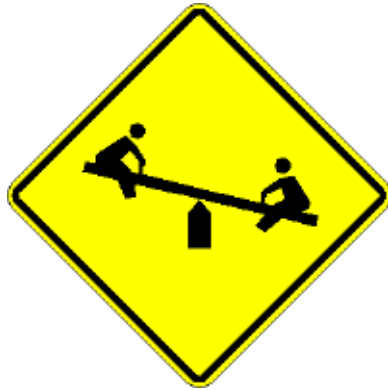
**Figure 2.1. Occasional Hazard (Playground) Warning Sign (1)**

This chapter provides a summary of studies, documented and completed, that are relevant to this research project. Several research projects have considered the potential impacts of occasional hazard warning signs. However, none of publications found during the literature search focused on the vehicle speed impacts of the OHPW sign (See Figure 2.1).
