Effect of Signing and Lane Markings on the Safety of a Two-Lane Roundabout

Minnesota
Department of
Transportation

January 2014

Research Project
Final Report 2014-04

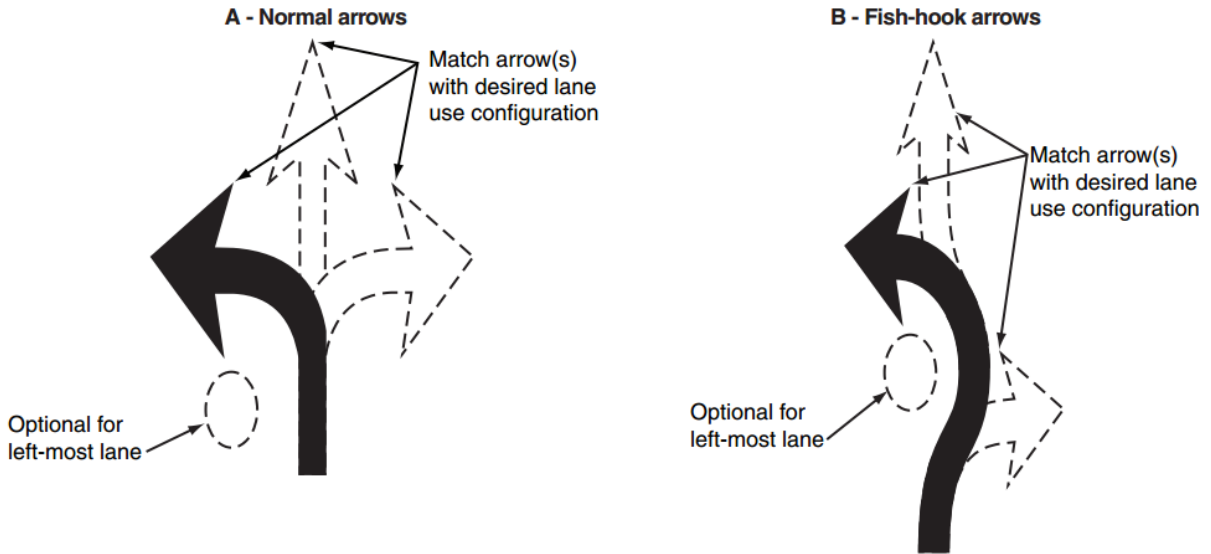
Figure 2 Turn Arrow Options. © 2009 MUTCD

In addition to the sign requirement content, the 2012 version of the MUTCD manual includes additional recommendations pertaining to lane-use arrows on approaches and markings within the circular roadway (Chapter 3C). Lane-use arrows deemed acceptable for approaches are demonstrated in Figure 2. They include normal (standard) arrows that would be located at a signalized intersection, as well as fish-hook arrows, which exhibit additional curvature that represents the radial direction of the circular roadway. Fish-hook arrows may be used with signs on the approach as well. An additional dot representing the central island for left turns and U-turns is an optional feature. Within the circular roadway, standard arrows must be used. Other markings within the circular roadway have also been addressed more specifically. It is now required that multi-lane approaches to roundabouts have lane lines (3C.02-1 (2012)), within the circulatory roadway continuous concentric lane lines may not be used (3C.02-4 (2012)), and exits cannot contain edge lines from the circulatory roadway (3C.03-3 (2012)), among other added recommendations and options for roundabout design. Differences between the Minnesota and federal MUTCD manuals are negligible pertaining to roundabout design regulations.

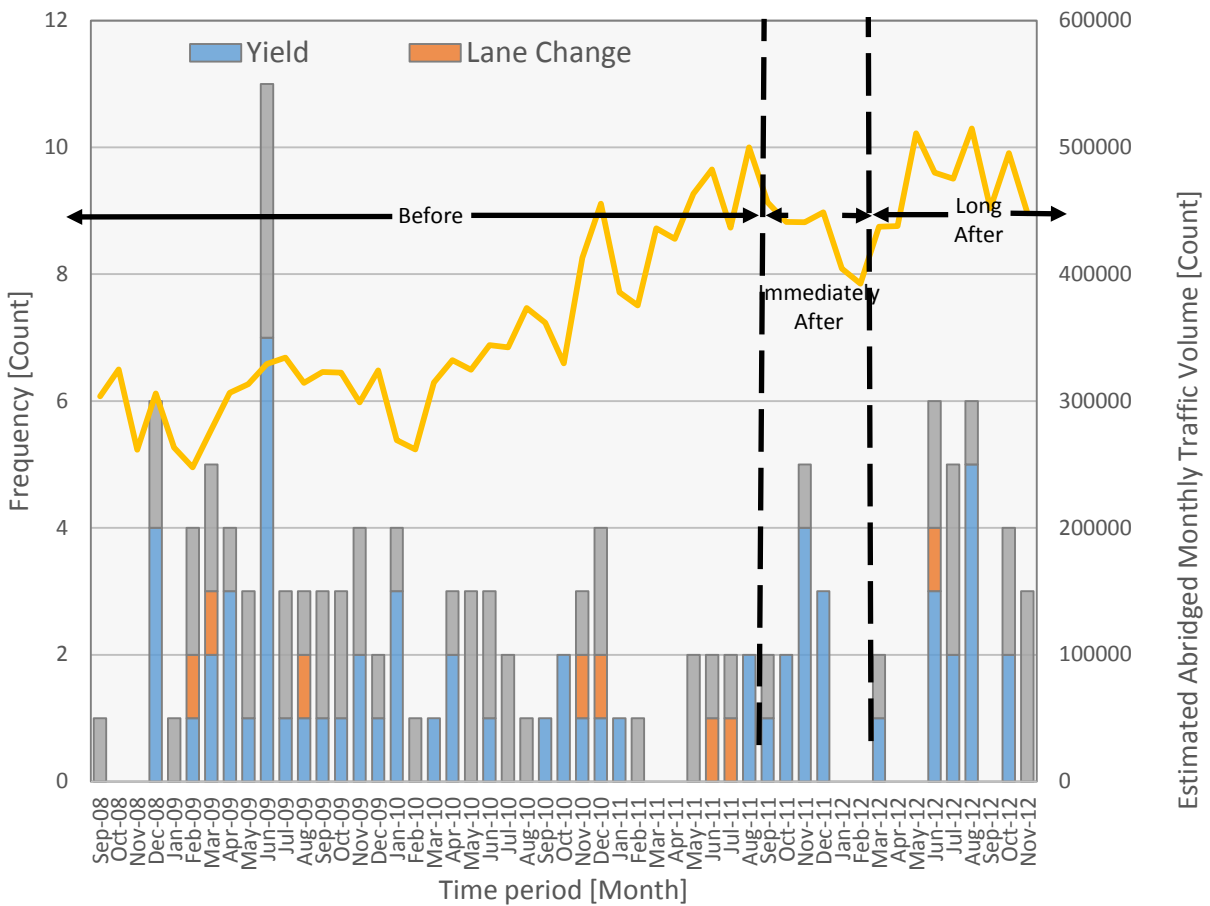
Figure 4: Distribution of Reported Crashes per Month

Below, Figure 4 presents the preceding crash breakdown chronologically alongside estimated traffic volumes. Due to the large variance in traffic volumes over time, counts of reported instances alone are not relevant. Volumes are affected by time of year, weather, construction, etc. Specifically, in the case of the subject roundabout, various portions of the nearby I-35W/Hwy 62 Crosstown reconstruction project significantly affected traffic intermittently from the time of the roundabout's commencement through the completion of the nearby reconstruction project in November 2010. The estimated traffic volumes illustrated in Figure 4 were calculated to ultimately approximate crash rates (Figure 8) as opposed to counts in order to provide a more significant demonstration of crash trends over the course of the subject roundabout's existence.

Figure 8 alters Figure 4 by dividing each monthly crash count by its corresponding estimated volume to produce a crash rate. Refer to January 2010 and October 2012, both of which demonstrate four reported crashes. However, due to a significant difference in the estimated volume, January 2010 exhibits a crash rate of approximately 15 per 1,000,000 vehicles versus eight per 1,000,000 in October 2012.

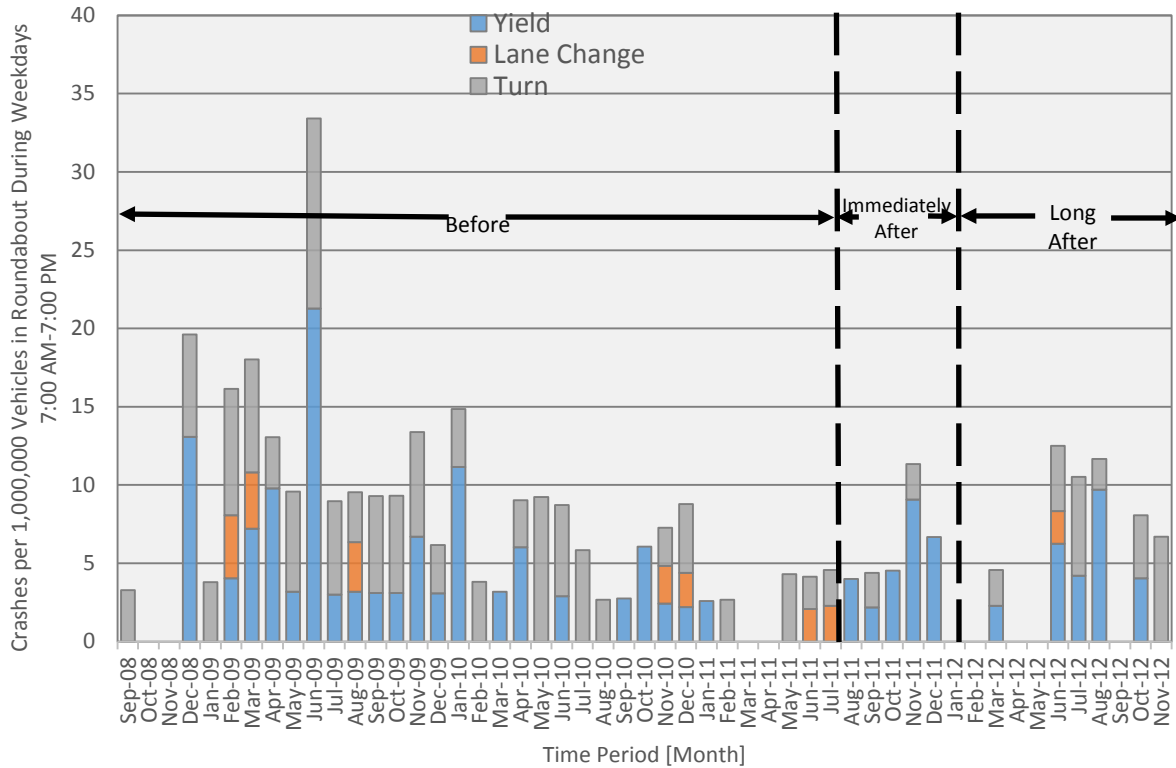
Figure 8: Crashes per 1,000,000 Vehicles from September 2008-November 2012

Seasonal trends are present within the data, with summers exhibiting a tendency to produce local maxima and winters tending to produce local minima, although this cannot be universally applied to the data.

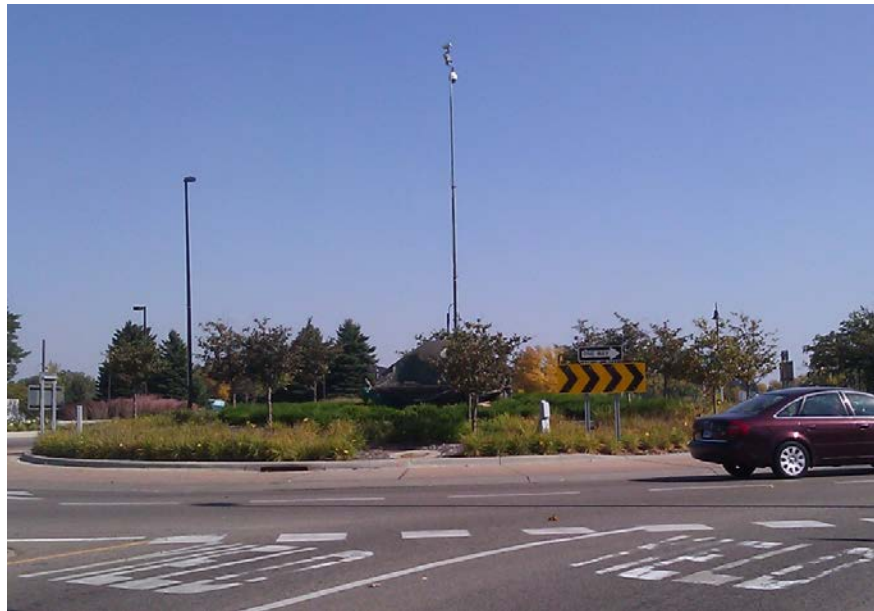
Figure 14 Instrumented Extendable Mast Trailer in the Roundabout

The Minnesota Traffic Observatory developed a set of custom digital recording devices allowing the recording of high resolution video from multiple cameras. The custom made surveillance hardware were mounted on an extendable mast trailer frequently utilized in highway work zones to carry and provide surveillance or illumination. The mast can reach a height of 38 feet. The power source of the deployed equipment consisted of rechargeable batteries that were built in the trailer’s structure. Even though the power consumption of the recording equipment was not high, the batteries were recharged at certain points so that the process was not interrupted. The recharge process was made with the help of a portable generator. Figure 14 shows a photo of the trailer as deployed in the roundabout. The main body of the trailer (bright orange) was covered with a dark green tarp to make it less visible.

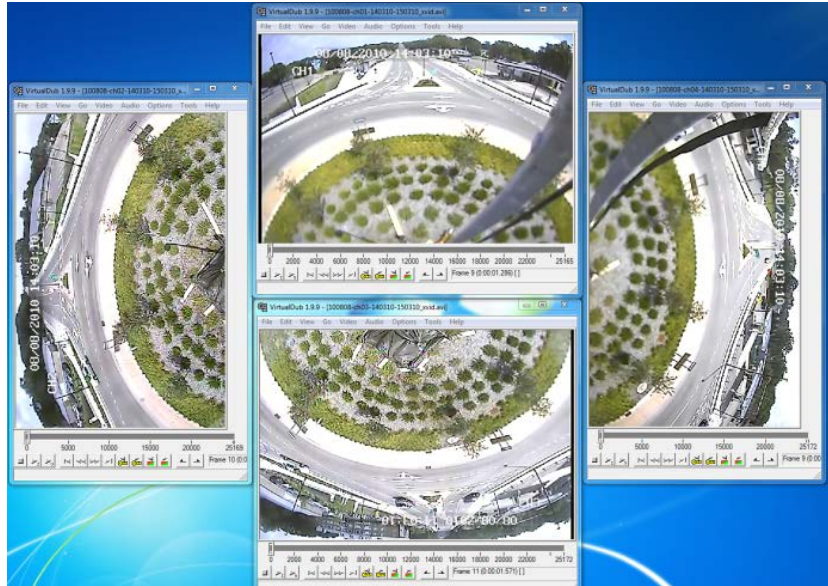
Figure 15 Screenshots of “Before” Roundabout Video

For the “before” video, four cameras comprised the view of the entire intersection, with each camera pointed at the splitter island of an approach (Figure 15). The format of the “after” video instead was changed to better facilitate the needs of this study, and differs from the “before” video by transitioning from four separate cameras to a single panoramic lens camera (Figure 16). Due to budget limitations it was not possible to concurrently collect data at a control site. While

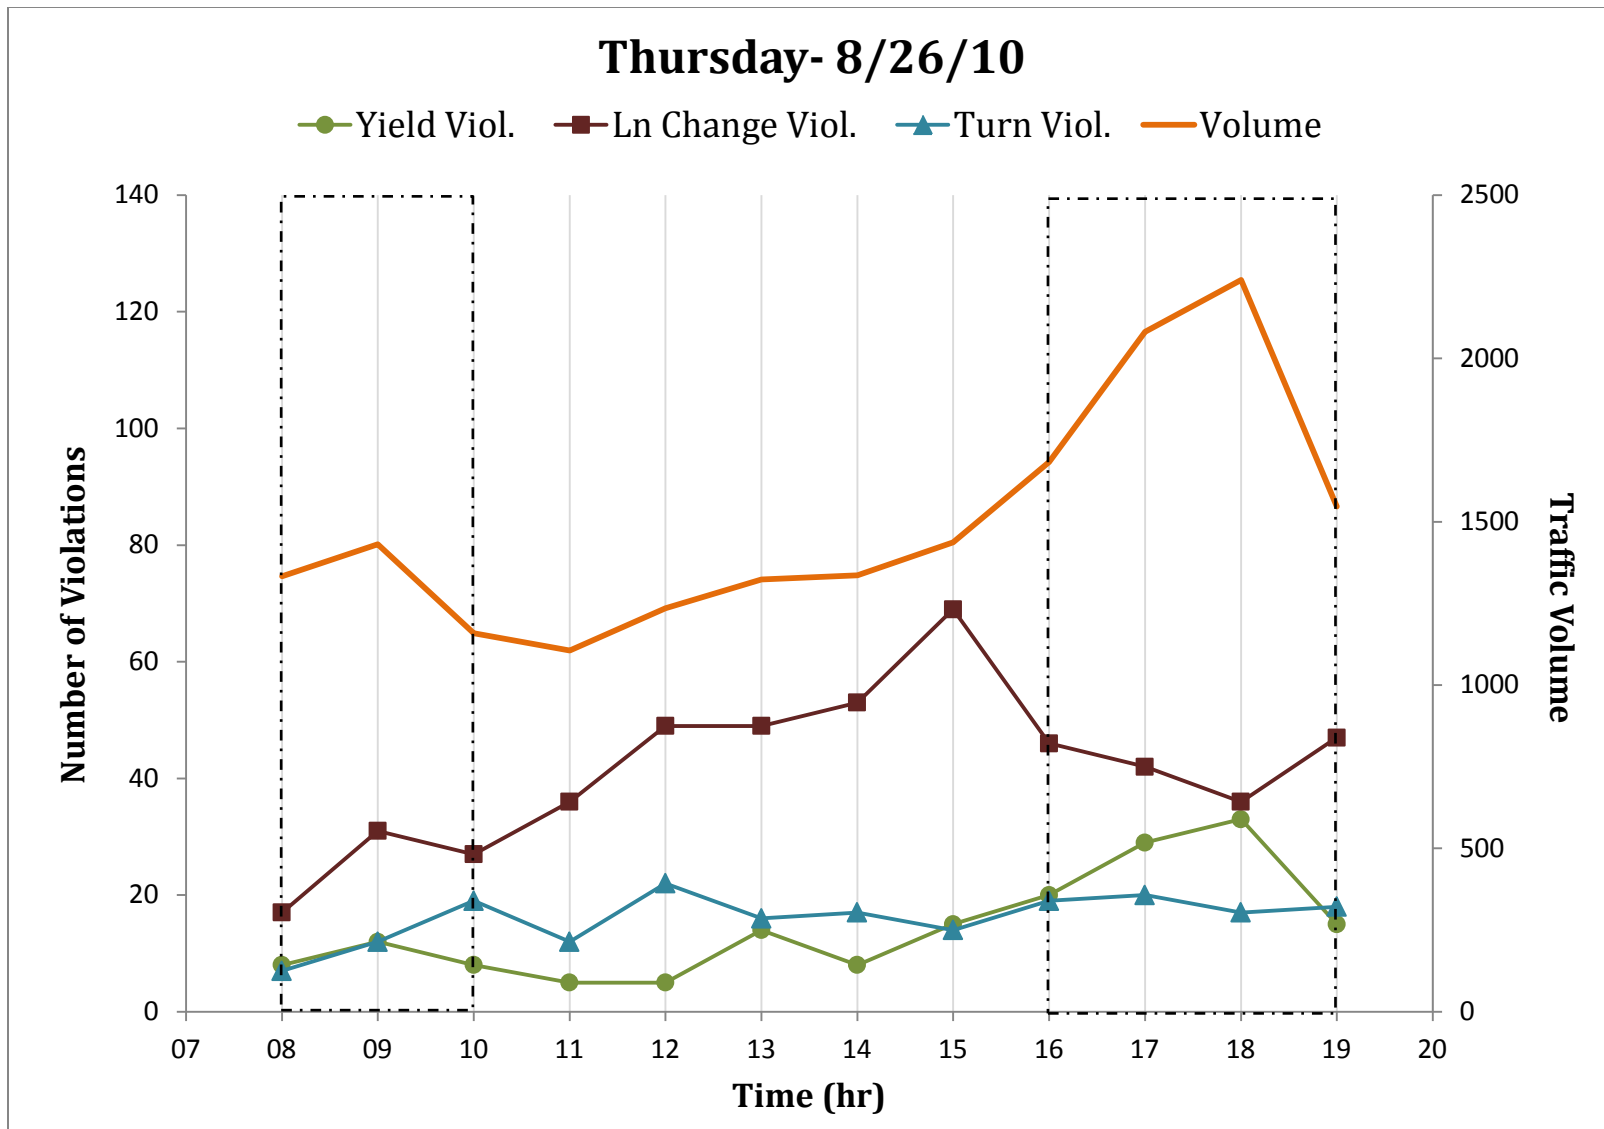
Figure 18 Violation Breakdown for Thursday, August 26th, 2010

From Table 3 one can also note that no significant regression was observed among instances of lane changes. In Figures 18-20 the trends in the "Lane Change" violations suggest that commuters, which are the predominant users during peak periods, are less susceptible to such mistakes as midday drivers. The "Improper Turn" violations show a weaker but observable correlation to volume.

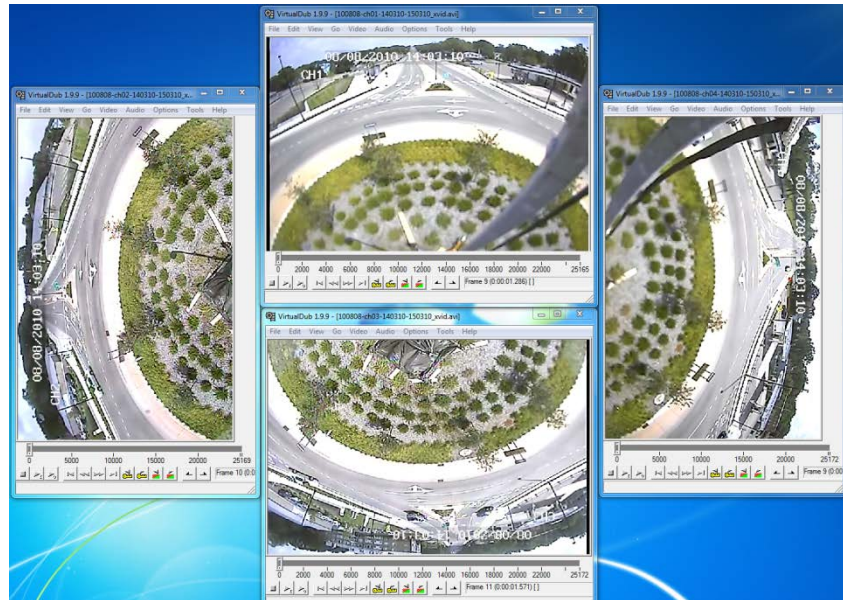
Figure 1: Screenshot of Roundabout Video Setup

One of the challenges for data collection in the Violations project came out of the way footage of the roundabout was recorded. The use of four separate cameras, each recording a separate channel of traffic, to collect footage meant that watching traffic move through the entire roundabout would require additional effort. For one, it was necessary to set up videos four at a time in order to see the entire roundabout at once. A protocol was developed for this that involved setting up four VirtualDub windows as shown in Figure 1.

This allowed the roundabout to be viewed in its entirety, and permitted any orientation, that is any channel number in the top position, so long as the channel numbers increased in the clockwise direction.

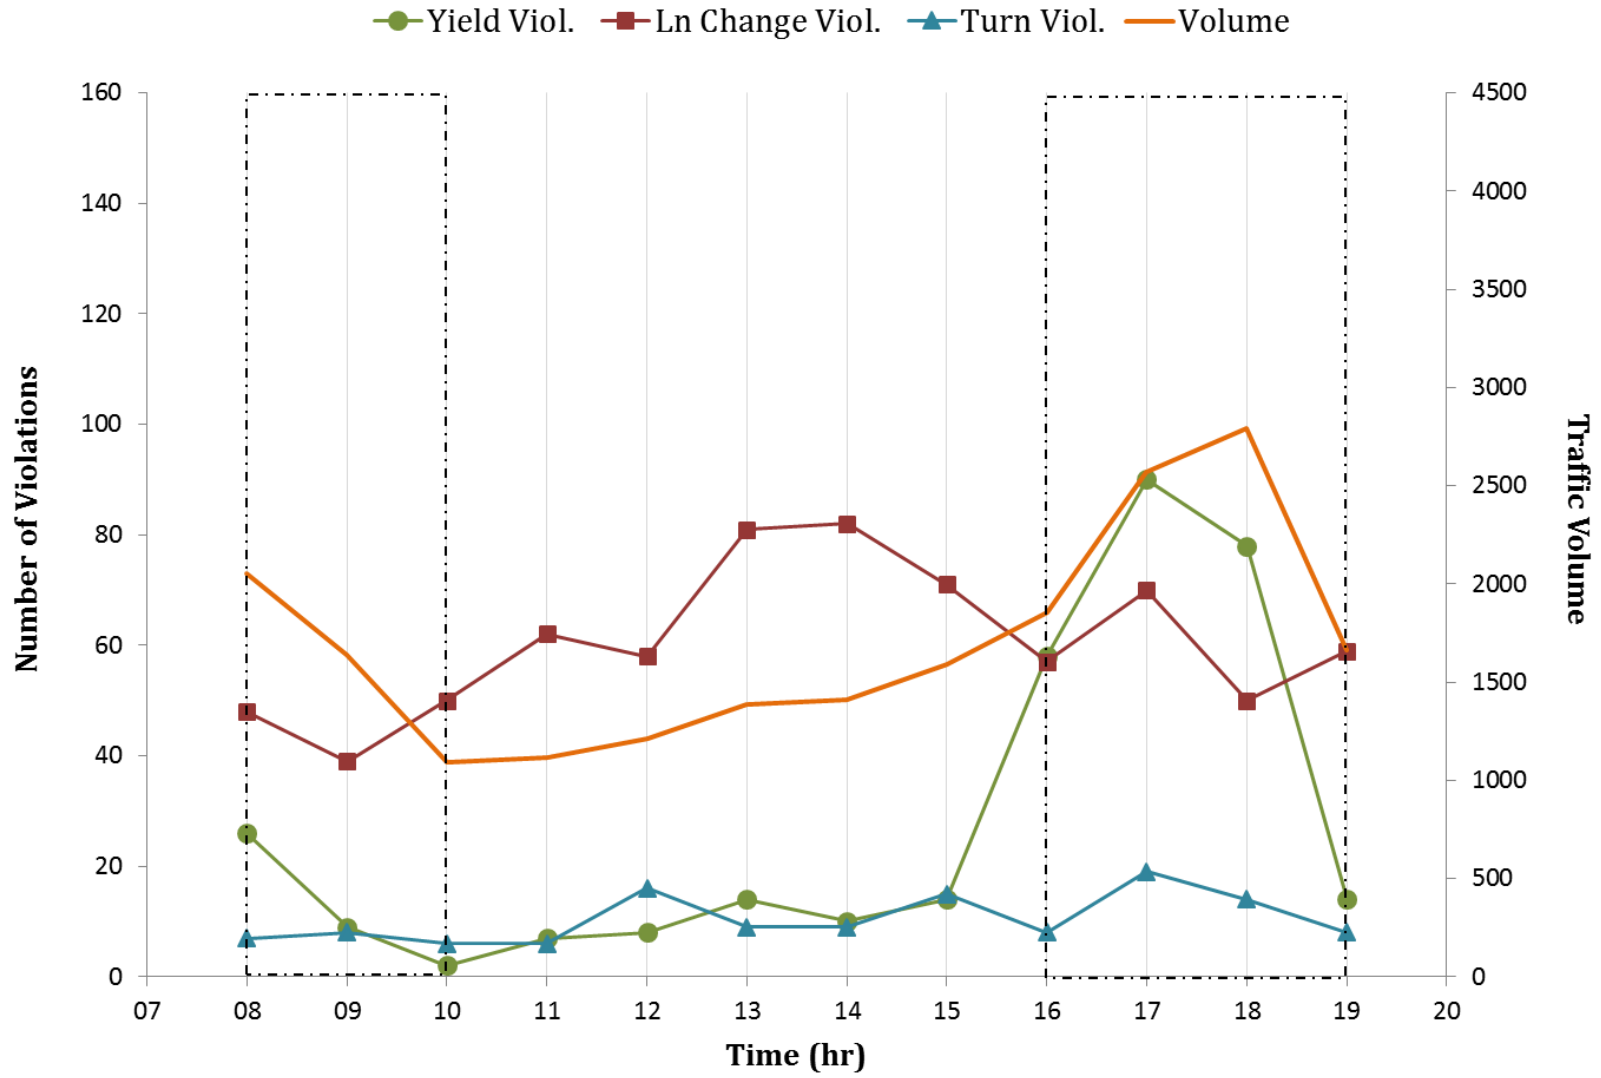
Wednesday - 11/07/12

The following figures present the hourly counts of violation on each of the days of the study along with the estimated hourly volume entering the roundabout
