# Evaluate and Develop Innovative Pavement Repair and Patching: Taconite-based Repair Options

Lawrence Zanko, Principal Investigator  
Natural Resources Research Institute  
University of Minnesota Duluth

Research Project  
Final Report 2016-03

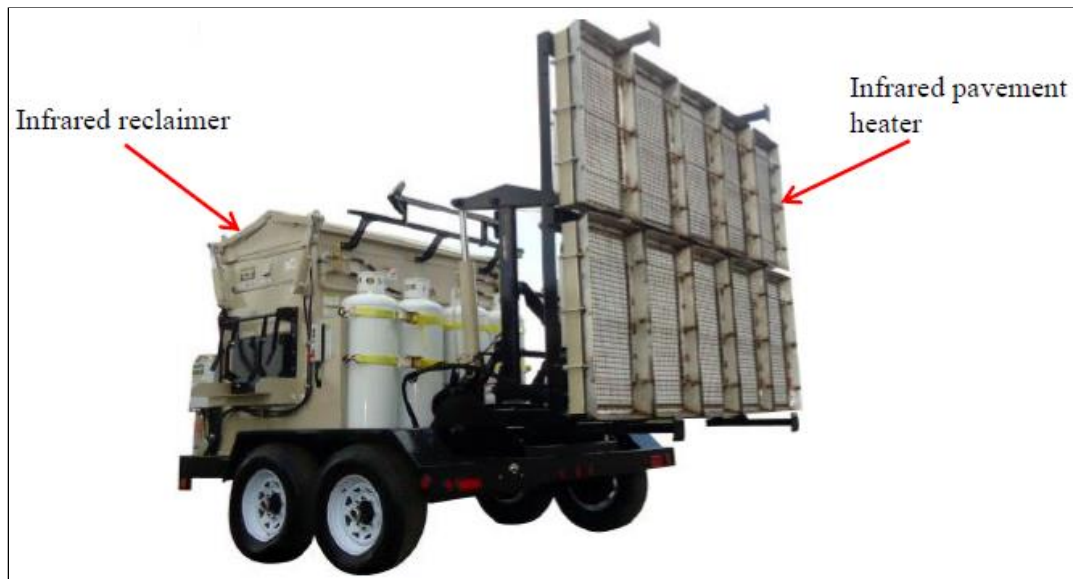
**Figure 2.4. Tow-behind combination infrared asphalt heater/reclaimer.**  
(Source: Nazzal et al., 2014)

A recent Ohio University study (Nazzal et al., 2014) evaluated the performance and cost-effectiveness of a tow-behind combination infrared asphalt heater/reclaimer patching method and compared it to throw and roll and spray injection methods. Figure 2.4 (from Nazzal et al., 2014) shows a combination propane-fueled infrared heater and reclaimer, while Figure 2.5 shows another type of infrared heater and its heating.

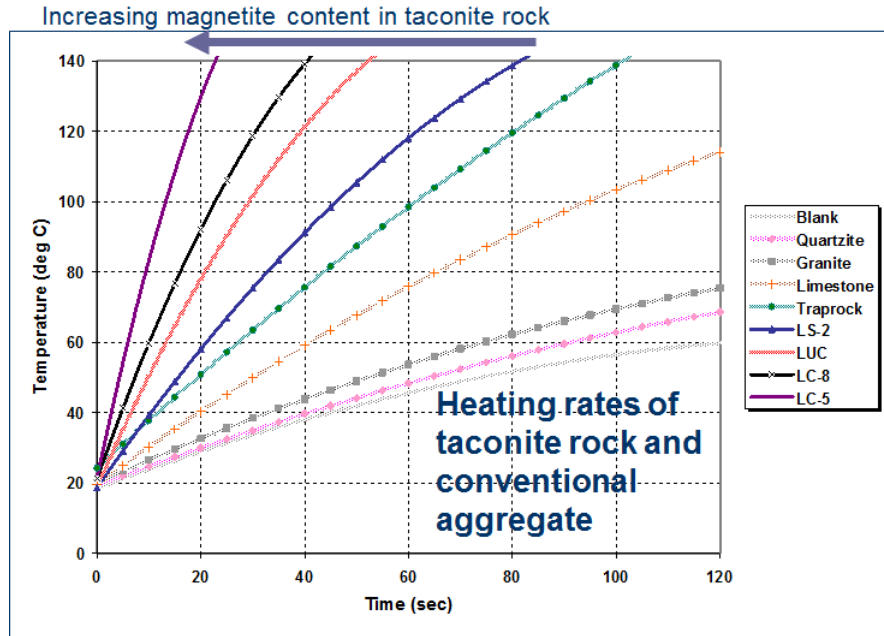
**Figure 2.6. Microwave heating rates of taconite rock and conventional aggregate (Zanko and Hopstock, 2004).**

Microwave Utilities, Inc. (MUI) is a company that specializes in ground thawing using a patented microwave system capable of thawing frozen ground to a depth of six feet in just 60 minutes (pers. comm., Microwave Utilities, 2012). NRRI and Microwave Utilities have been collaborating to test pothole patching compounds that utilize the microwave-absorbing properties of the iron mineral magnetite. Magnetite is contained in iron ore (aka "taconite" ore) rock mined and processed on Minnesota's Mesabi Iron Range, and has the ability to readily adsorb microwaves and heat very quickly (Fig. 2.6).

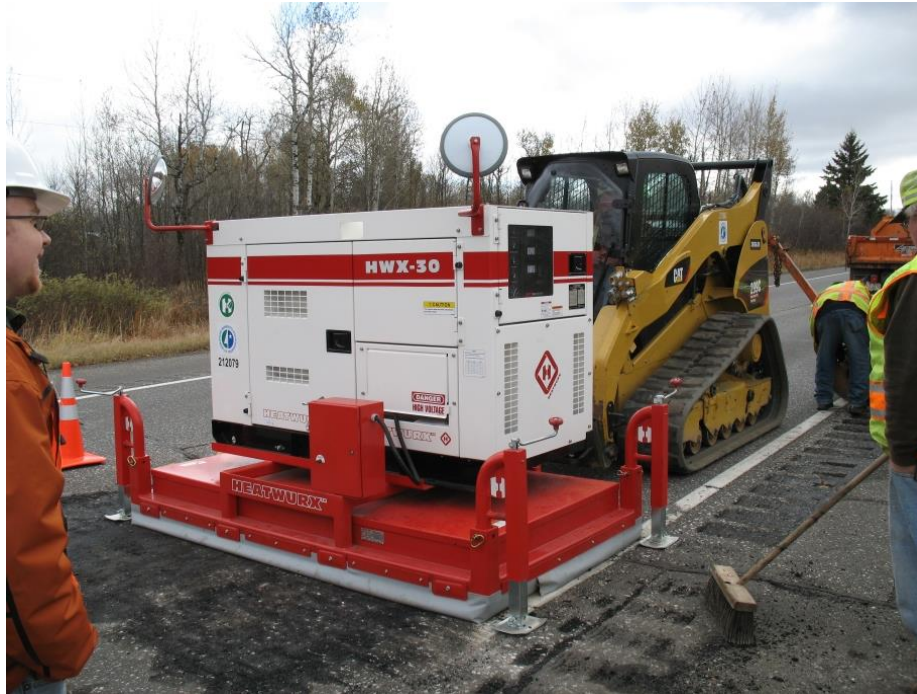
**Figure 3.2. HeatWurx unit and skid-steer.**

shows, the unit has a broad footprint and is moved/positioned with a skid-steer. After the pavement is heated, crews can use rakes and shovels (Fig. 3.3) or a rototiller type of attachment (Fig. 3.4) to work/disaggregate the softened pavement prior to its re-compaction. The unit essentially acts as a hot in-place recycler.

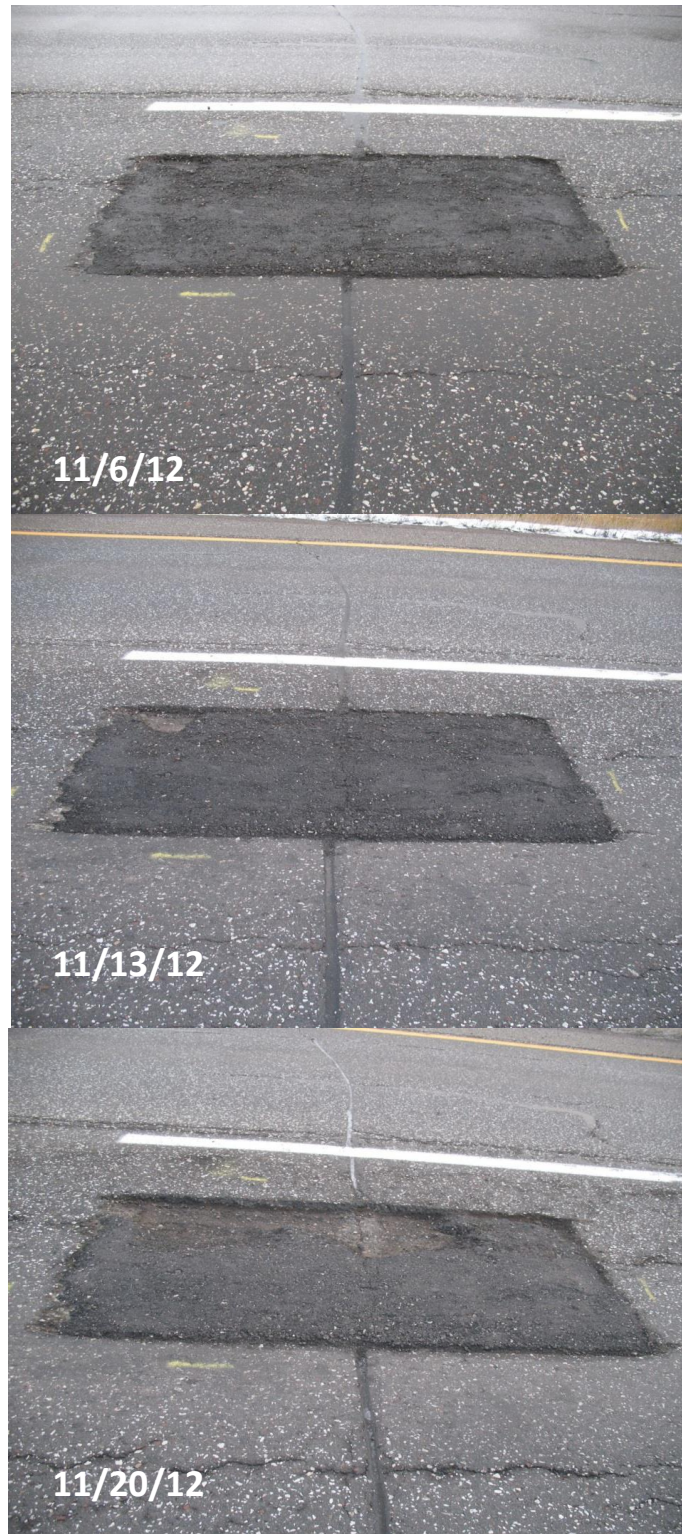
**Figure 3.15. HeatWurx repair #1 (Bullyan location), showing progressive loss of material.**

To be fair, at this point in time the HeatWurx unit was still in its earliest stages of use. Still, the premature failures could be partially attributed to the nature of IR heating itself. Temperature measurements made with a rigid probe indicated that the HeatWurx's surface-downward heating mechanism resulted in a steep temperature differential between the pavement surface (hot) and the deeper underlying pavement (cooler). If the temperature of the surficial asphalt becomes too hot, the overheated asphalt binder can lose some of its binding properties. That is why a "rejuvenator" is part of the HeatWurx process; it is added to impart additional binding capacity to the recycled pavement. However, it is also likely an insufficient amount of "rejuvenator" was added to the heated and milled asphalt prior to the repair's compaction. Another factor that probably played a role was the mechanical "tilling" of the heated pavement (refer back to Fig. 3.6), which also removed not only what was softened but likely incorporated some deeper asphalt that was merely warm and therefore relatively "dry" (binder not softened). Further, the "tilling" action exposed the disaggregated asphalt to the ambient air, which may have accelerated its cooling. Therefore, when all of these contributing factors are considered and the disaggregated asphalt was recombined and re-compacted, the asphalt probably lacked the cohesive properties it needed for producing a durable and lasting repair.

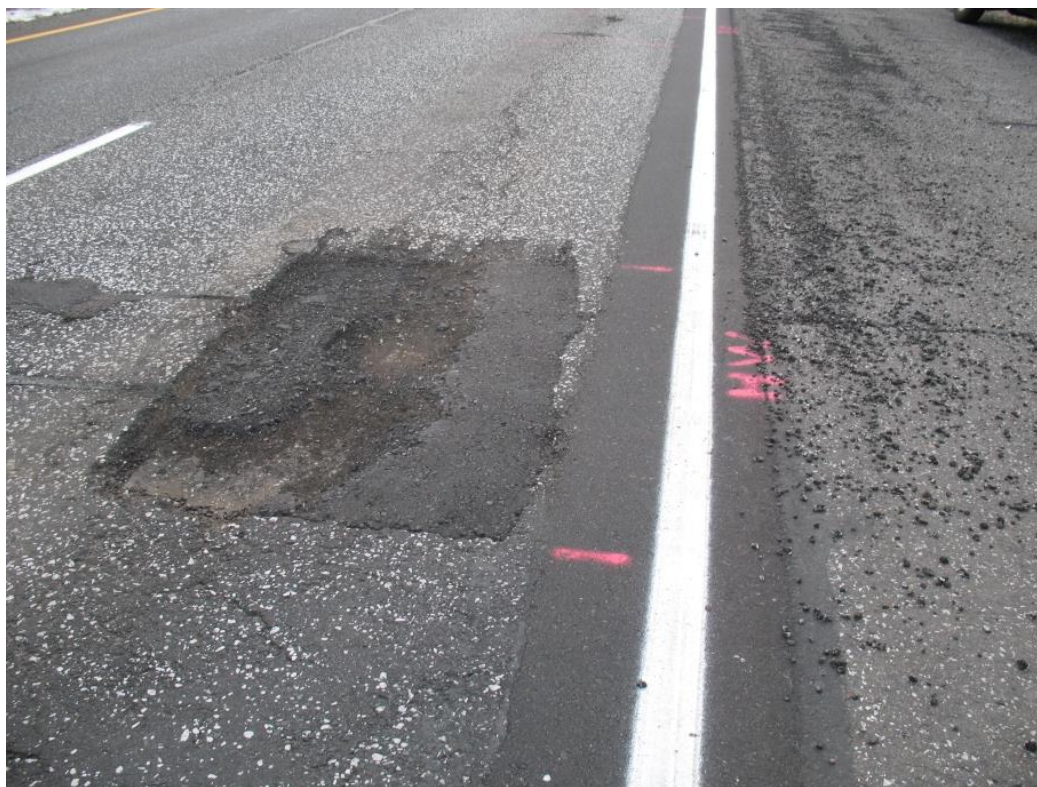
**Figure 3.17. HeatWurx repair #2, Highway 53 (Monaco Air sign) location: failing condition on November 13, 2012.**

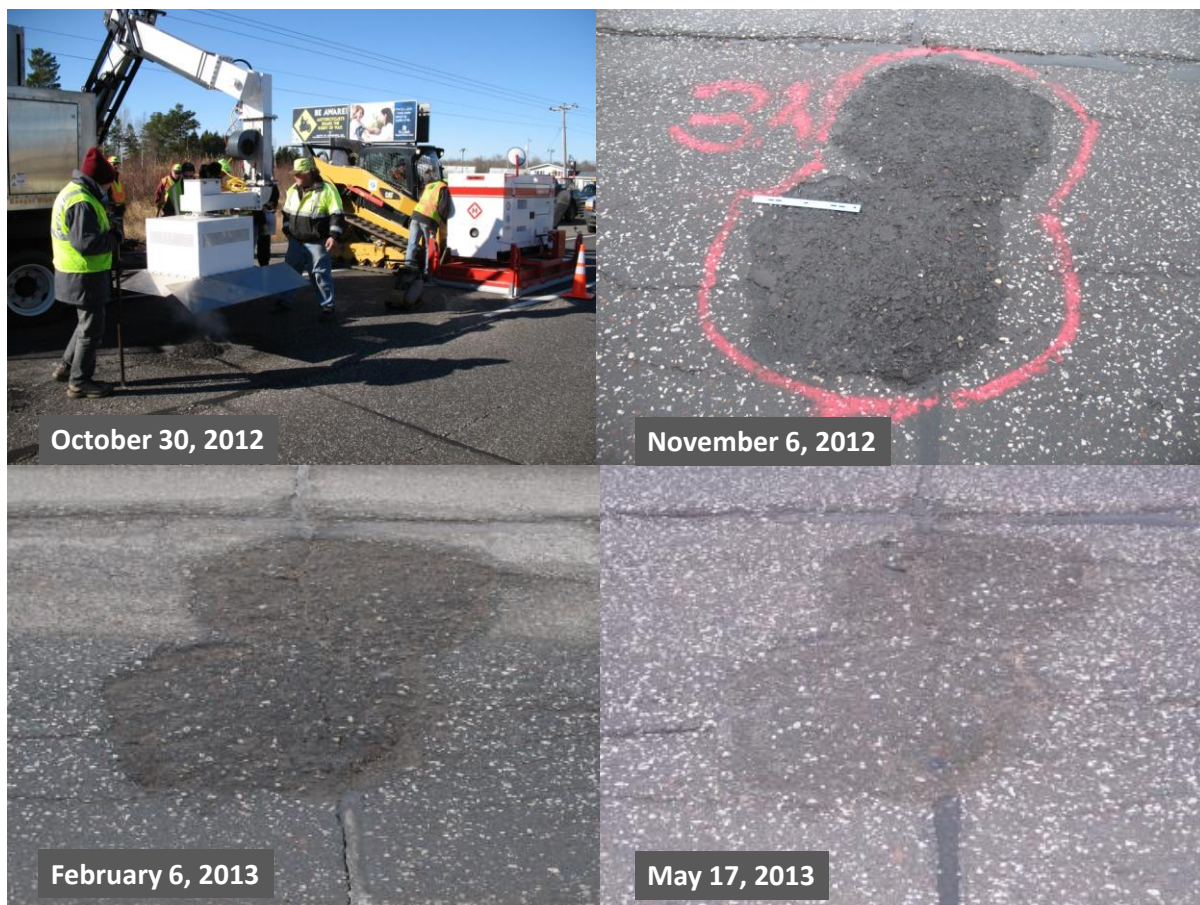
**Figure 3.18. Highway 53 microwave pothole (Hole 3) repair; note the 12 inch ruler for scale in the November 6 photo.**

The condition of the selected October 30, 2012, microwave repair (noted as Hole 3) is shown in the following sequence of photos, from its installation on October 30, 2012, through May 17, 2013 (Fig. 3.18). The aforementioned repair compound was placed in the hole (slightly overfilled to accommodate compaction); heated with MUI's microwave for 6 minutes at 50kW; shoveled, raked, and combined with the softened adjacent pavement; and compacted. The temperature of the pre-compacted mixture was noted to average 105° C (220° F). As Figure 3.18 shows, the repair held up well following installation, exhibiting a minor amount of surface loss (raveling).

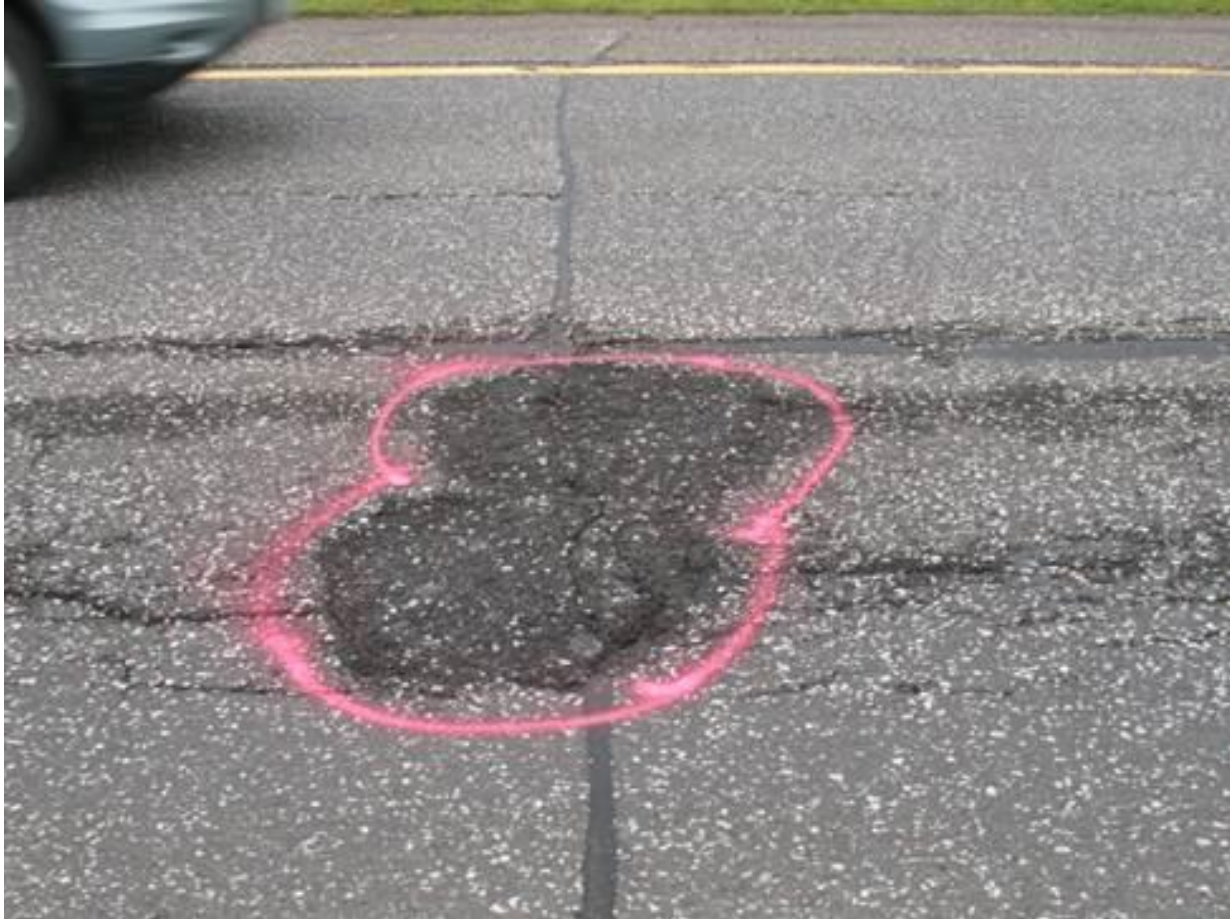
**Figure 3.19. Highway 53 microwave pothole (Hole 3) repair condition on July 30, 2013.**

Figure 3.19 shows the repair's condition on July 30, 2013. While continuing to exhibit minor raveling, it generally remained a sound repair. The surrounding pavement, however, continued to deteriorate, which led MnDOT to mill-and-fill this section of Highway 53—including this repair.

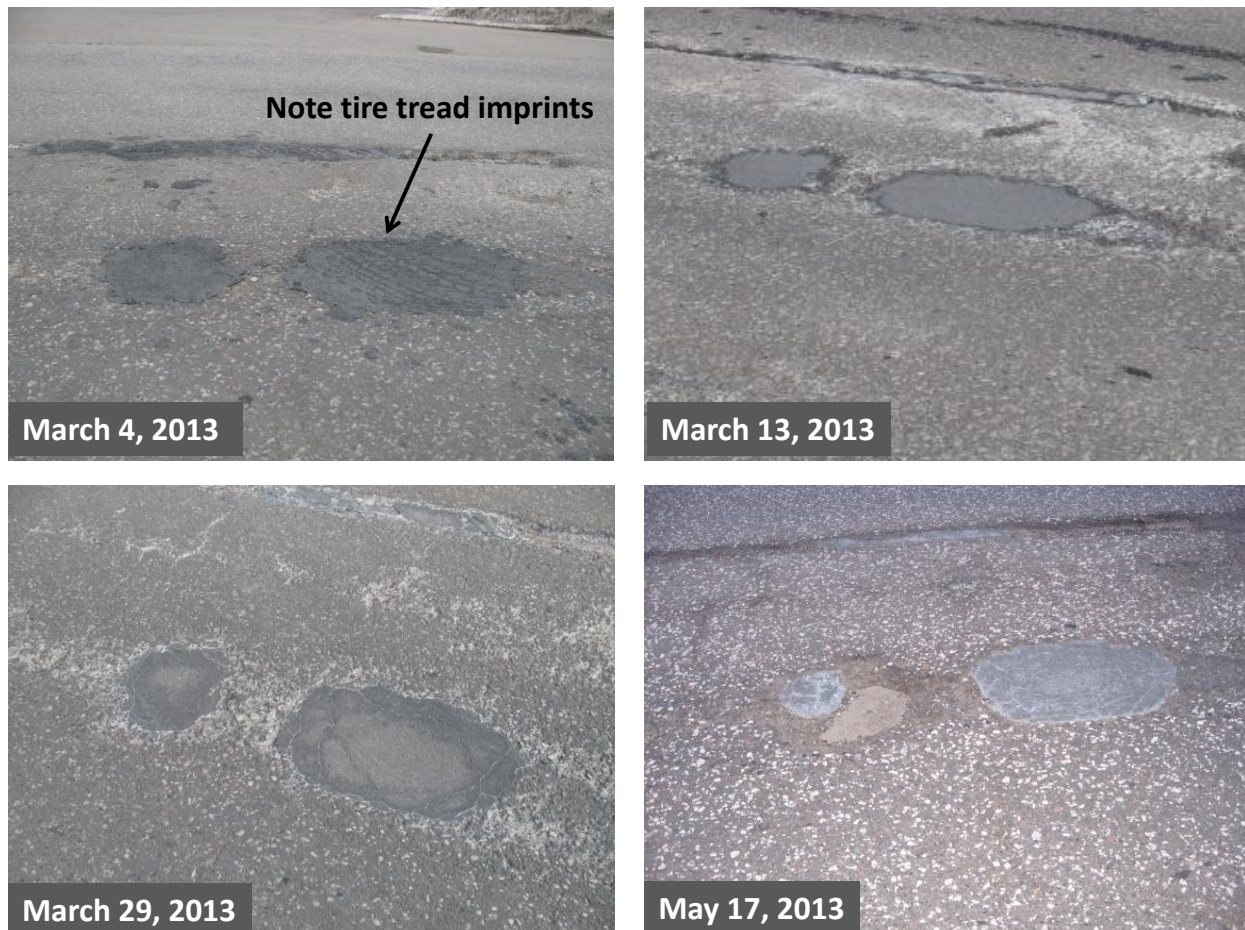
**Figure 3.24. Documentation of condition of the Rapid Patch Cirrus Drive/Highway 53 repair over time (March 4 through May 17, 2013).**

As described previously, the Rapid Patch compound can be provided in either a summer or winter formulation (i.e., longer workability and slower set time in the summer, or quicker workability and faster set times in the winter). Unfortunately, the summer formulation was used during the March 1, 2013 installation and took much longer to set up than it did in the fall, despite the exothermic reaction that occurs when the compound is mixed. As the tire tread imprints in the March 4 photo of Figure 3.24 indicate, the compound remained soft at its surface more than an hour after installation. Still, it had firmed sufficiently to resist serious deformation. Given that the ambient temperature was  $-8^{\circ}\text{C}$  ( $17^{\circ}\text{F}$ ), this outcome showed that a winter formulation would have been the better choice for the cold conditions. Figure 3.24 also documents the condition of the Rapid Patch Cirrus Drive/Highway 53 repair over time. Note that most of the repair was missing from the smaller of the pothole repairs by May 17, 2013, while the other larger repair remained intact.

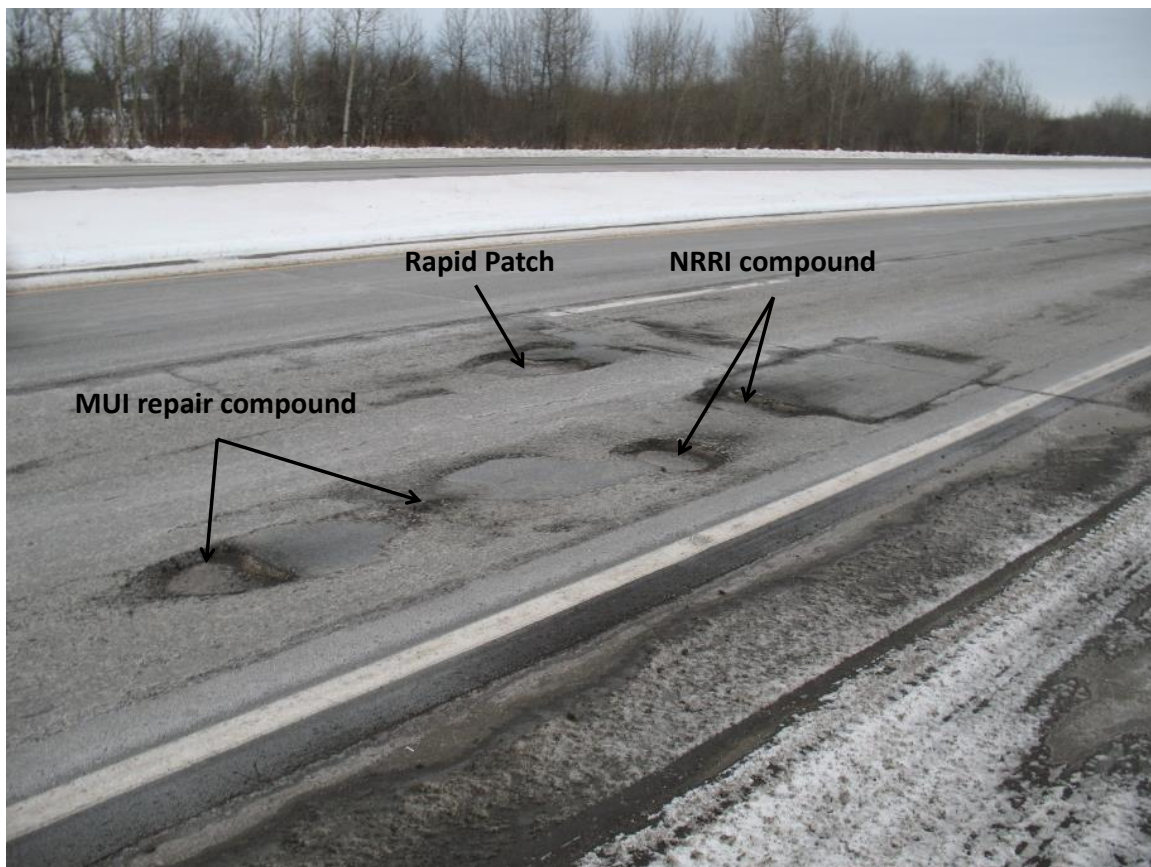
**Figure 3.28. Highway 53 Monaco Air sign location for March 1, 2013 field trial; target holes prior to patching.**

Figure 3.28 shows the pre-repair condition of target potholes, and notes where each repair was to be placed. Note also: 1) the large rectangular patch to the right of the notation, “NRRI compound” in Figure 3.28; it was a hot-mix repair installed in late November 2012 that replaced the original October 30, 2012, HeatWurx repair; and 2) the two patches to the immediate right of both MUI arrows; they are an epoxy product previously placed by MnDOT at this location.

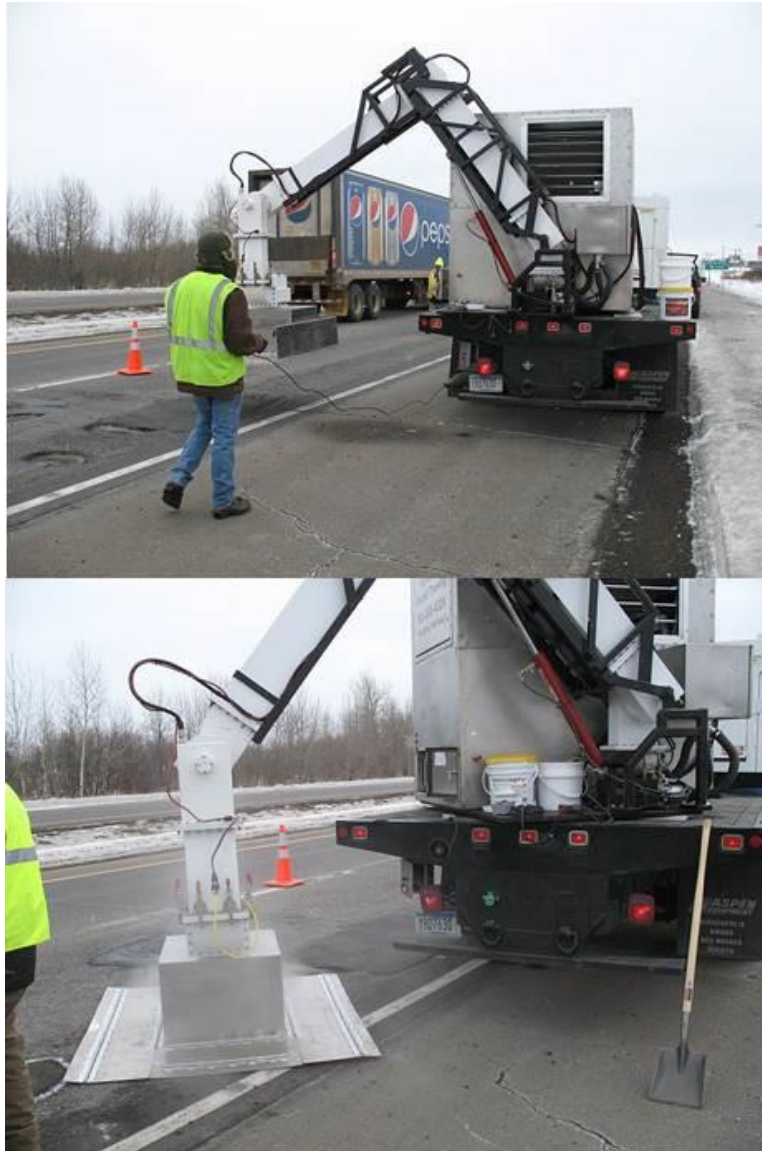
**Figure 3.29. Positioning microwave unit (upper photo) and microwave heating (lower photo), Highway 53 Monaco Air sign location: March 1, 2013.**

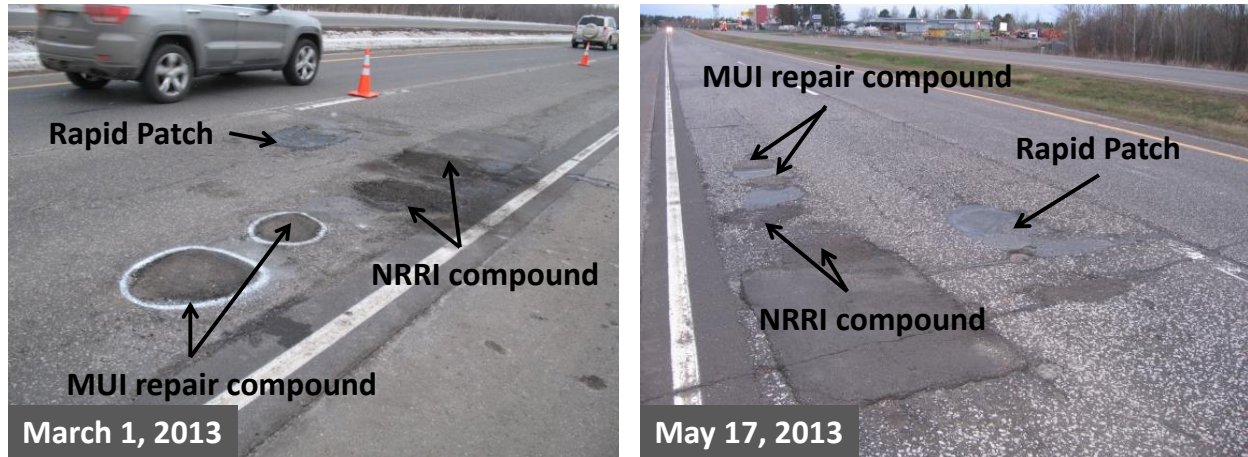
**Figure 3.30. Condition of Highway 53 (Monaco Air sign) repairs: March 1 and May 17, 2013.**

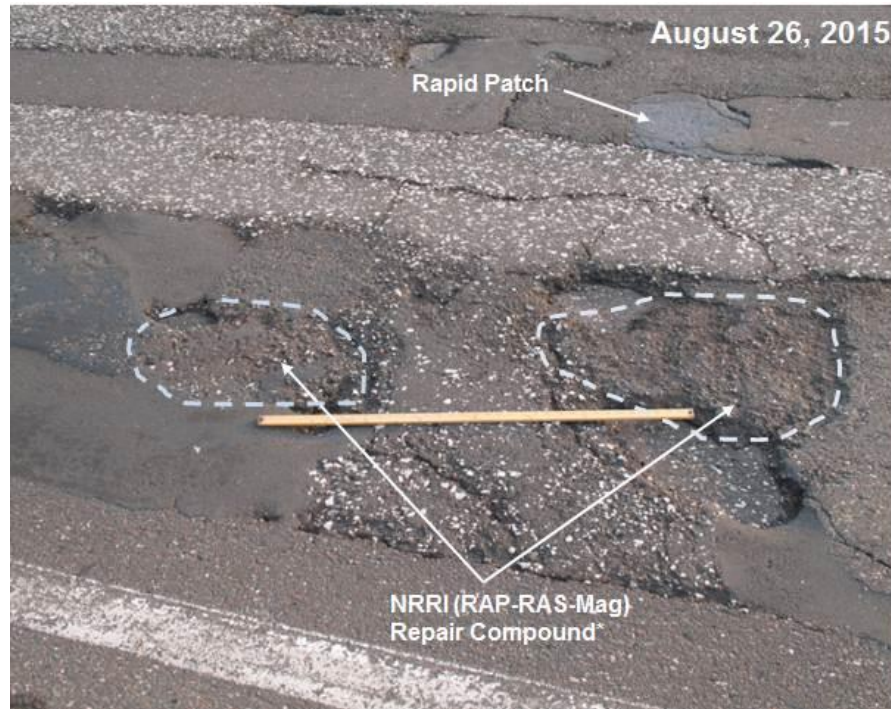
**Figure 3.36. Highway 53 (Monaco Air sign) location, NRRI RAP-RAS-Mag microwave repairs (dashed outlines) and the Rapid Patch repair: August 26, 2015.**

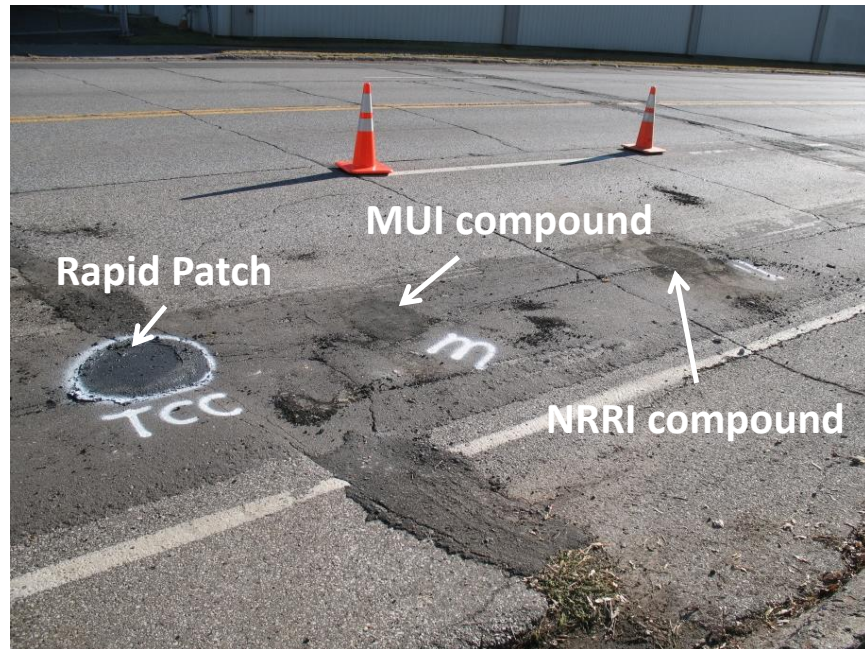
**Figure 3.51. Three-hole repair, October 31, 2012, Grand Avenue: TCC Rapid Patch (left); MUI microwave (center); NRRI microwave (right).**

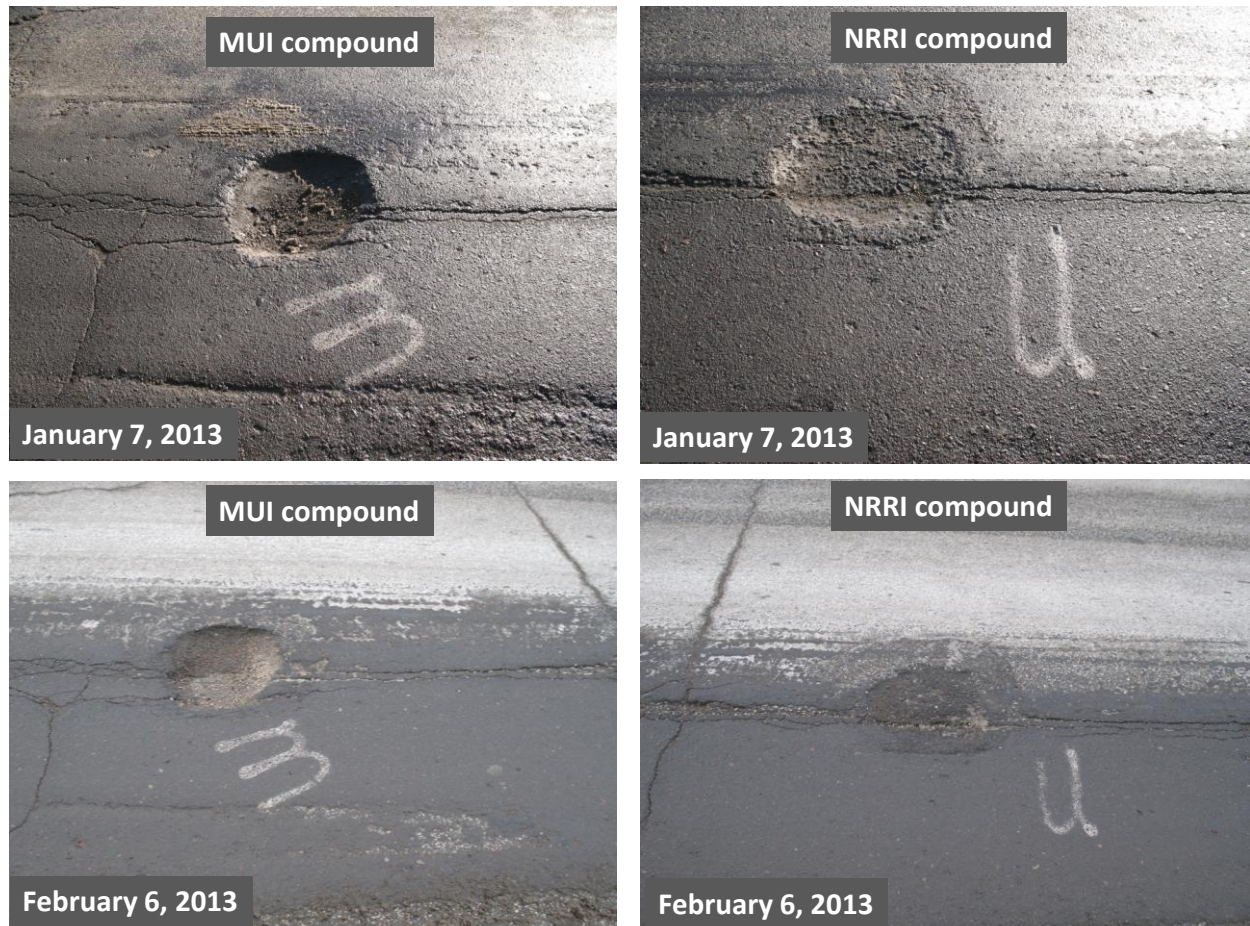
**Figure 3.54. MUI and NRRI microwave compounds, Grand Avenue repair comparison.**

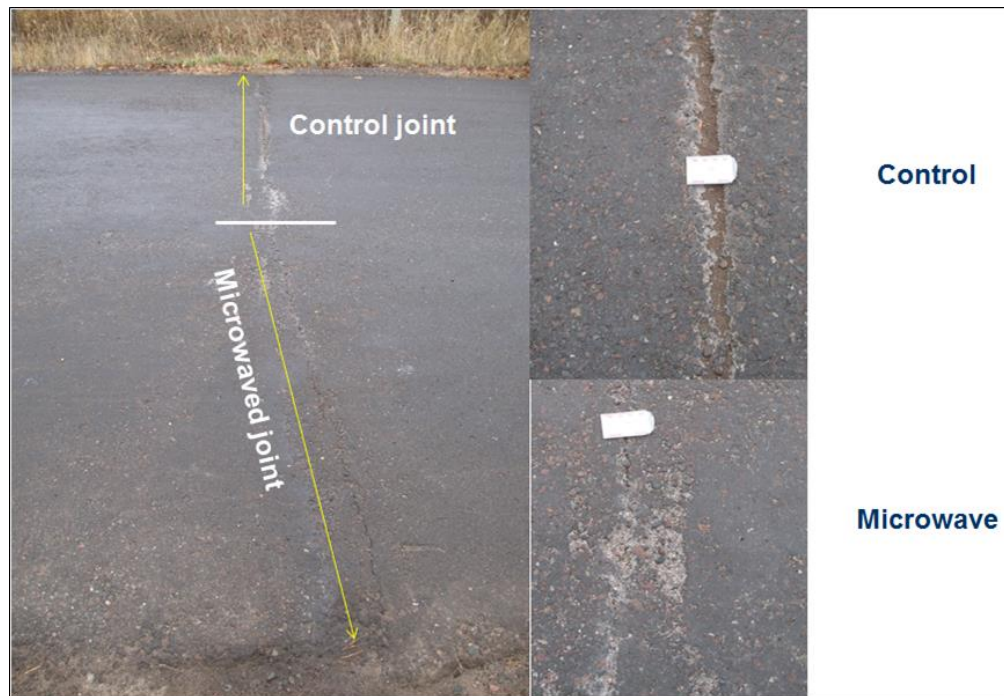
**Figure 3.59. Condition of butt joint microwave repair on November 18, 2013.**

Figure 3.59 shows the condition of the repair just over one year later, on November 18, 2013.

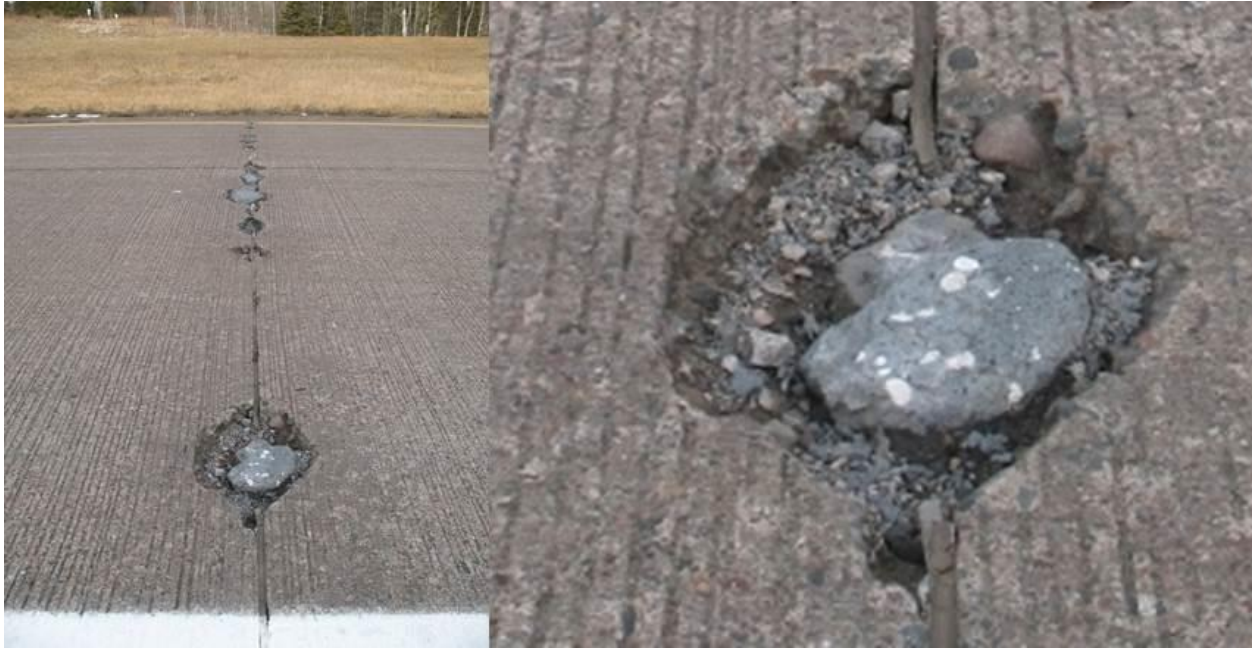
**Figure 3.69. Failing condition of a Highway 61 Rapid Patch repair 2 years after installation: December 26, 2014.**

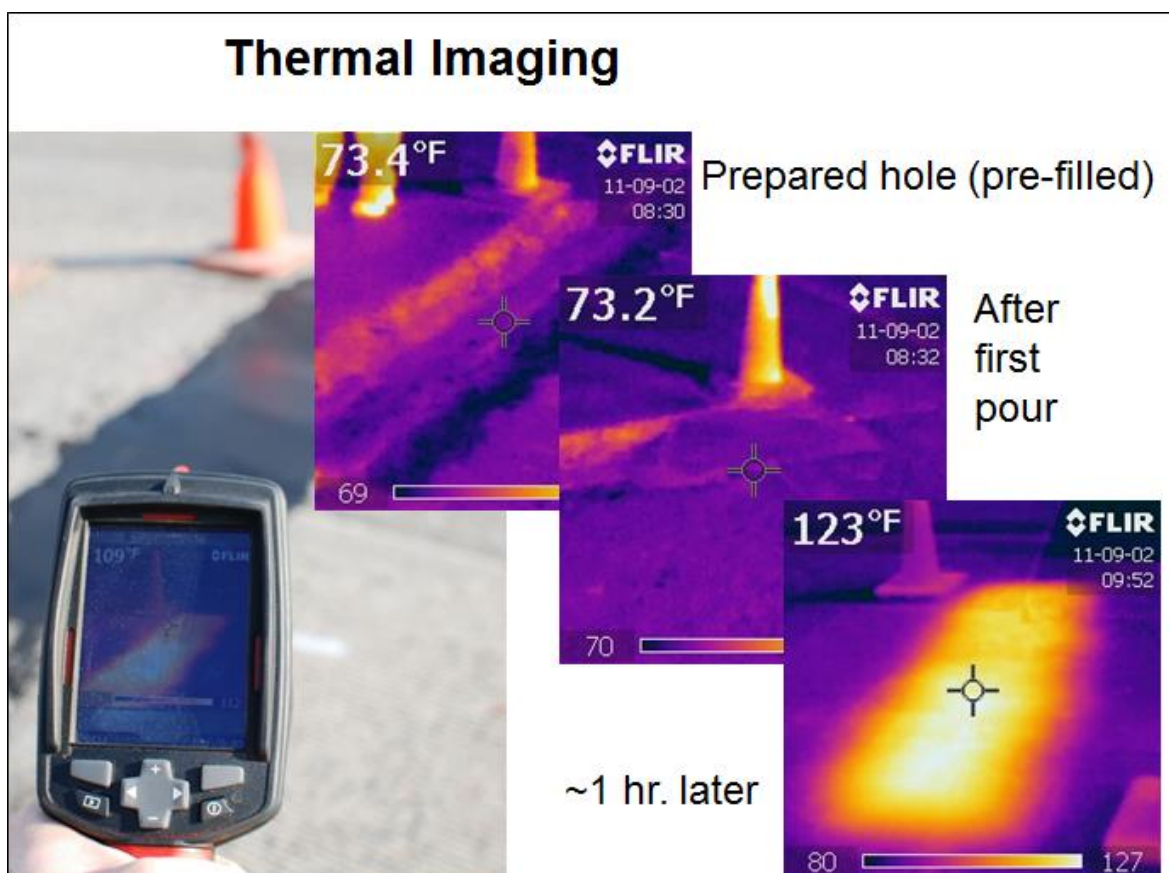
**Figure 3.75. Thermal imaging showing exothermic reaction as Rapid Patch repair set and cured: September 1, 2011.**

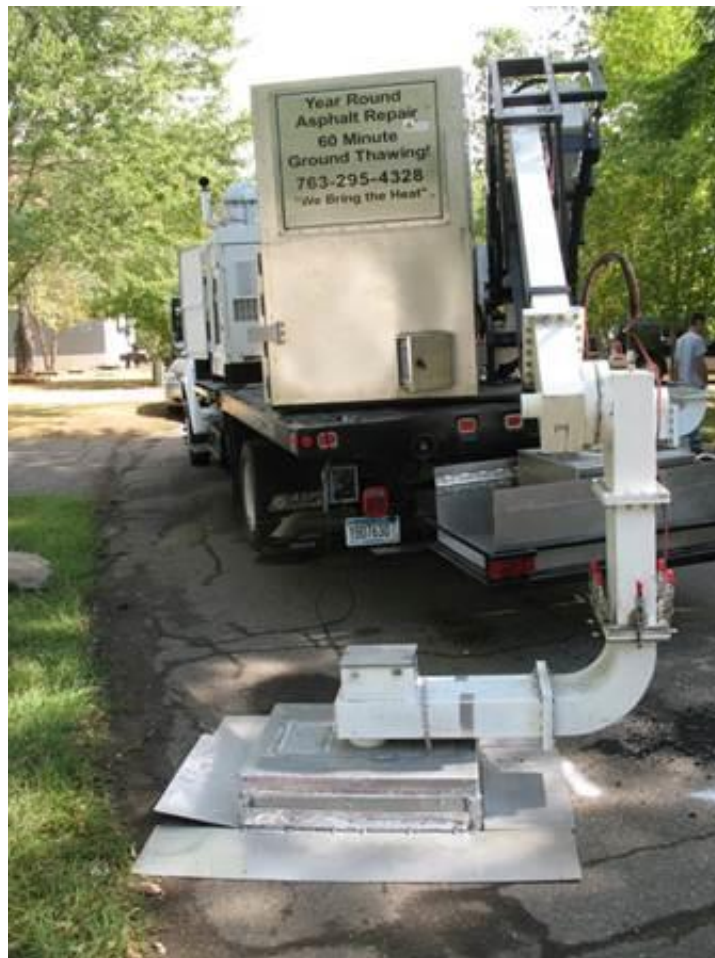
**Figure 3.77. Modified microwave equipment: September 10, 2013 field test, Monticello, MN.**

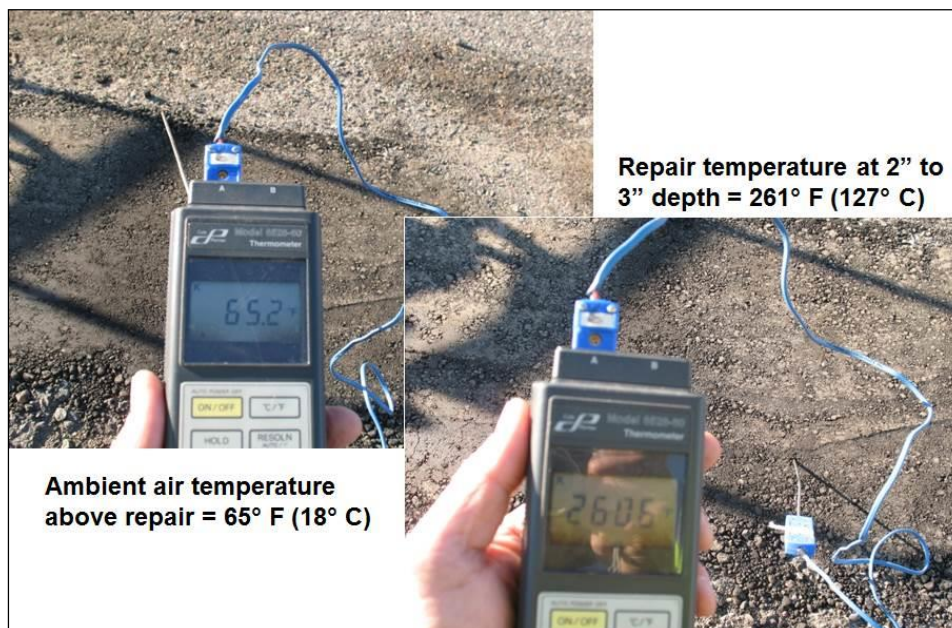
**Figure 3.81. Photographs showing air temperature and internal temperature of microwave repair: November 14, 2013, Monticello, MN.**

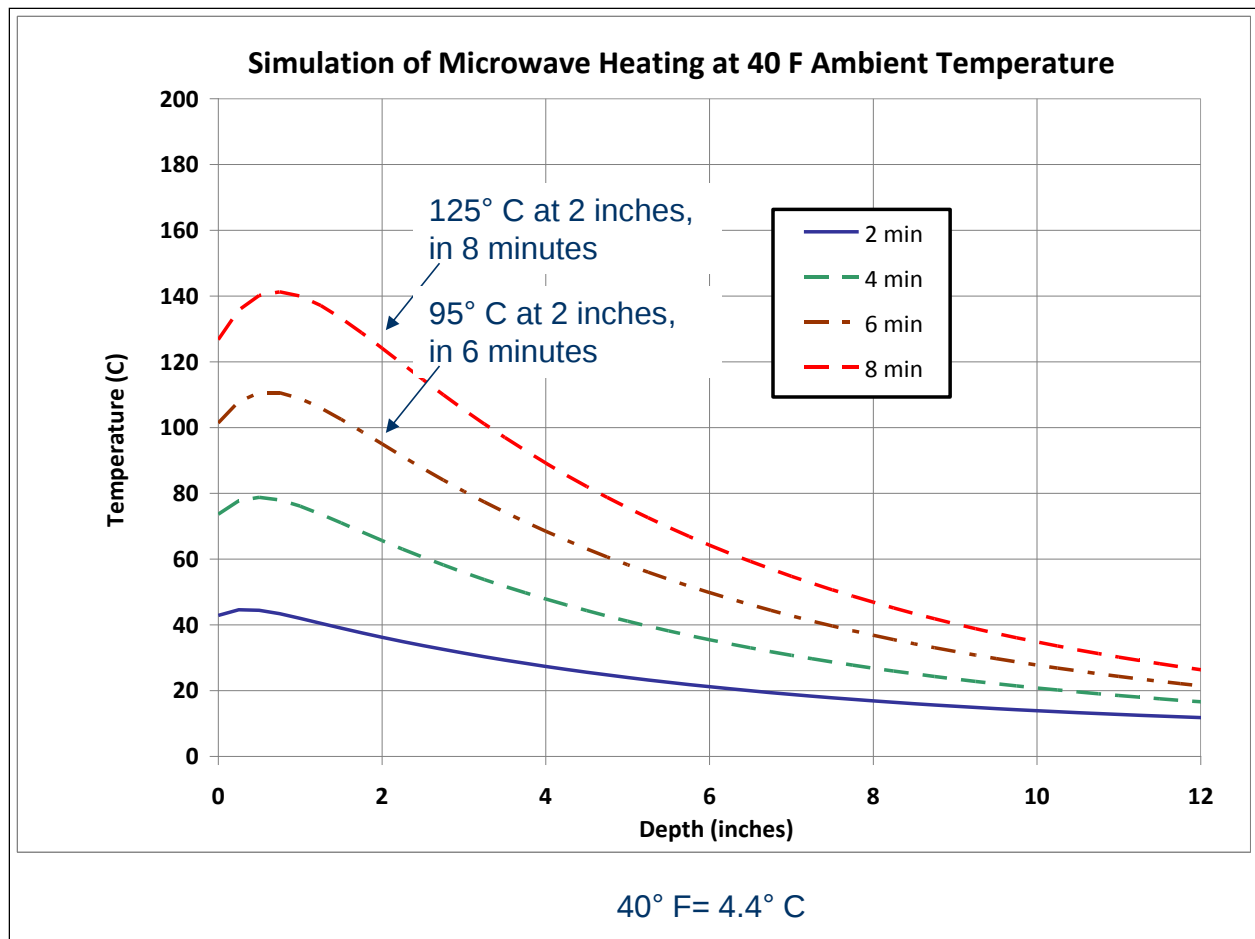
**Figure 3.82. Simulation of microwave heating of asphalt pavement at 40° F ambient temperature.**

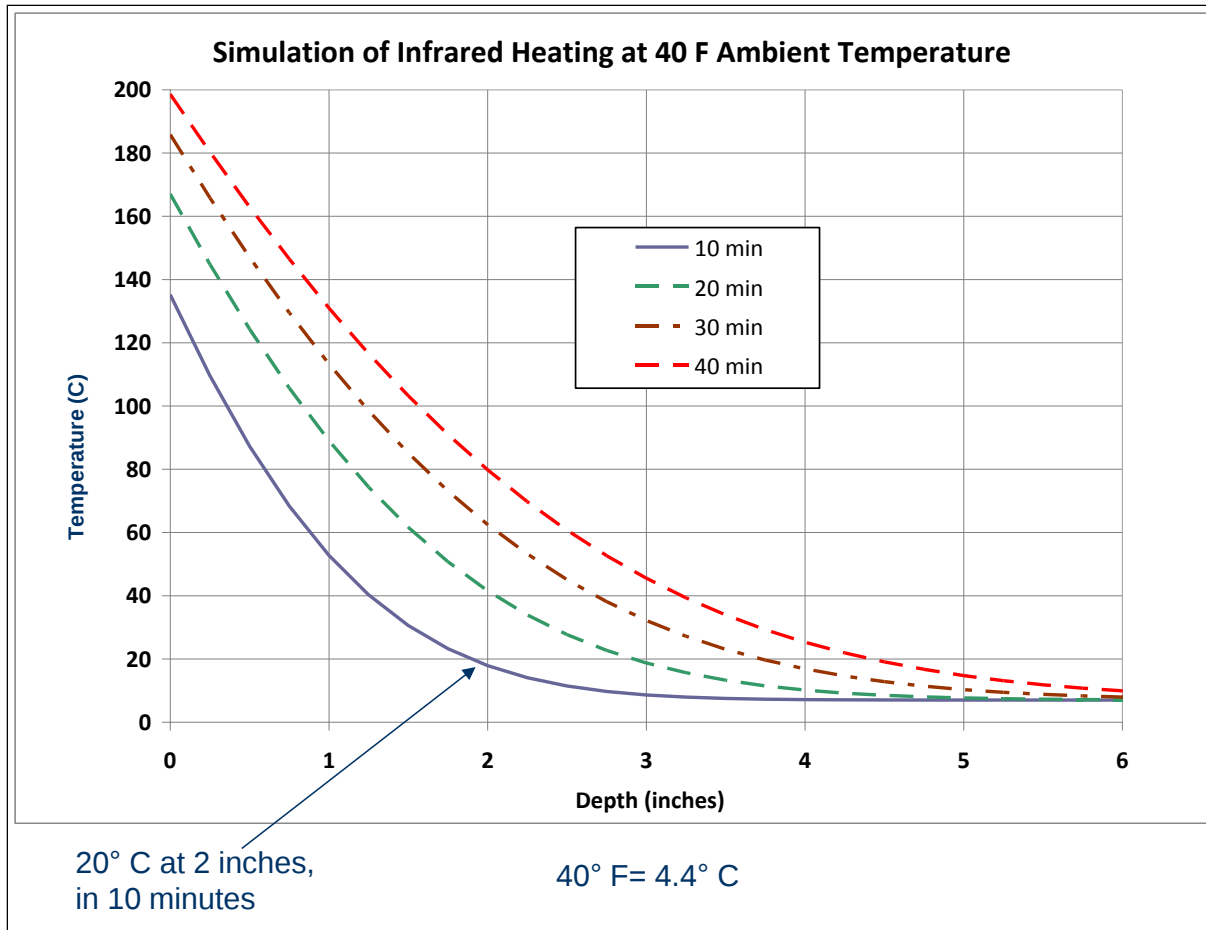
**Figure 3.83. Simulation of infrared heating of asphalt pavement at 40° F ambient temperature.**

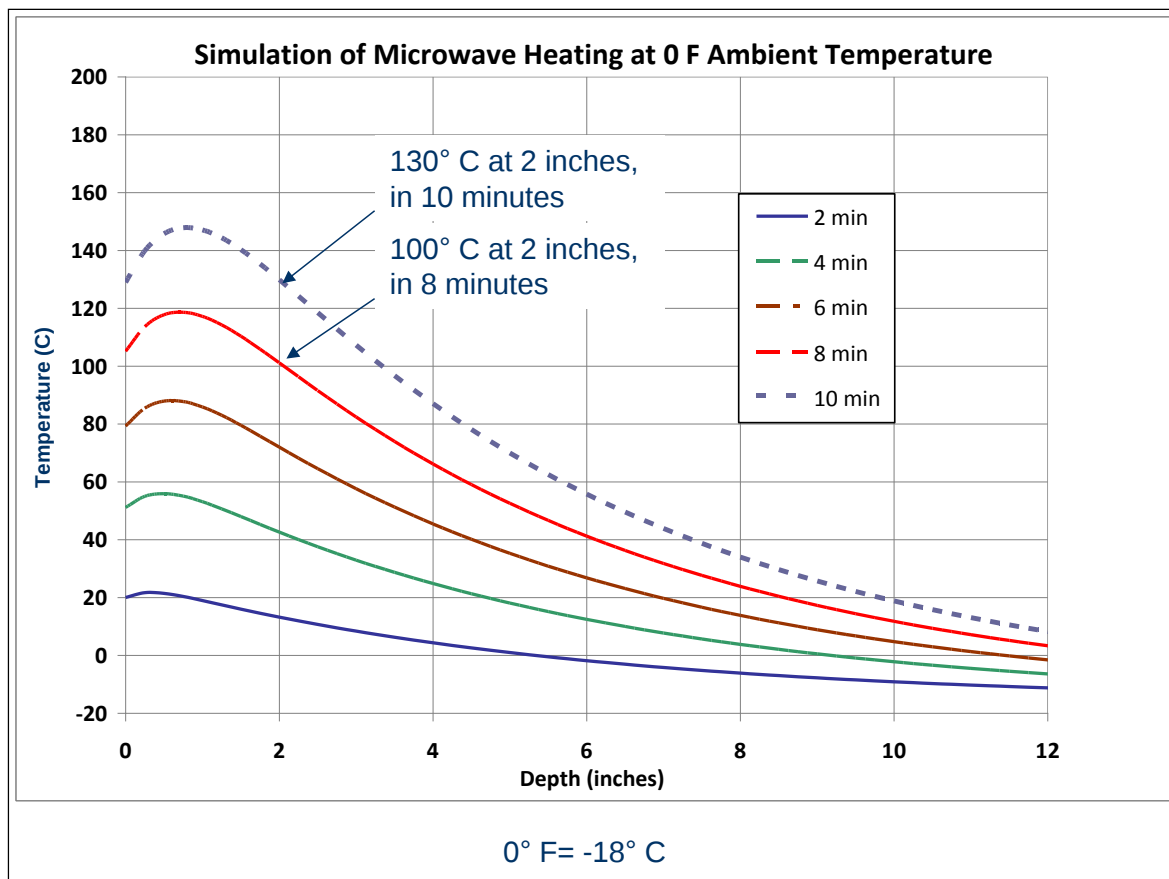
**Figure 3.84. Simulation of microwave heating of asphalt pavement at 0° F ambient temperature.**
