# **Pavement Marking/Colored Pavement Friction Differential and Product Durability**

**Mihai Marasteanu, Principal Investigator**  
Civil, Environmental, and Geo- Engineering  
University of Minnesota

Research Report  
Final Report 2025-30

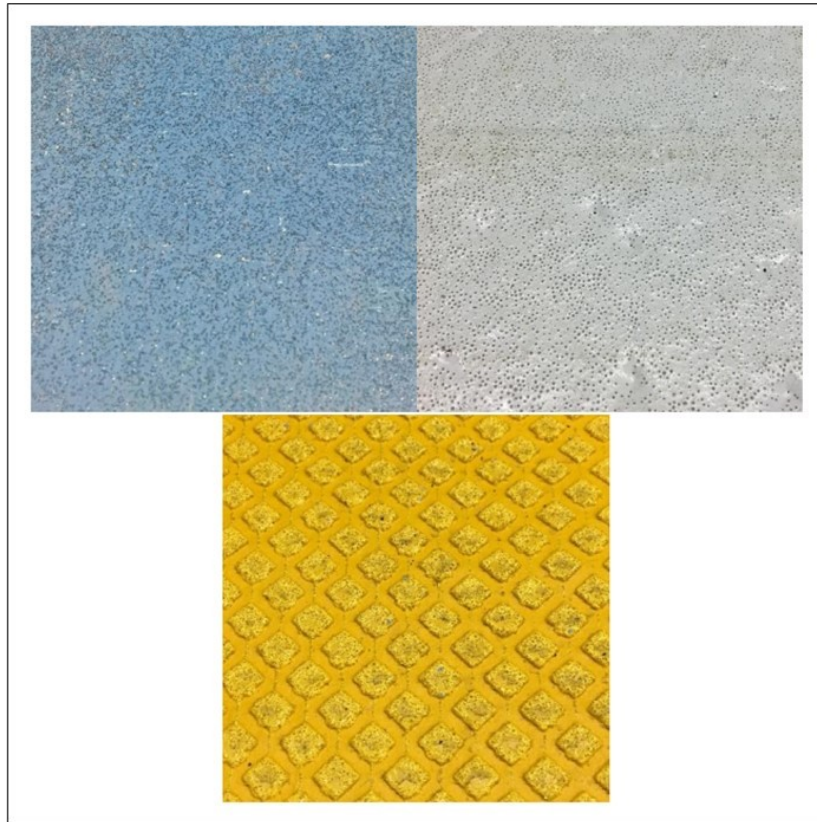
**Figure 2.4 Slab surface markings for a) paint with beads, b) thermoplastic with beads, and c) cold-applied preformed tape (Nassiri, 2018)**

In a different study, Nassiri et al. (2018) investigated the frictional properties of three different types of pavement markings materials using a British Pendulum Tester (BPT) in the laboratory and in the field. Waterborne paint, preformed fused thermoplastic, and cold applied pre-formed tape were applied to concrete slabs and tested in the laboratory under dry, wet, and icy conditions. The three pavement marking types are shown in figure 2.4.

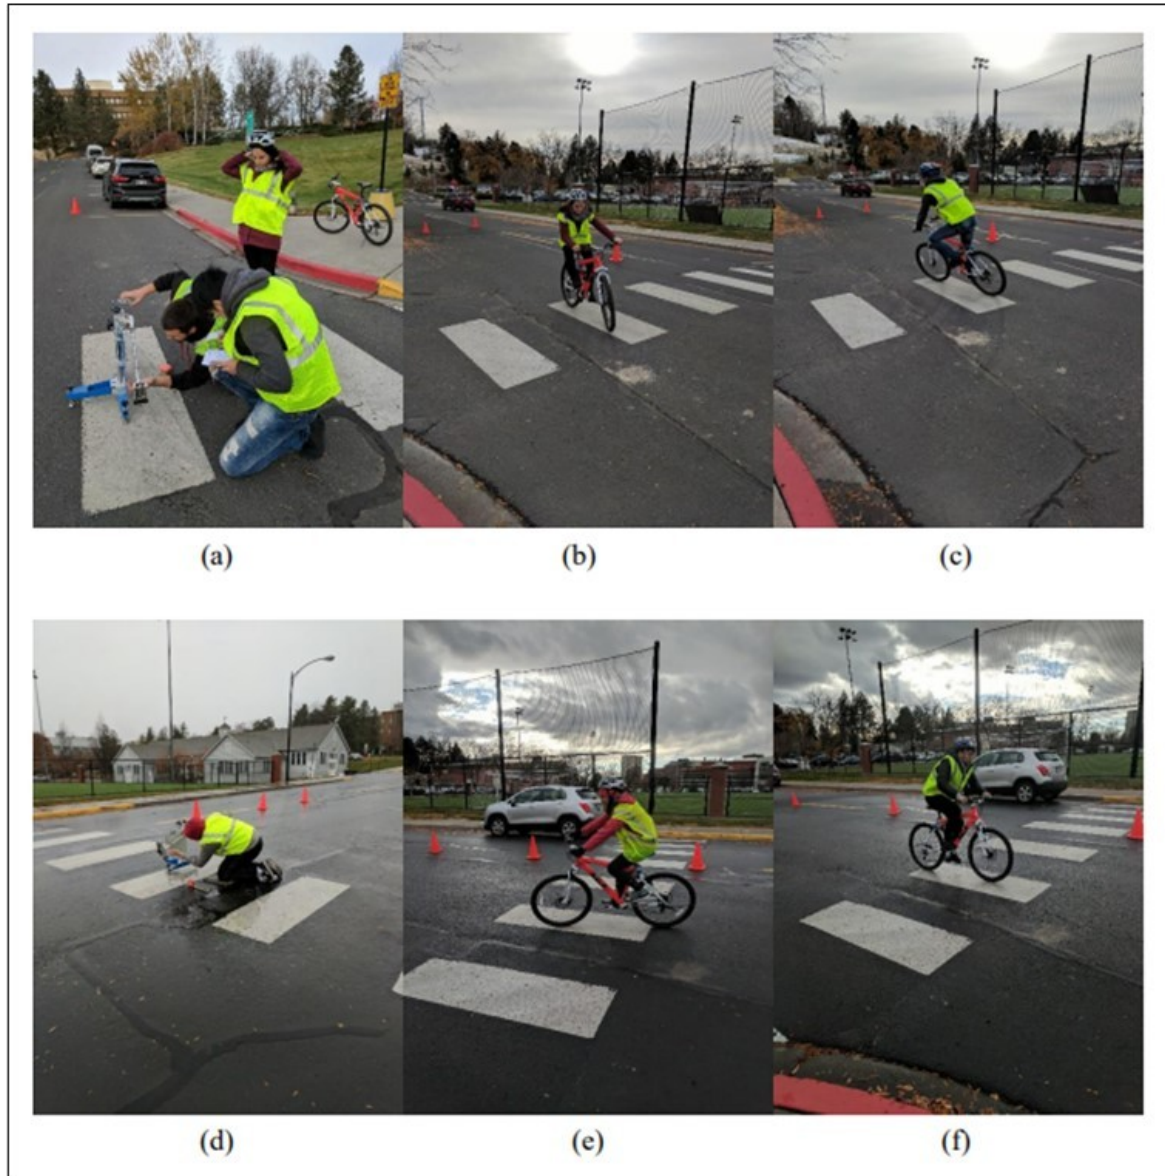
**Figure 2.5 Dry testing using the mountain bike at Test Site 1 by a) the BPT, b) rider one, and c) rider two. Wet testing at Test Site 2 by d) the BPT, e) rider one, and f) rider two (Nassiri, 2018)**

The field testing evaluated painted markings applied at two different locations on the Washington State University (WSU) Pullman campus, under dry and wet conditions. The testing used a BPT and two bicyclists that rode over the markings in a variety of ways (figure 2.5). The riders, then, evaluated the field markings using a safety scale created by the authors. (Nassiri, 2018)

Laboratory test results revealed that the paint and thermoplastics resulted in lower BPN values than the control concrete surface. Results from the field testing revealed that most riders feel unsafe when turning and braking on wet pavement markings. The BPN values obtained in the laboratory tests were higher than the values obtained in the field, likely due to the fact that beads were used only in the laboratory. The authors concluded that the centerline striping showed promising frictional properties. Out of the three marking materials tested with the BPT, only cold-applied preformed tape was found suitable for difficult road sites, such as a) roundabouts, b) bends with radius less than 150m on unrestricted roads, c) gradients, 1 in 20 or steeper, of lengths greater than 100m, and d) approaches to traffic lights on unrestricted road. (Nassiri, 2018)

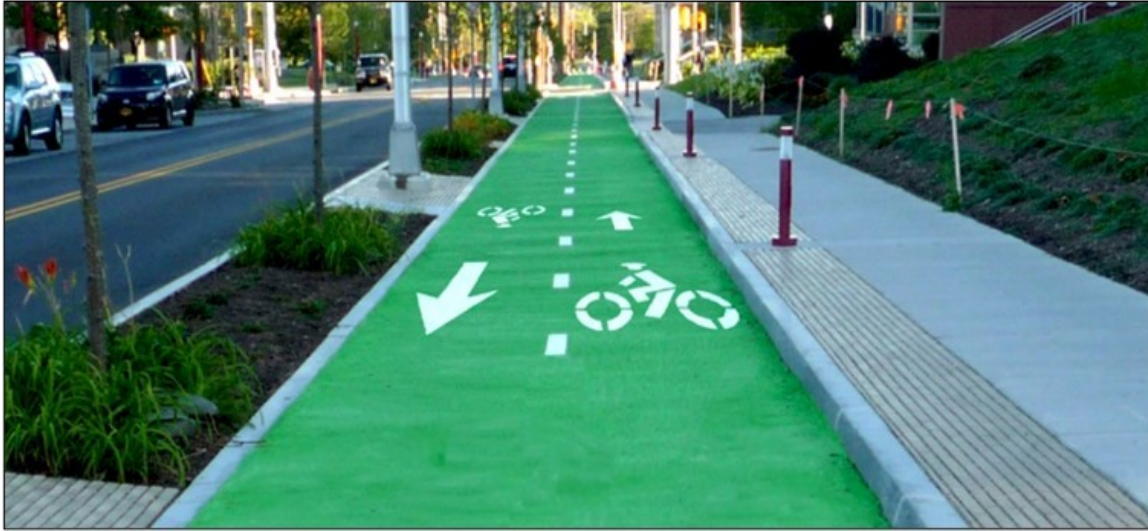
**Figure 2.6 Green bike lane in NYC colored with Color-Safe™ Methyl methacrylate (MMA) (Grossman, 2017)**

The commercial product Color-Safe™ (figure 2.6), from Transpo Industries of New York, is sold as an acrylic based resin system used for area markings and anti-skid surfacing for asphalt and concrete pavements. The product is advertised as a pavement coloring material and as a surface coat to enhance skid-resistance on hazardous turns and other high accident areas. It is expected to have a life cycle of 6 to 10 years, requires a curing time of 20 to 40 minutes, and the application does not need specialized equipment. (Grossman, 2017; Coral Sale Co., n.d)

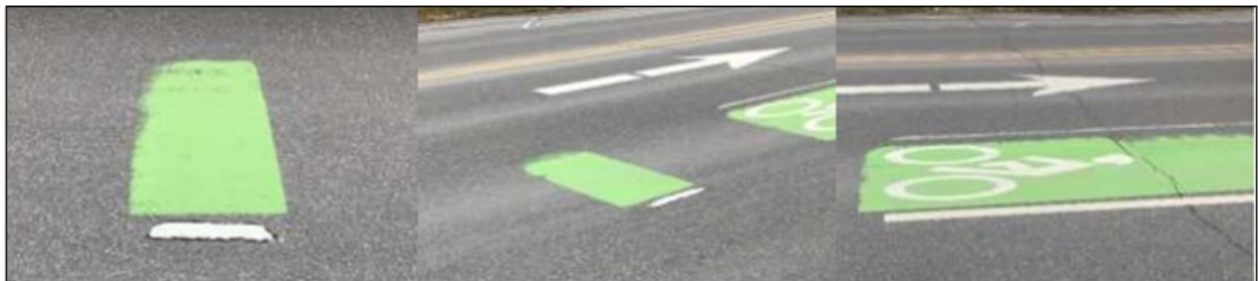
**Figure 2.9 Location 1 PreMark in fair condition**

The authors used visual observations of the bike lane markings and categorized each marking on a Good/Fair/Poor/Missing scale. Examples of the classification can be seen in Figure 2.8 for Good Condition, in Figure 2.9 for PreMark in Fair Condition, and in Figure 2.10 for Poor performing markings. Observations after 2 years of service revealed that the Color-Safe MMA was performing the best in both of its applications, followed by the CycleGripMMA, and PreMark having the worst performance. Color-Safe had more texture remaining and retained a greater depth/thickness of material. Based on the results, the study suggested that MMA green bike material should be explored for future bike lane markings, when cost, time to use, and environmental factors permit. (Anderson, 2018)

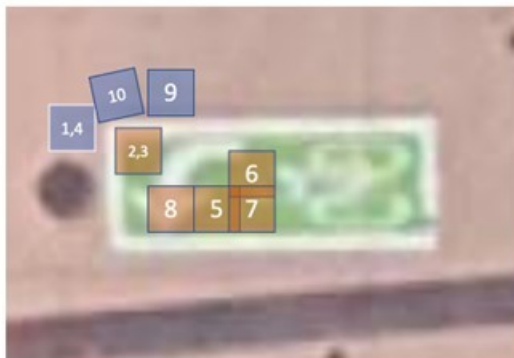
DFT tests were performed on both the epoxy marking and the concrete pavement near the marking. The locations and the testing conditions (dry or wet) of the ten tests are shown in Figure 4.5.

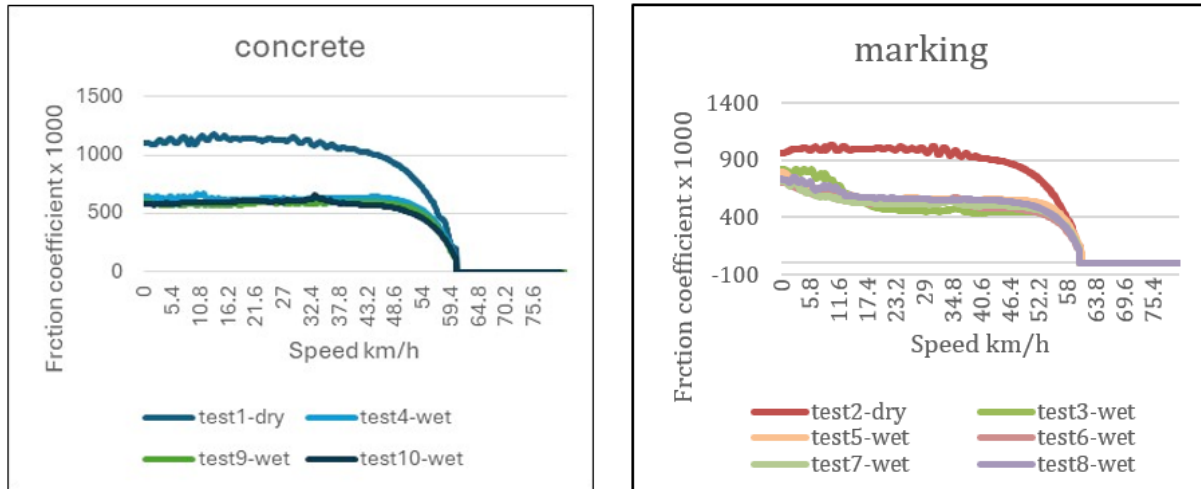
concrete pavement at low sliding speed, while at high sliding speed, the friction coefficient of marking becomes lower than that of the concrete pavement. This observation implies that there might be two different mechanisms for friction at low and high sliding speeds, and the effect of surface water on these mechanisms might differ for concrete pavement and pavement marking.

Figure 4.6 DFT results (a) concrete, (b) marking

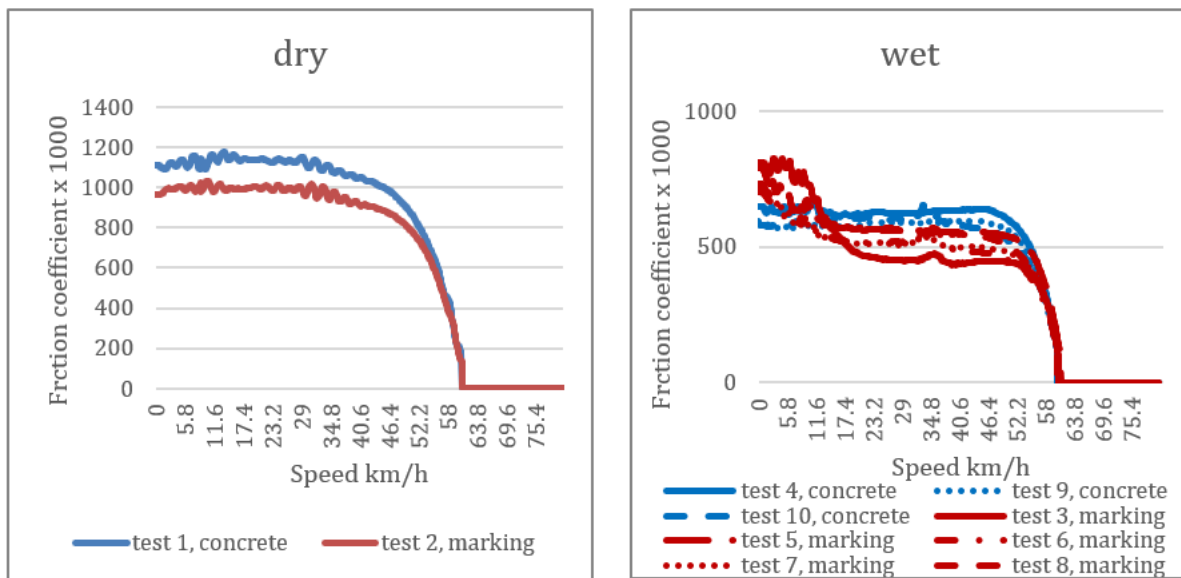
Figure 4.7 DFT test results (a) dry, (b) wet

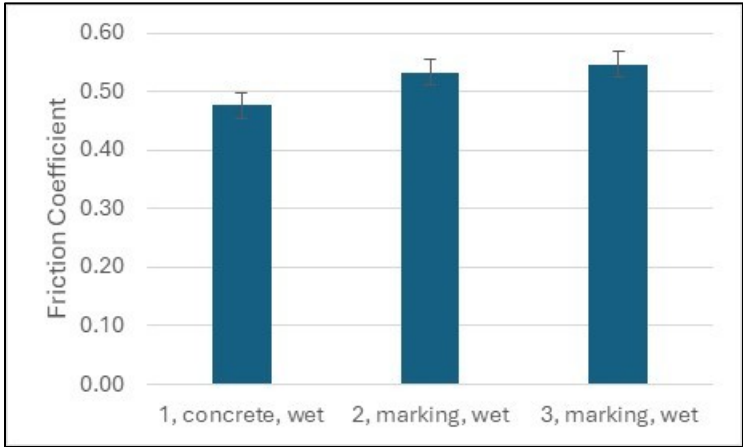
**Figure 4.9** British pendulum test results

The test results are shown in Figure 4.9. It can be seen that in wet surface condition, the friction coefficient of epoxy marking is higher than that of the concrete pavement. This result is consistent with the DFT result at low sliding speed.

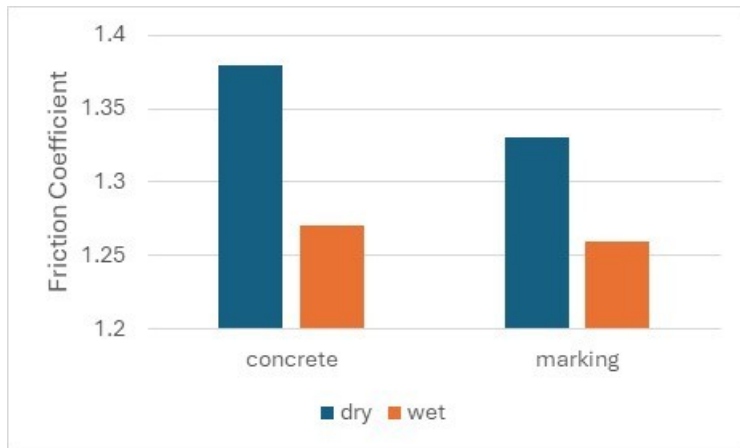
The test results are plotted in Figure 4.11 and show that concrete pavement has higher friction coefficient than the epoxy marking in both dry and wet conditions. This result is consistent with the DFT results at high sliding speed, and is inconsistent with the BP results.

**Figure 4.11 T2Go test results**

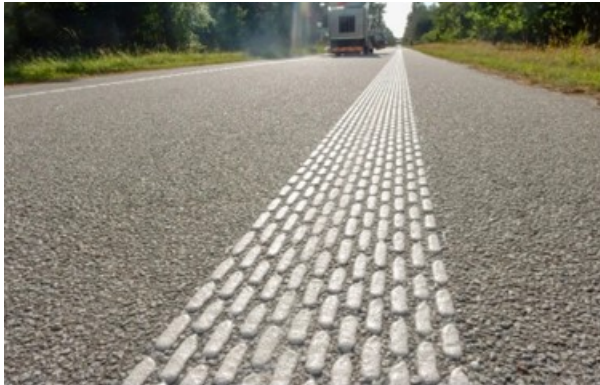
**Figure 4.19 Geveko Markings new road marking profile (Geveko, 2018)**

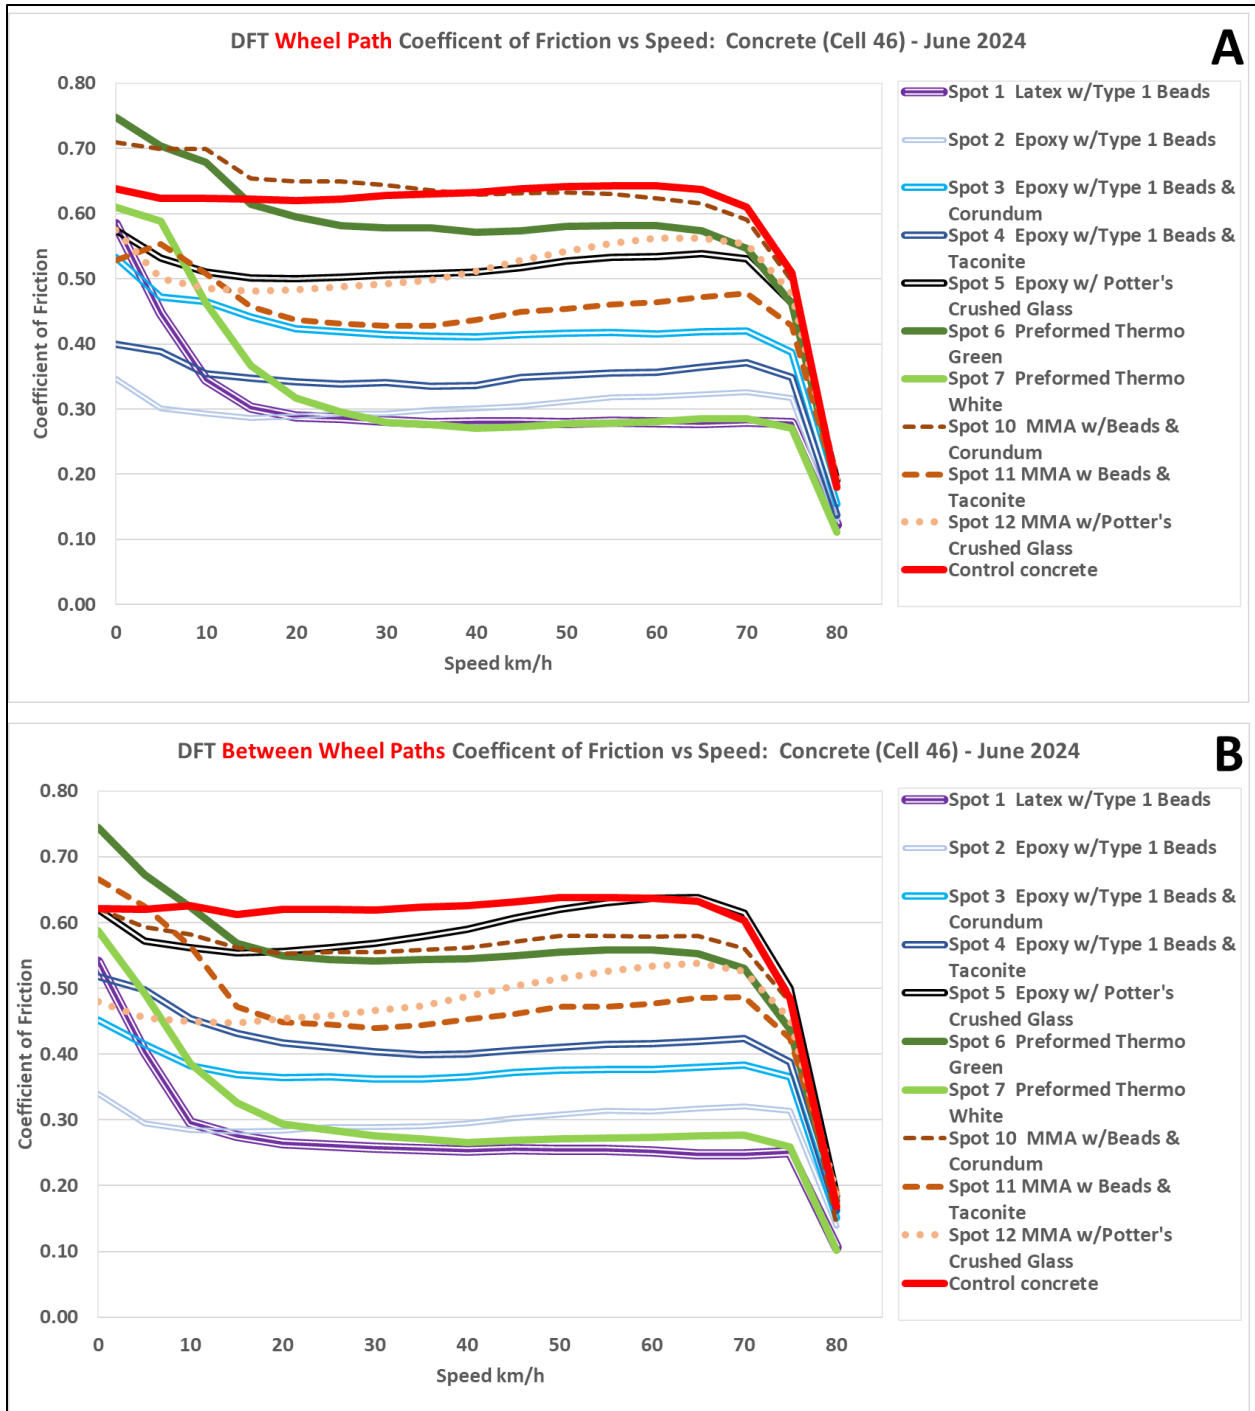
Figure 6.2 June 2024 DFT results for markings applied to MnROAD concrete Cell 46: WP (A) and BWP (B)

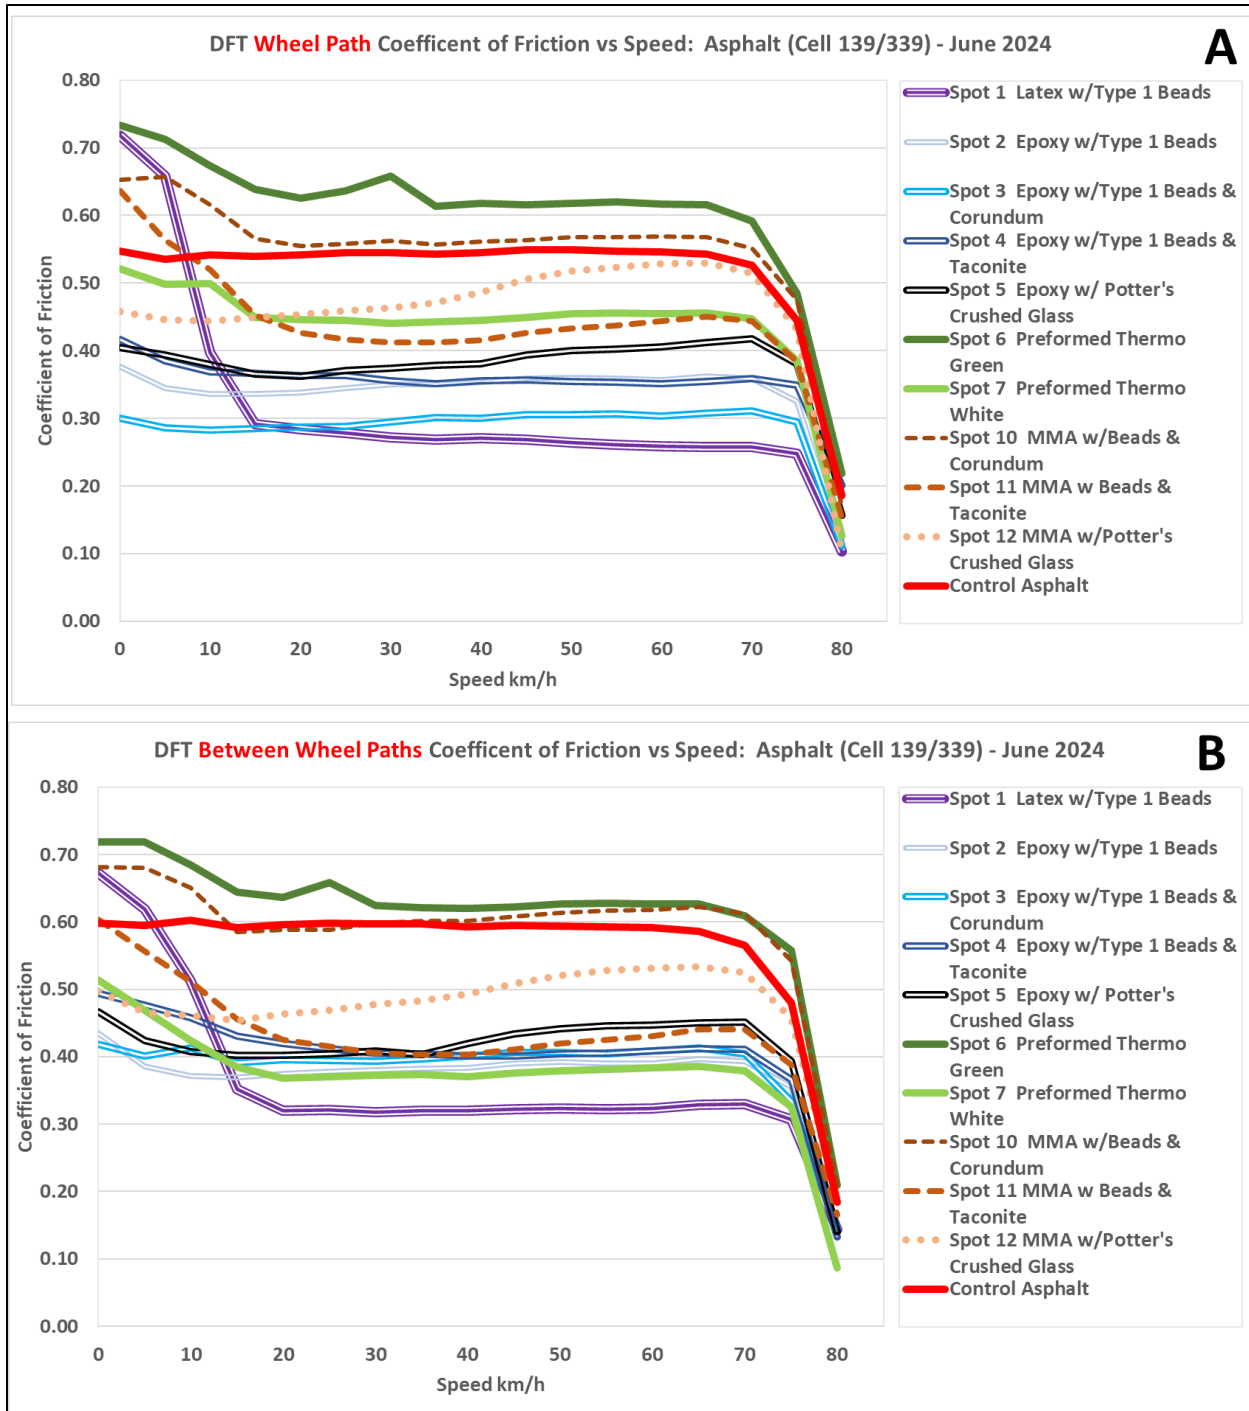
**Figure 6.4 June DFT results for markings applied to MnROAD asphalt Cell 139: WP (A) and BWP (B)**

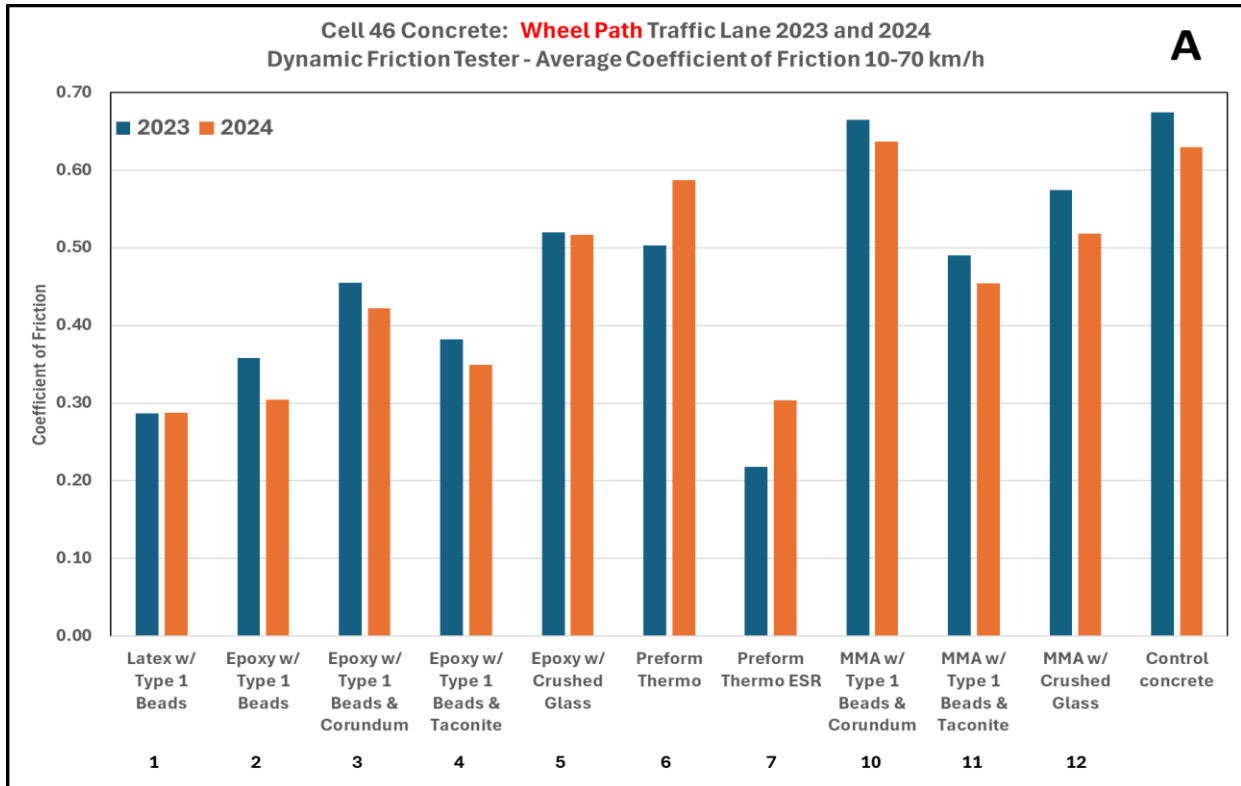
Figure 6.5 Average coefficient of friction measured by the DFT for Cell 46 markings: WP (A) and BWP (B)

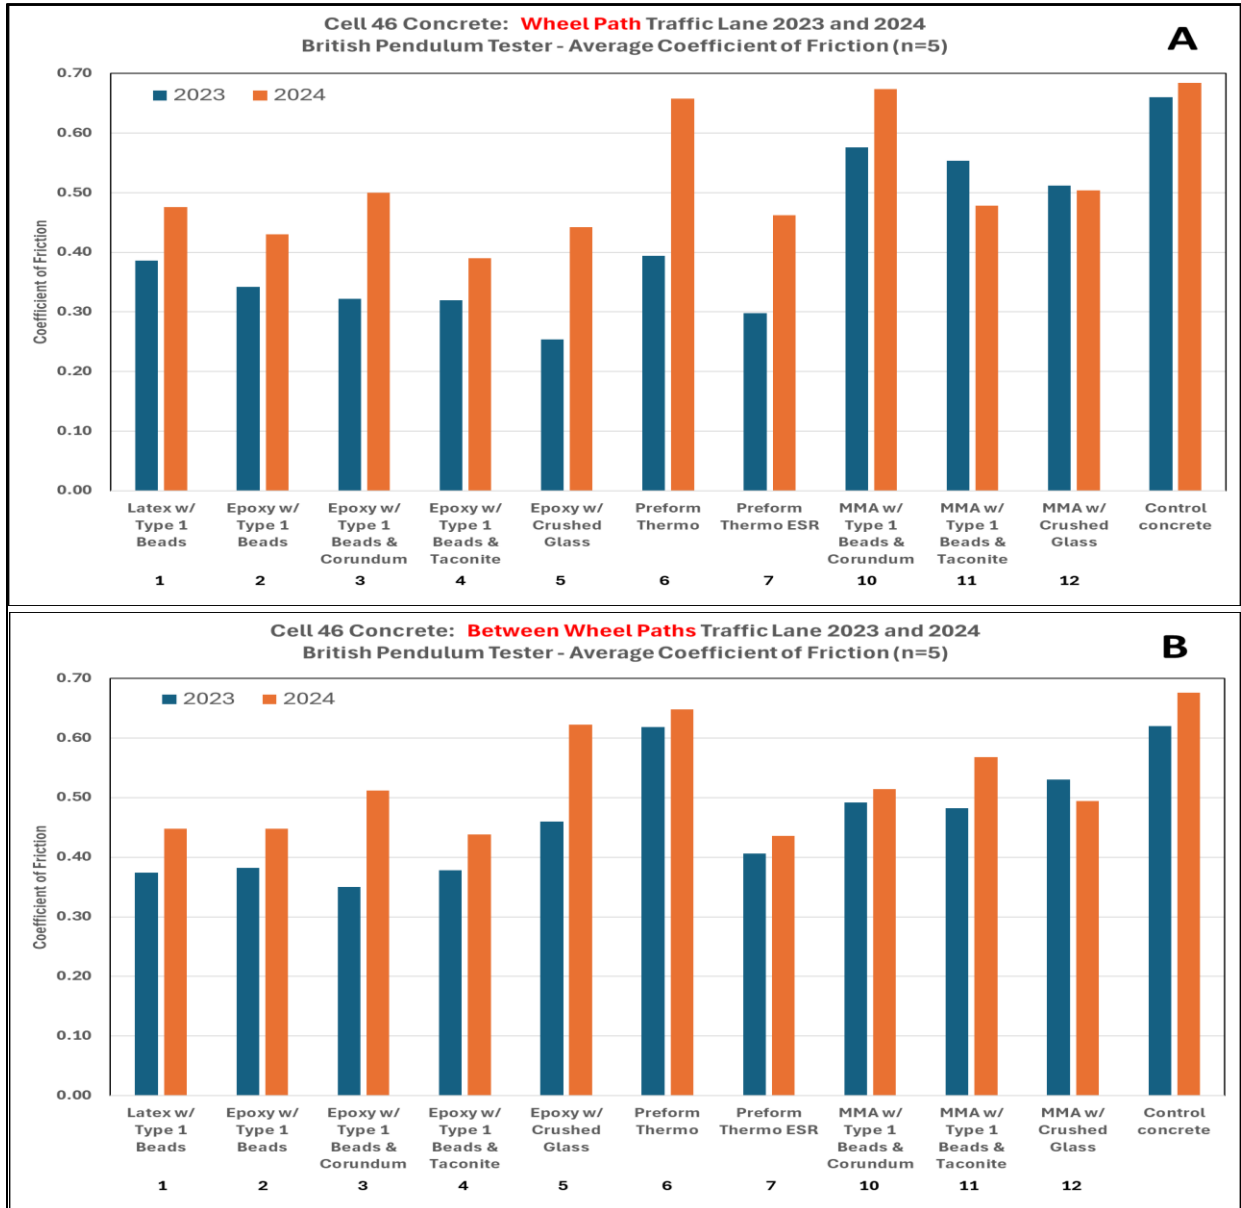
Figure 6.7 Average coefficient of friction measured by the BPT for Cell 46 markings: WP (A) and BWP (B)

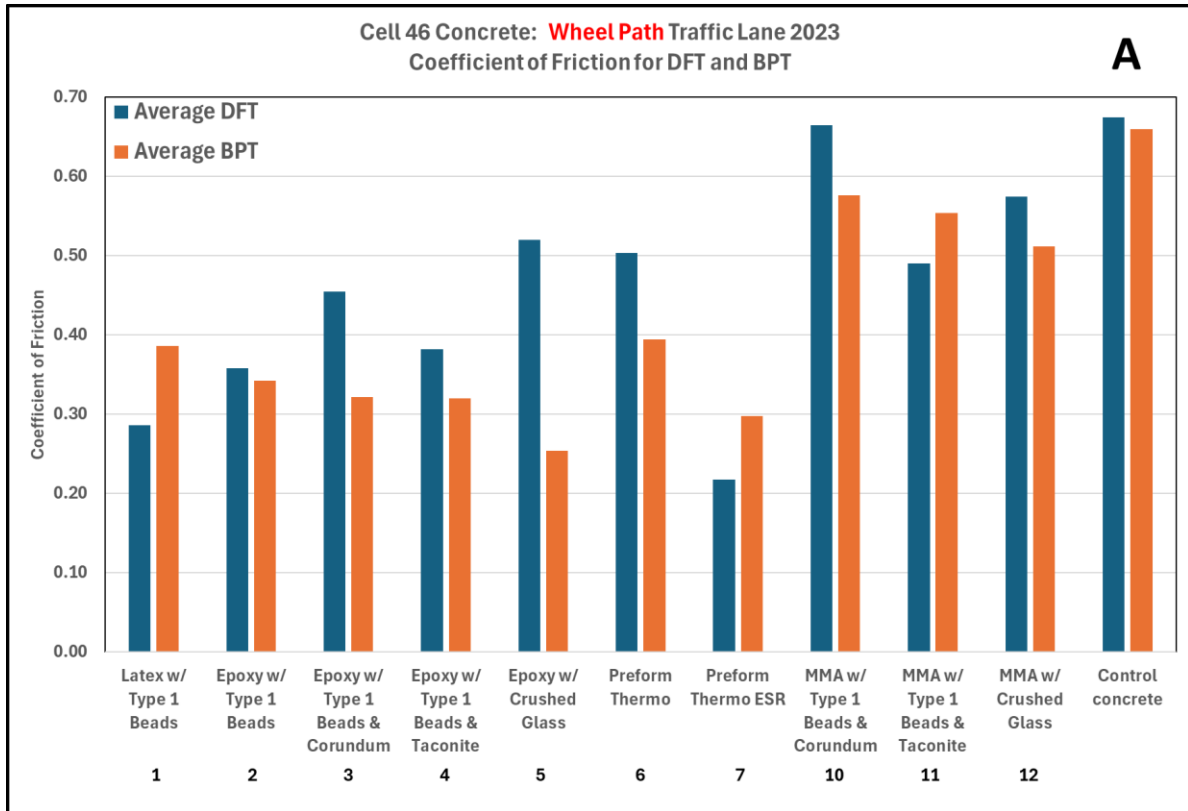
Figure 6.9 DFT and BPT measurements of WP of Cell 46 markings and control (A and A')

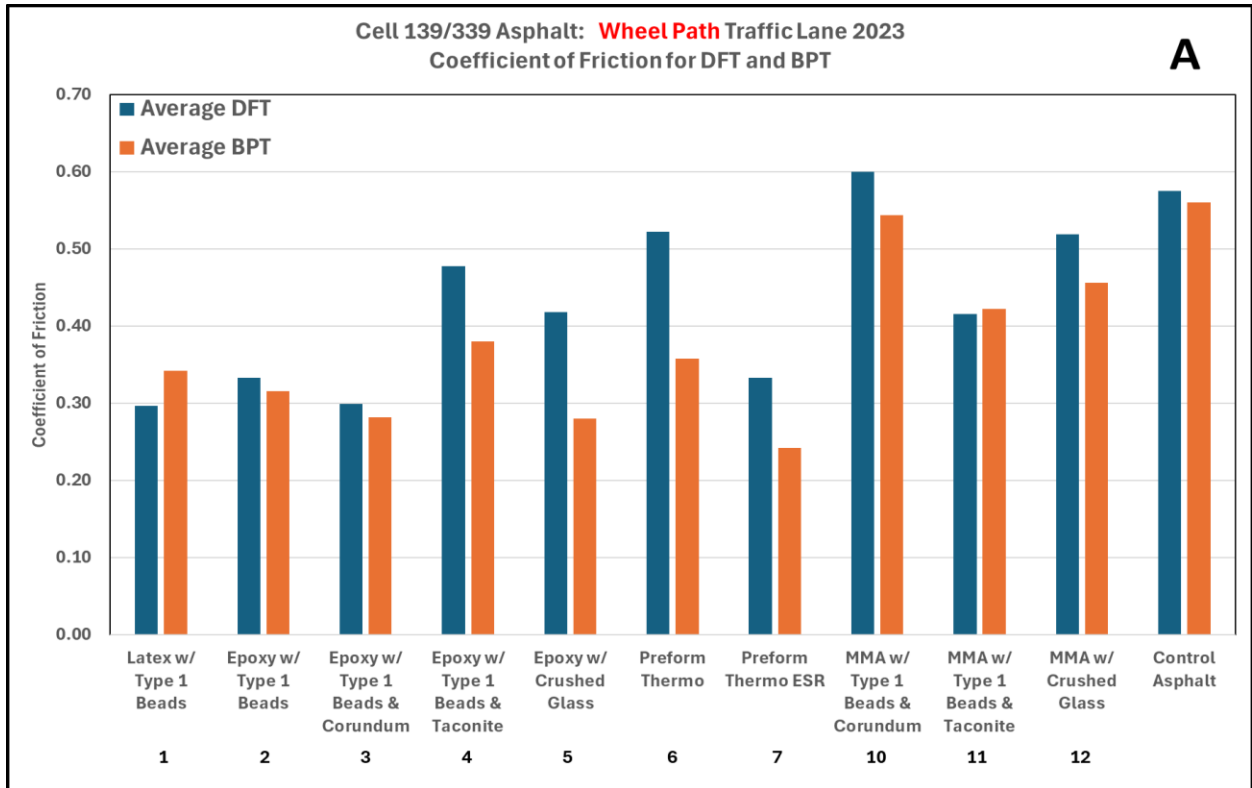
Figure 6.11 DFT and BPT measurements in WP of Cell 139/339 markings and control (A and A')

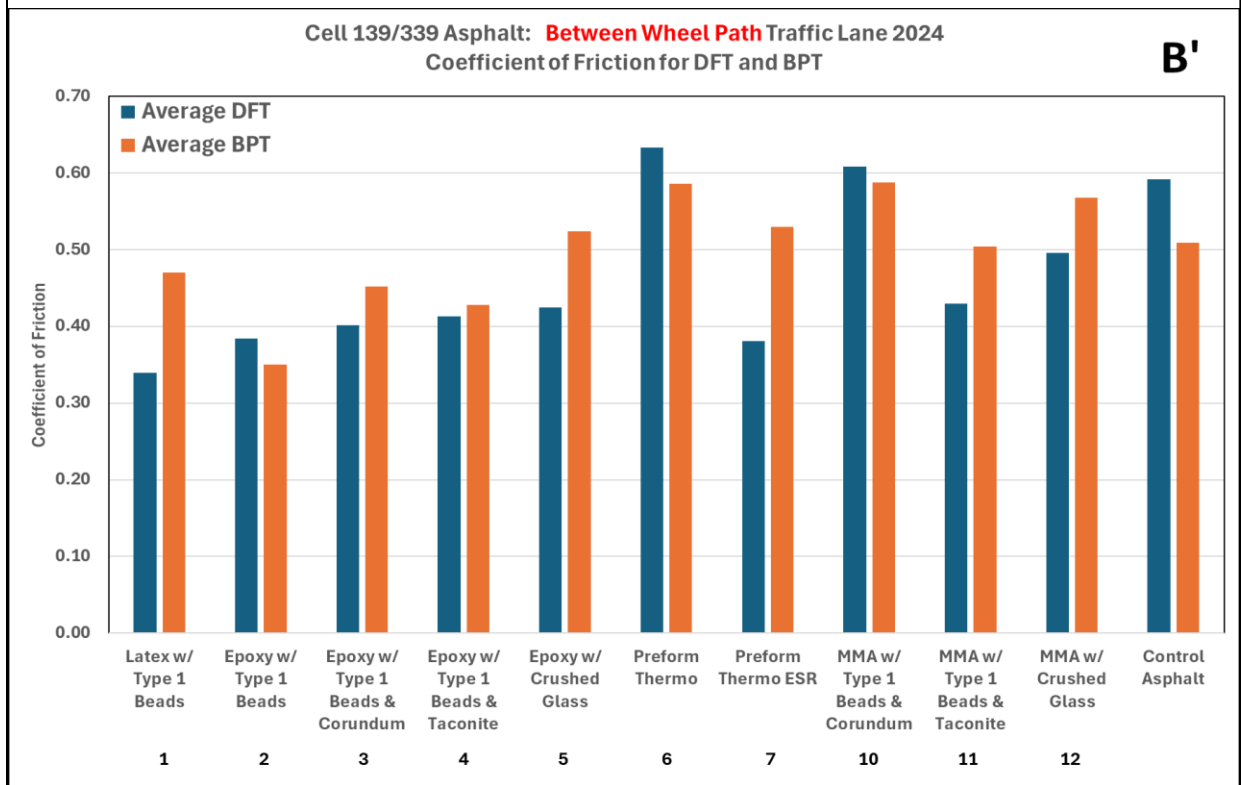
Figure 6.12 DFT and BPT measurements BWP of Cell 139/339 markings and control (B and B')

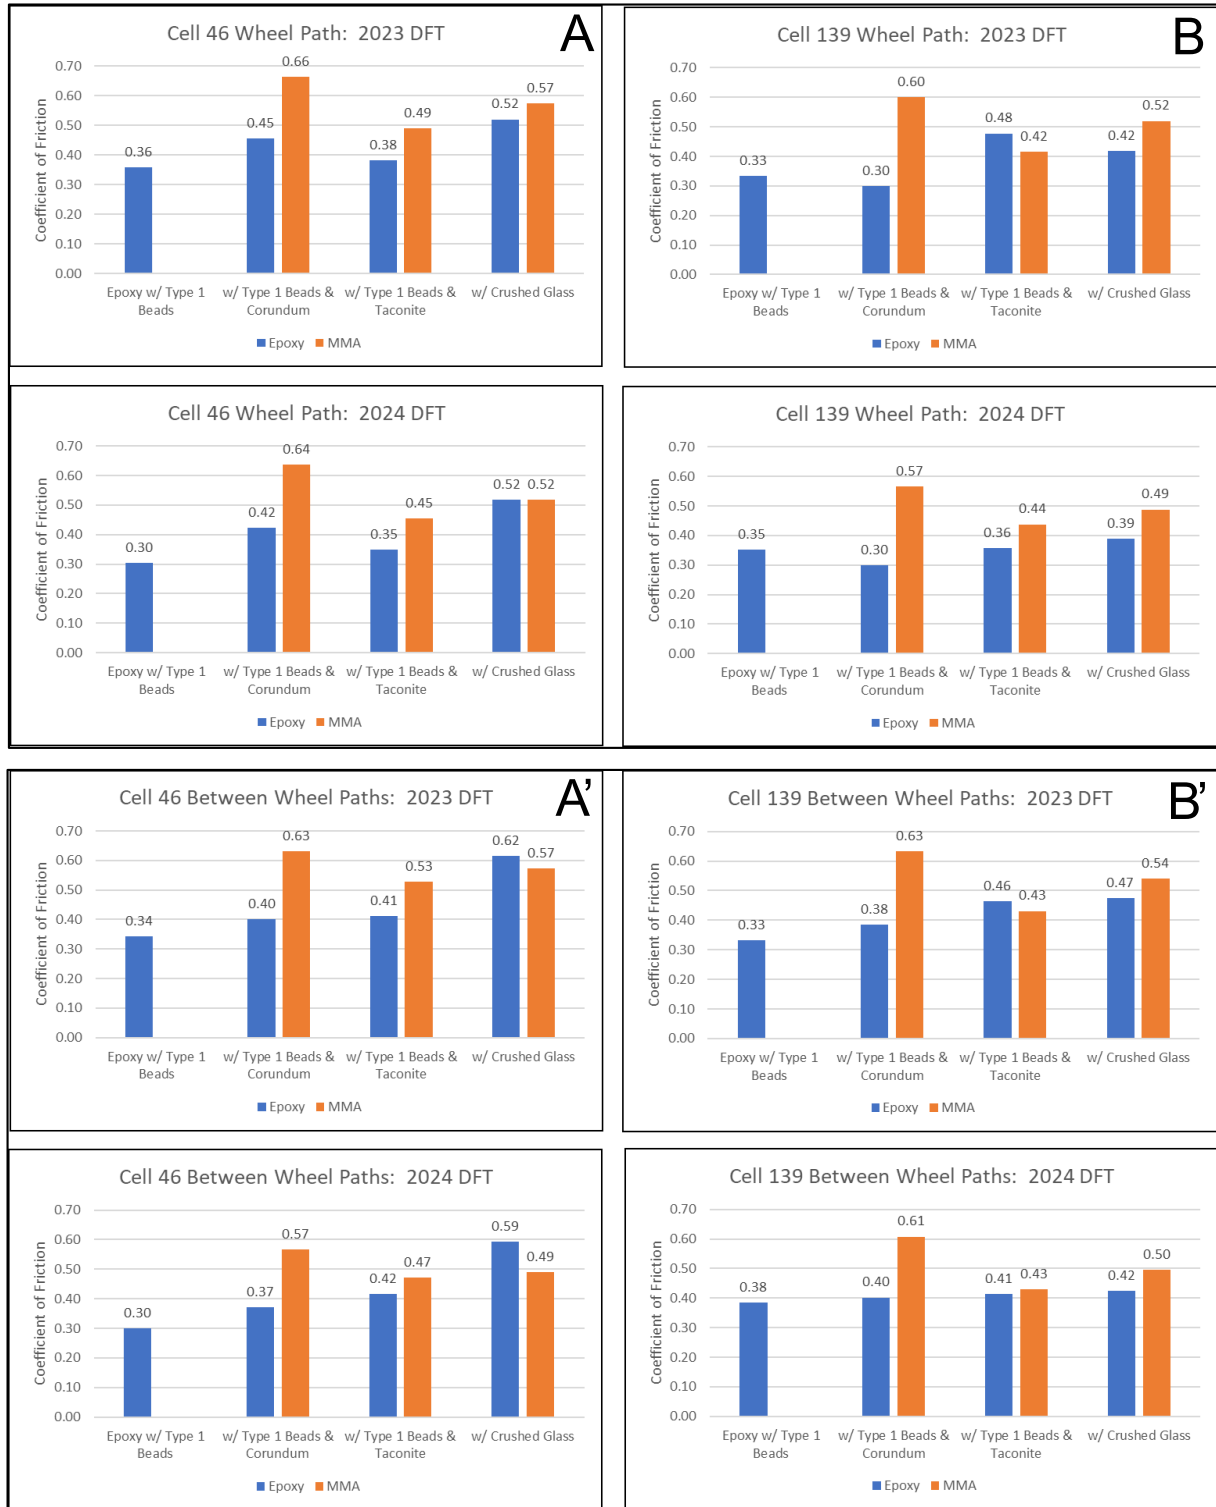
**Figure 6.14 DFT-measured coefficients of friction for epoxy-based and MMA-based markings: wheel path (A and B) and between wheel paths (A' and B') in 2023 and 2024 of Cells 46 and 139, respectively.**

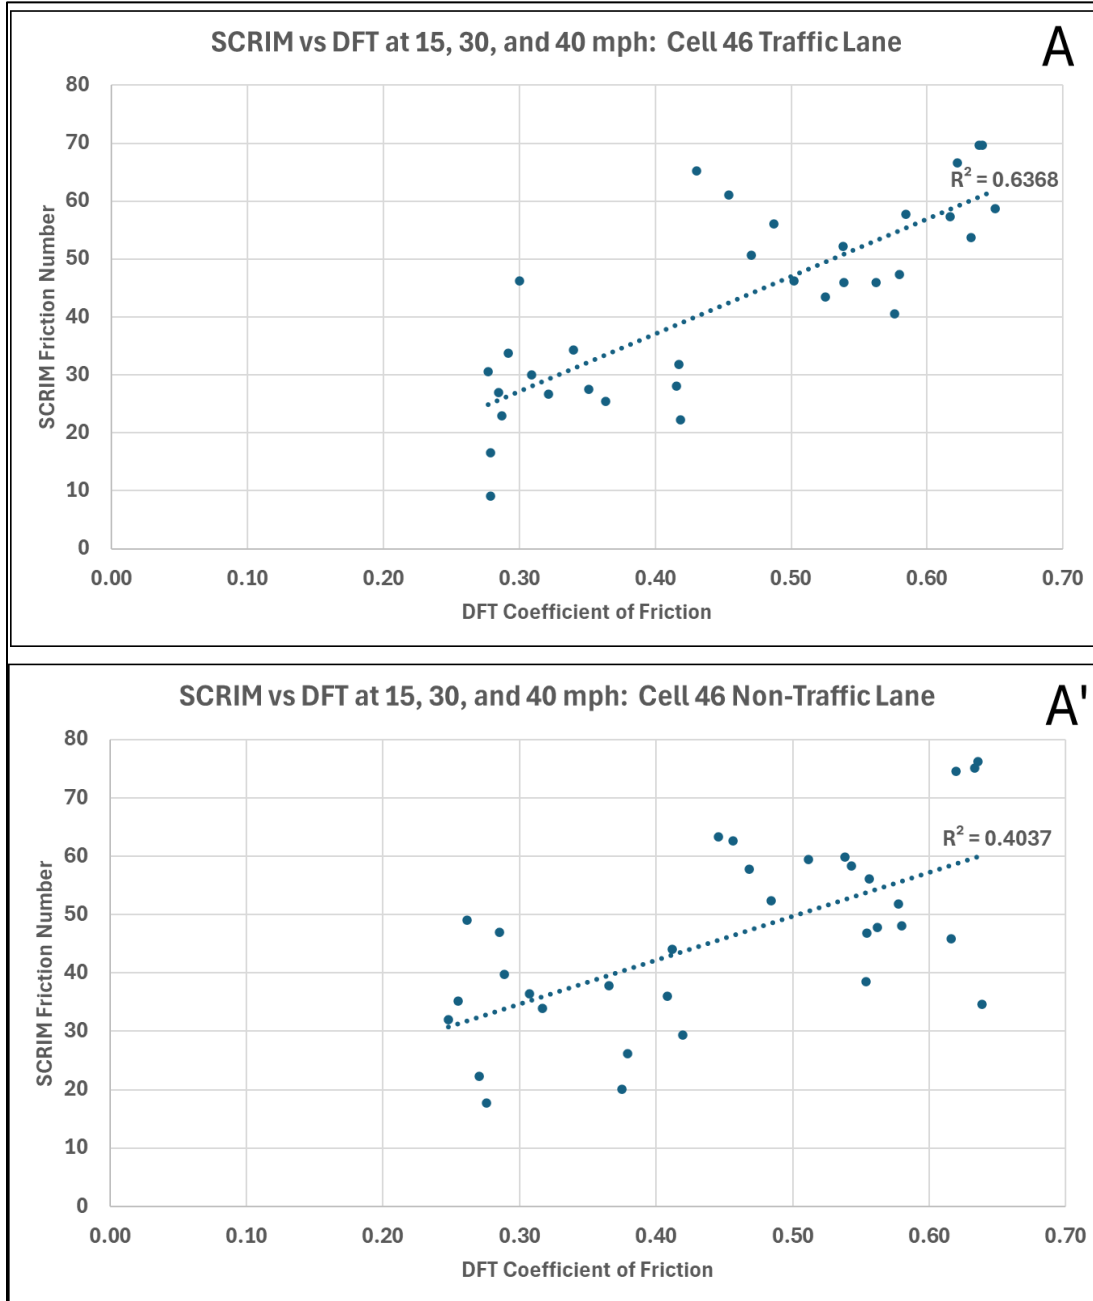
Figure 6.18 Scatter plots of SCRIM vs DFT friction values and linear regressions for Cell 46 Traffic Lane (A) and Non-Traffic Lane (A')

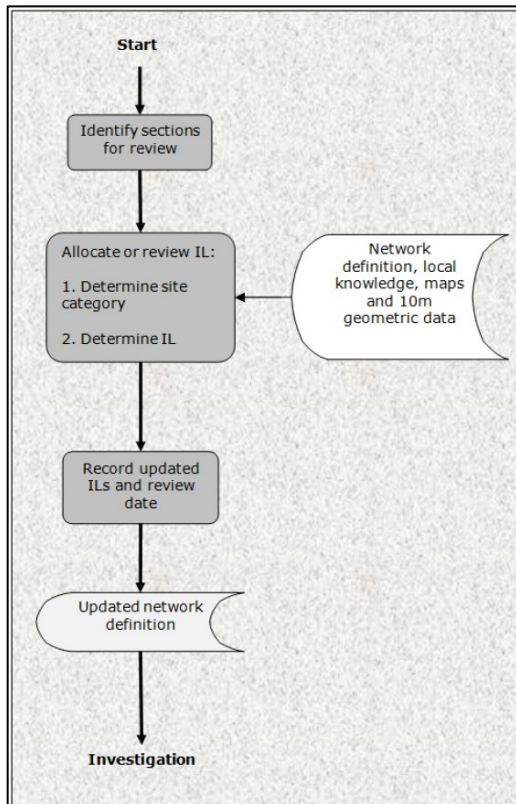
Figure 7.1 Process that shall be followed for the initial investigation (Highways England, 2021)
