# **Taconite As a Lower-Cost, Alternative High-Friction Surface Treatment to Calcined Bauxite for Low Volume Roads in Minnesota**

**June 2025**

Research Project  
Final Report 2025-41

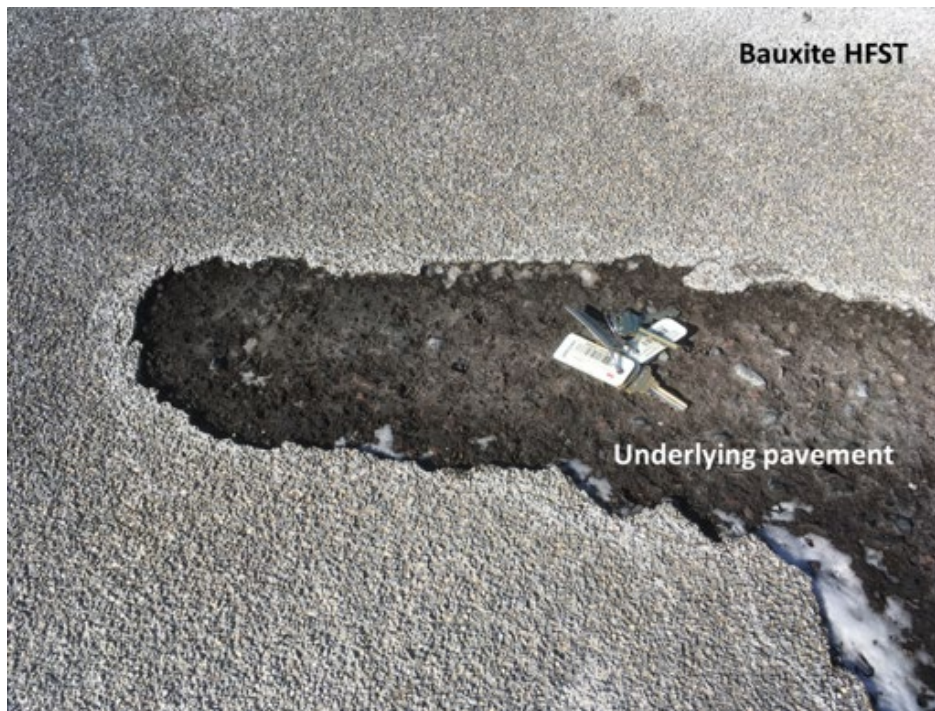
**Figure 7.14. Photo showing complete exposure of underlying pavement where HFST loss occurred in the bauxite test section**

A meeting between the project's PI, TL, and St. Louis County TAP representative at the time (Victor Lund) took place on March 7, 2022, to discuss these pavement distresses. Micro-milling the existing chipseal prior to the HFST installations had originally been planned, but the contractor said micro-milling was unnecessary based on their prior experience. Whether the decision not to micro-mill contributed to the distresses is uncertain. However, it was recommended that an analysis of failure be conducted to help identify the cause, including collecting cores of selected portions of the pavement. This analysis of failure began on June 6, 2022, during the project's third set of friction tests, and continued during a follow-up site visit on July 5.

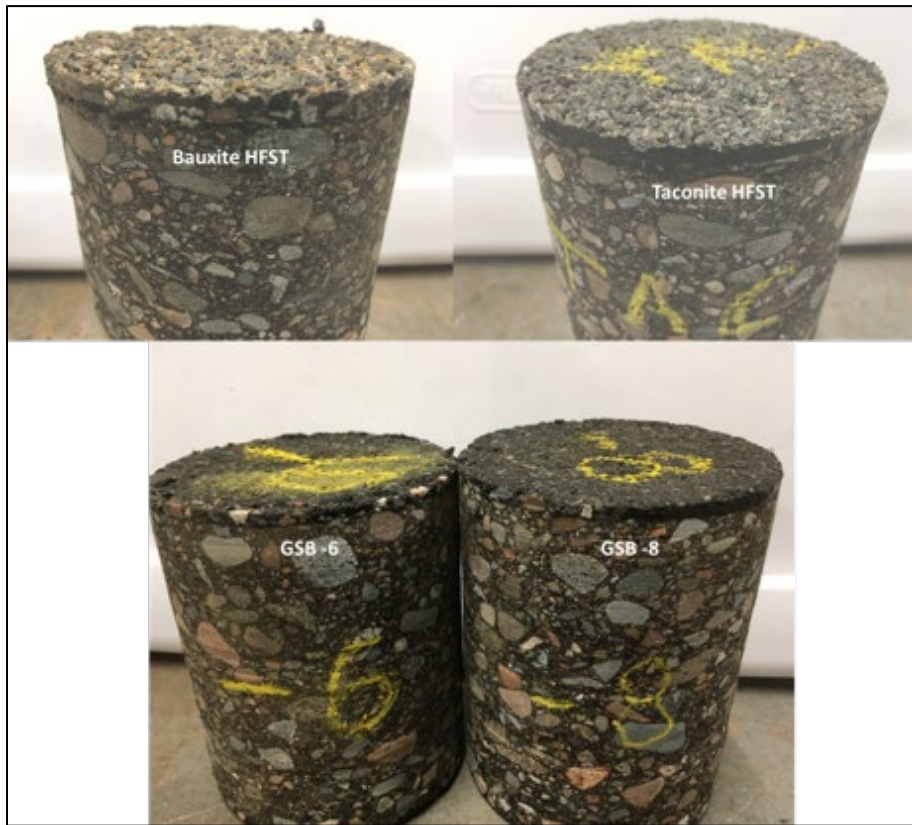
Figure 7.16. Cores collected from the four pavement treatment test sections

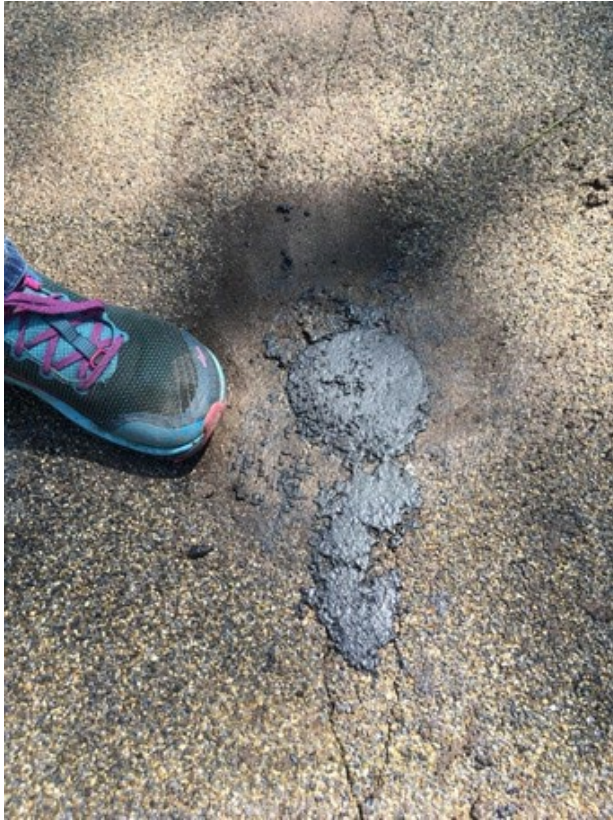
**Figure 7.18. Core hole filled with the NRRI's rapid-setting repair compound**
