# Development of Best Practices for Inspection of PT Bridges in Minnesota

Minnesota  
Department of  
Transportation

Andrea Schokker, Principal Investigator  
Department of Civil Engineering  
University of Minnesota Duluth

Research Project  
Final Report 2012-09

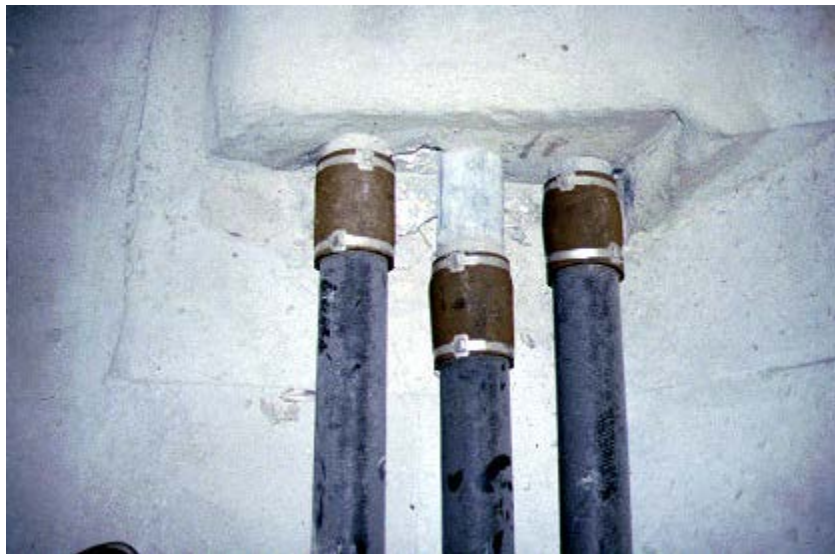
**Figure 2.1. Plan view of tendon slip at deviation saddle (Corven Engineering, 2002)**

Located in the Florida Keys, the Niles Channel Bridge built in 1983 is a 4,557 foot long bridge (4557 m) with a deck width of 38.5 feet (11.7 m). It spans between Summerland Key and Ramrod Key over salt water. The bridge was built with precast box girders with six grouted external post tensioned tendons in each span. During an inspection in the summer of 1999, several notable problems were recorded. The first critical problem found was that one of the exterior tendons had slipped at the deviation saddle approximately 9 inches (22.9 cm), indicating a tendon failure (see figure 2.1).

After full inspection, it was found that one of the six tendons in each span had failed. The boot connecting the steel pipe and the duct was opened for further investigation and active corrosion was found. Investigation of the removed tendon showed voids in the grout around the tendon, and pitting on the prestressing strands at the anchor head as shown in figure 2.2. The failed tendons were removed and replaced.

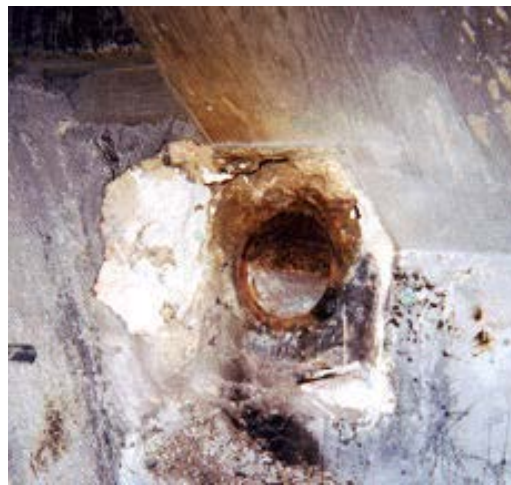
There was initial concern that this corrosion at the voids was due to corrosive bleed water from the grout, although continued examination concluded that the corrosion was due to saltwater ocean spray. It was believed that the wind carried ocean spray and came into contact with the tendons through a void in the anchor head. Seeping between the segments at the expansion joints the chloride enriched water entered the anchor and provided the conditions for active corrosion to occur. Figure 2.3 shows the staining around the anchor where the tendon corroded. While the bleed water itself did not corrode the strands, the void left by the bleed water provided a void where chlorides, moisture and oxygen could congregate and cause severe corrosion.

**Figure 2.3. Water staining at expansion joint around anchor where tendon corroded (Corven Engineering, 2002)**

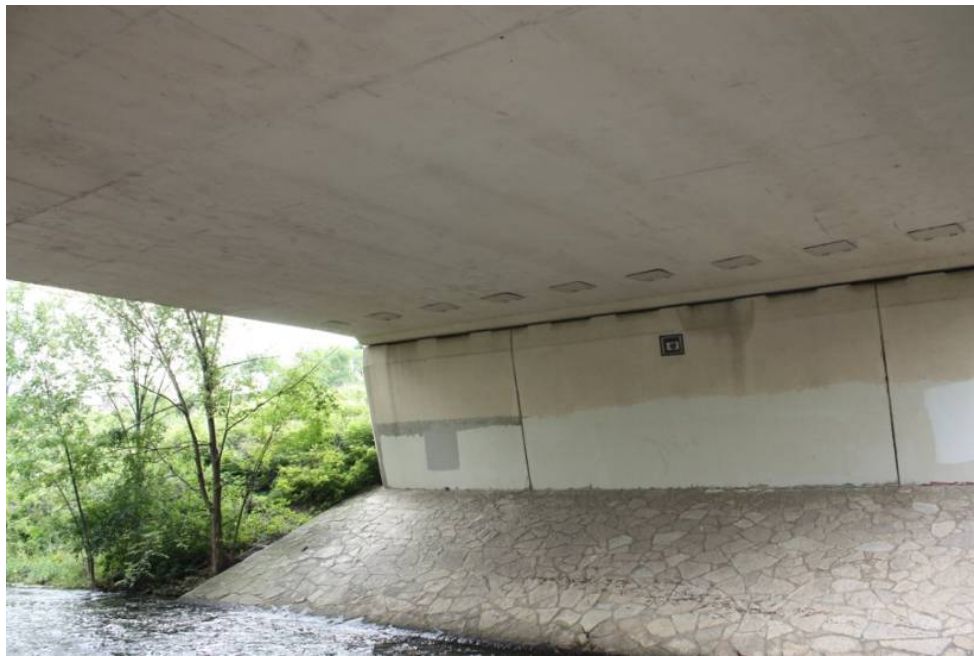
**Figure 5.7. Bridge 27719 overview picture**

The bridge received an inspection recommendation of 8 (see section 4.1.6 for justification). During the visual inspection some indications of potential PT related issues were seen. Figure 5.7 shows an overview of the single span of the bridge. Visual access from the ground is relatively good, but access to the interior of the bridge would require a snooperscope and lane closures due to the conditions under the bridge (creek and pedestrian trail).

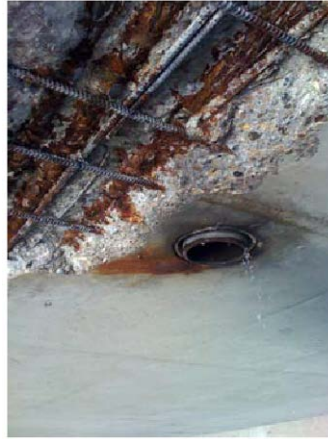
**Figure 6.4. Bottom slab drainage outlet (Corven Engineering, 2010)**

appeared around these areas of the water flow, and with removal of cracked concrete, corrosion of the spiral wound galvanized metal duct and the prestressing strand was present. Figure 6.4 shows the rust staining around the outlet duct and the corrosion on the steel reinforcement, galvanized ducts and prestressing strands.

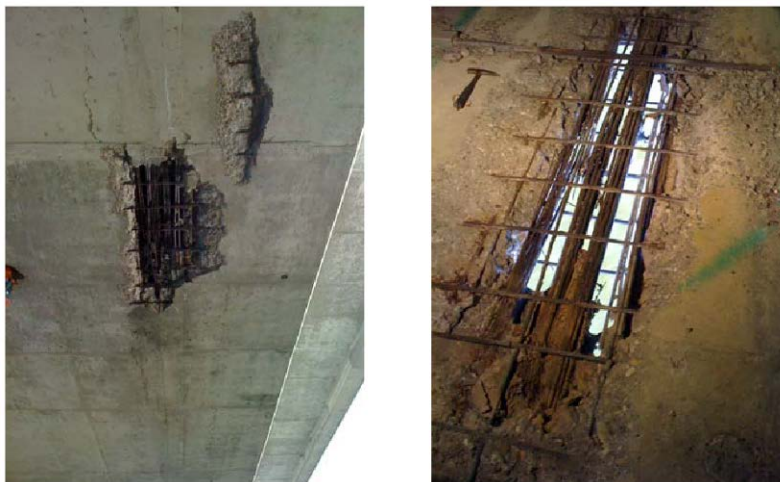
**Figure 6.5. (Left) Exposed post-tensioned tendons view exterior (Corven Engineering, 2010)**

A jackhammer was used to remove a limited portion of damaged concrete in the bottom slab of the main span (span 3) at mid-span. Five of the ten tendons in the exposed area are visible. One of these tendons has corroded completely through, and the other four exposed tendons have broken strands as well as cross section loss to the prestressed strand (of varying degrees). The other unexposed tendons produced a hollow sound when struck with a hammer. Figure 6.5 shows the exterior (bottom) of the exposed post-tensioning and in figure 6.6 is the interior of the same segment.

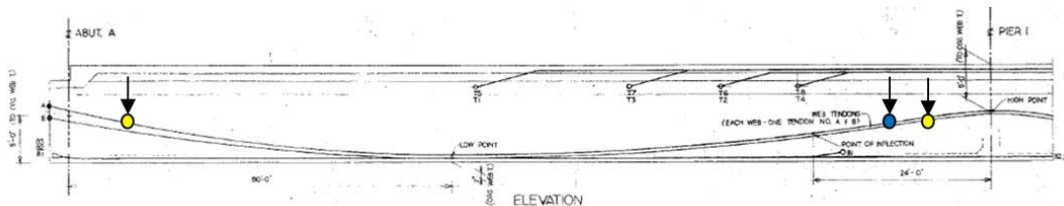
**Figure 6.7. Span 1 web S1 and web N1 elevation view**

The span 1 inspection consisted of a visual inspection, as well as drilling inspection holes into 6 locations along the post-tensioned tendons in the webs of the box girder. Figure 6.7 shows an elevation view of web S1 (interior web of eastbound box girder) and web N1 (exterior web of westbound box girder) of span 1. Highlighted with a circle (yellow for eastbound, blue for westbound) on the figure are the approximate locations that were drilled for tendon access during the inspection (this applies to all elevation views in this section of the report).

All web duct inspections done in span 1 were found to have clean and dry ducts with no voids detected, and no moisture seen. The grout in all the ducts appeared to be solid and of good color. Figure 6.9 shows an overview photo of the drilled hole into tendon A, in web S2 that is located 10.17 feet (3.1 meters) from abutment A (a representation of a typical drilled hole in span 1).

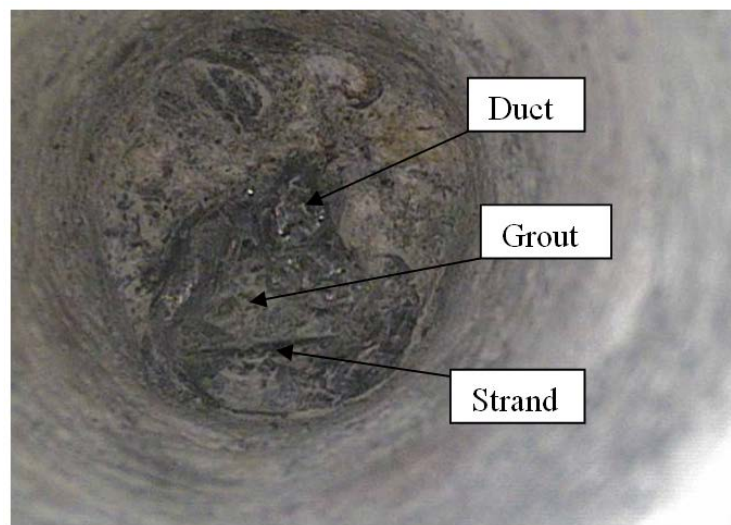
**Figure 6.10. Boreoscope picture of drilled hole in web S2 of span 1**

Figure 6.10 shows a picture taken with the borescope inside of the drilled hole in web S2 of Span 1 as seen above. The metal duct is visible in the picture with no signs of corrosion. One wire of one of the cables can also be seen, and no signs of corrosion are visible. The grout within the duct also is solid and of good color.

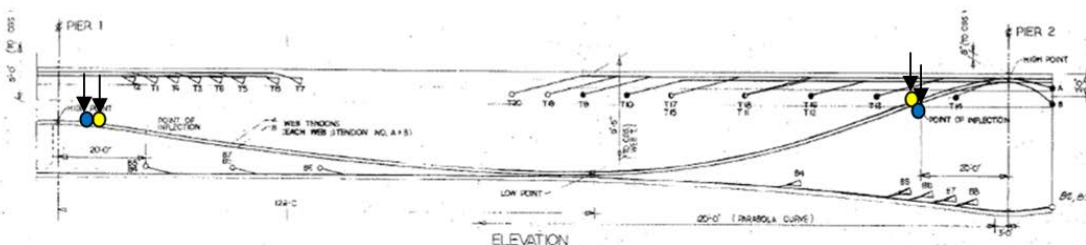
**Figure 6.13. Span 2 web S2 elevation view**

All web duct inspections done in span 2 were found to have clean and dry ducts with no voids detected, and no moisture seen. The grout in all the drill holes appeared to be solid and of good color. Figure 6.14 is an overview photo of the drilled hole into tendon B in web N1 that is located 24.83 feet (7.57 meters) from pier 2 (representation of all inspection holes drilled in span 2).

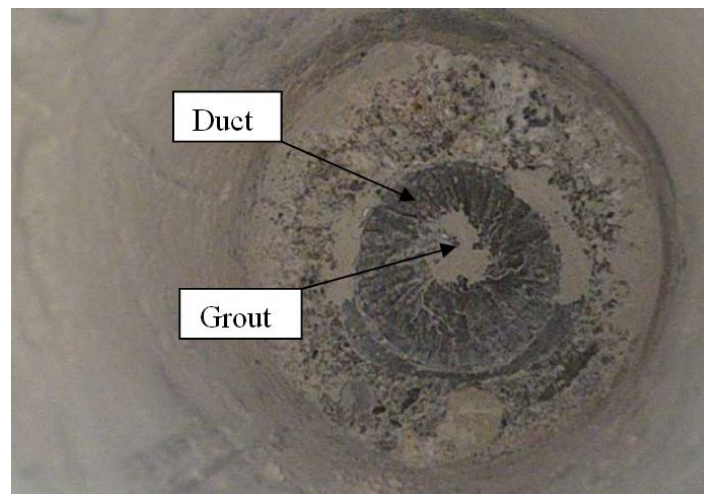
**Figure 6.15. Borescope picture of drilled hole in web S2 of span 2**

Seen below in figure 6.15 is the picture taken with the borescope inside of the drilled hole in web S2 of Span 2 as seen above. The metal duct is visible in the picture with no signs of corrosion. The grout within the duct is seen to be solid and of good color.

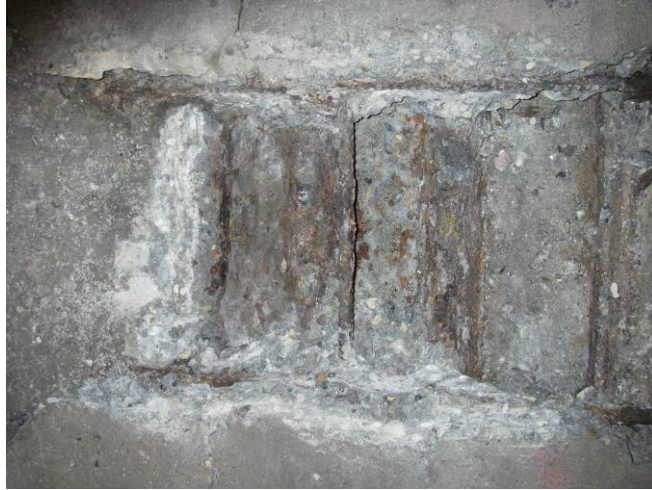
**Figure 6.23. Overall view of opened/chipped area at mid span**

Further removal of the concrete cover exposed tendons B18 and B17 as shown in figure 6.23 below. Like tendon B19, tendons B18 and B17 are corroded to the point that individual wires cannot be identified.

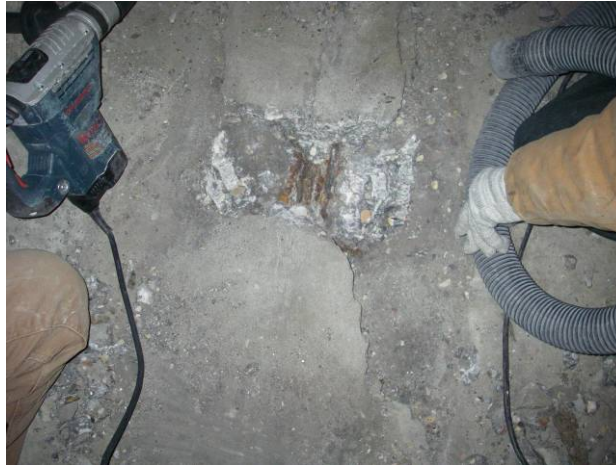
**Figure 6.31. Removal of concrete exposing tendon B28**

Figure 6.31 shows the concrete cover being chipped away exposing tendon B28. Surrounding delamination can also be seen along area of opening. The delamination areas appear to be of a different concrete mixture than the bottom slab primary concrete. It is not known if these areas represent an attempt at patching uneven or cracked concrete during construction, but they are prevalent throughout the bottom slab. The patch concrete is delaminated/ separated in many areas allowing easy access for ingress of chlorides, moisture and oxygen.

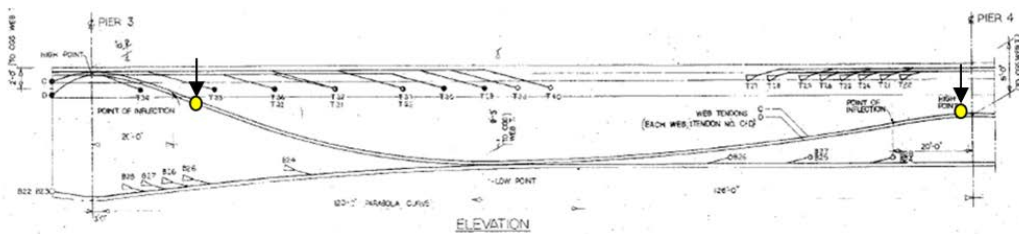
**Figure 6.33. Web S1 eastbound structure span 4 drill locations**

Two locations were drilled along Web S2 to inspect the tendons within the webs. Figure 6.33 shows an elevation view of web S1 (interior web of eastbound box girder). Highlighted on the figure are the approximate locations that were drilled into during inspection. When the web was tapped in these locations, a clean and dry duct was found with solid grout of good color filling the duct. In the drilled hole near pier 3 one wire of strand was exposed and had no visible corrosion.

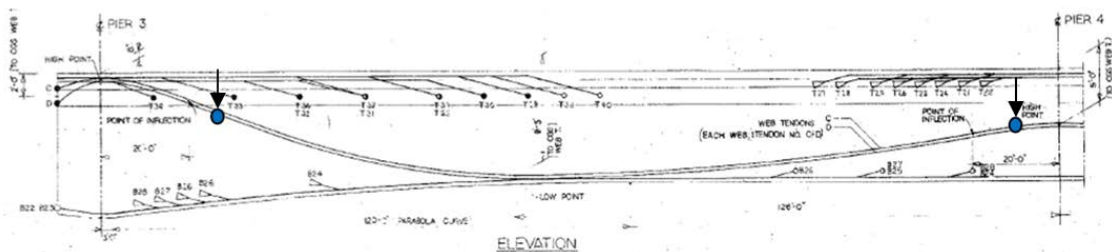
**Figure 6.37. Web N1 westbound structure span 4 drill locations**

Figure 6.37 shows the two drill locations highlighted in blue in web N1 (interior web of box girder). Drilled inspection holes into web N1 were found to have clean and dry ducts without moisture or voids. The grout in all the drill holes appeared to be solid and of good color.

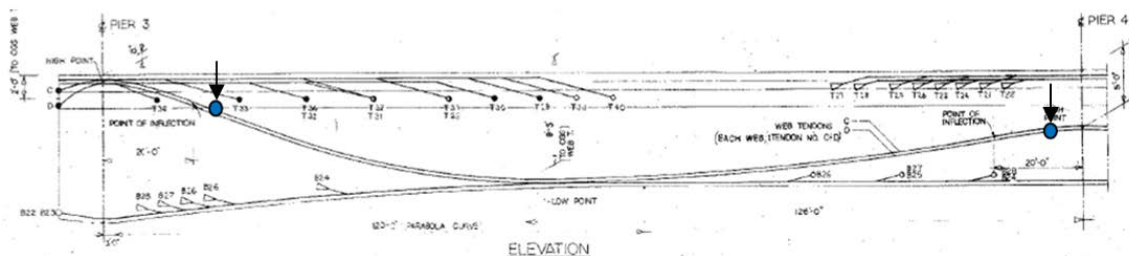
**Figure 6.38. Web N2 westbound structure span 4 drill locations**

Figure 6.38 shows the drill location highlighted in blue in web N2 (exterior web of box girder). Again grout appeared solid and of good color and no voids were detected.

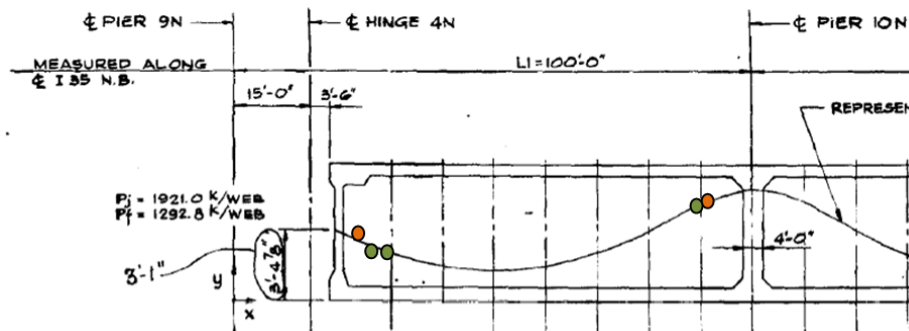
**Figure 7.11. Span 1 web 2 structural unit 6N tendon profile view**

The invasive inspection consisted of drilling into both ducts that are contained in web 2 and web 3 to inspect the internal tendons. Figure 7.11 shows a profile view of web 2 of span 1 of structural unit 6N. The tendon profile seen represents the center of gravity of the two contributing tendons (tendon 1 is the above the center of gravity, tendon 2 is below). Highlighted are the approximate locations that were drilled into to inspect post-tensioning system (orange represents inspections on tendon 1, green represents inspections on tendon 2).

Each opened duct showed the metal duct to be in good condition, free of any visible corrosion. The interior of the ducts showed solid grout of good color that filled the entire duct. As a representation of all the ducts drilled into in web 2 of span 1 in structural unit 6N, figure 7.12 shows the inspection hole. The location shown is the drilled hole into tendon 2 located 77.5 inches (1.97 meters) from pier 9N. Seen in the figure is the top of the duct and the grout contained in the conduit.

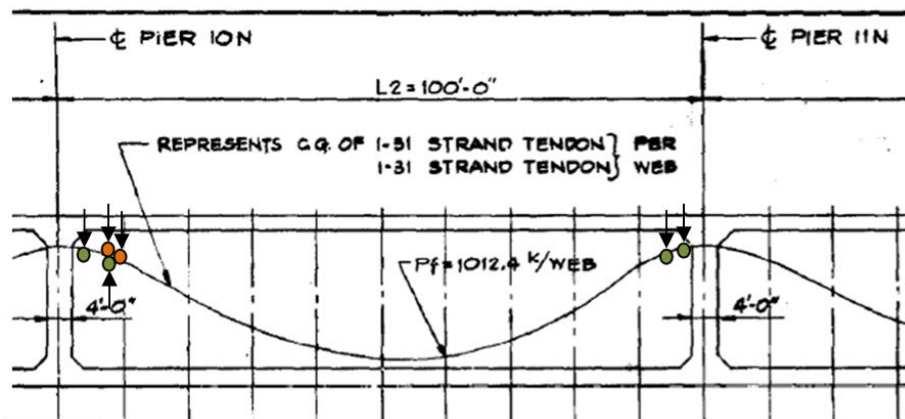
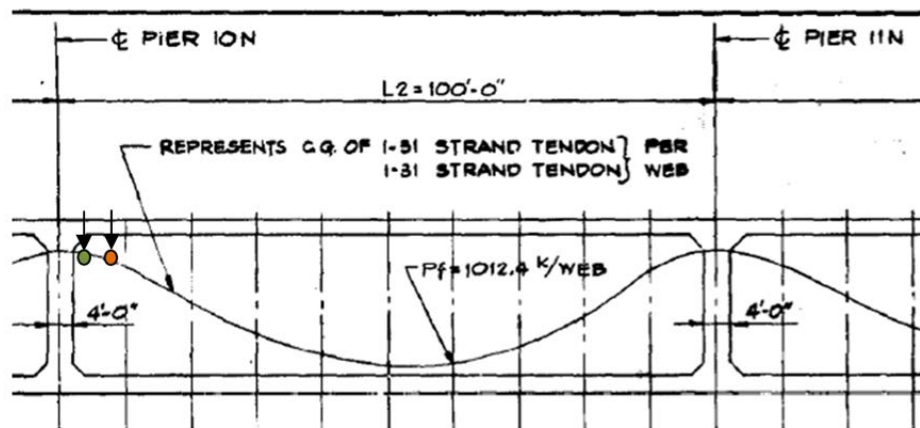
To continue inspection of a suspected trouble area, span 2 of structural unit 6N was investigated. Drilling locations were in webs 2, 3, 4, and 5. Figure 7.14 shows the tendon profile view of span 2. The locations that were drilled into were highpoints in the tendon profile. Figures 7.14 through 7.17 show the drill locations. Approximate locations that the post-tensioning system was inspected are highlighted (orange represents inspections on tendon 1, green represents inspections on tendon 2).

Grout was found covering a large area on the bottom slab of cell 4 near at mid span. This was a possible indication of a grout leakage that may have left of void. Upon inspection of the ducts in web 4 and web 5, no voids were found.

In each of the post-tensioning ducts in span 2 of structural element 6N, good colored, solid grout was found. During the August inspection no problems were found directly related to the post-tensioning system or due to grouting. Although no problems were found in the structure, the sample size taken during the inspection was very limited, so it should not be used to conclude that no problems exist in the structure. A more widespread sample of points from along a larger number of spans would be preferable. At this time, preliminary indications from the spans tested show good quality grouting.

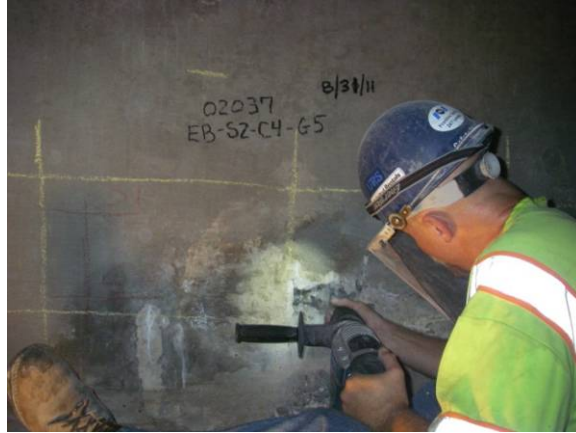
**Figure 8.5. Removing cover at inspection area**

The second location was located in cell 4 on girder 5 a distance of 78 feet (23.8 meters) from pier 1. This location is highlighted in figure 8.1 with a blue highlight box. Again the area was a location where a patch had effluence emitting from cracks. Figure 8.5 shows the location of interest during chipping of the patch material. Small tools were used once the duct was reached so that no damage was done to the tendon.

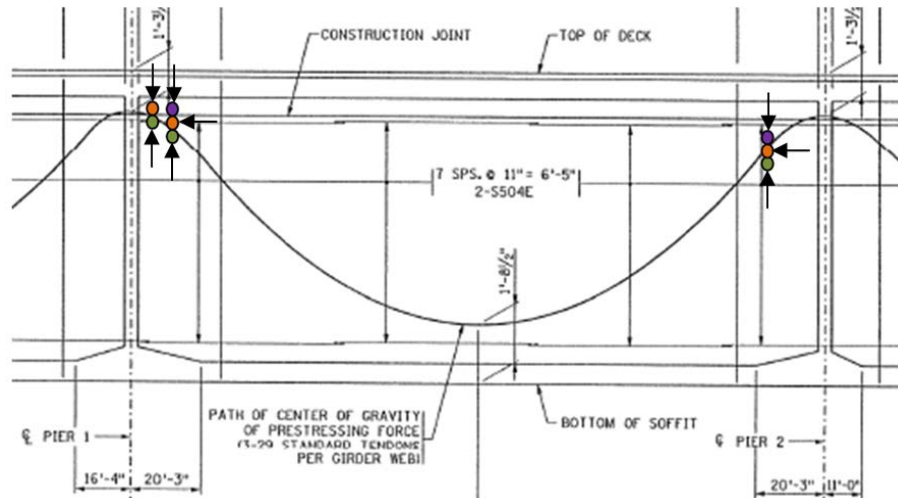
**Figure 8.8. Span 2 tendon profile of girder 5**

During the inspection of 02037 E, eight duct locations within girder 5 were inspected. Each of the three tendons had their highpoints examined near pier 1 and pier 2. Figure 8.8 shows the elevation view of the tendon profile (the tendon line represents the path of the center of gravity of the three contributing tendons) with a highlight on the inspection locations (indicated by purple for tendon 1, green for tendon 2, and orange for tendon 3).

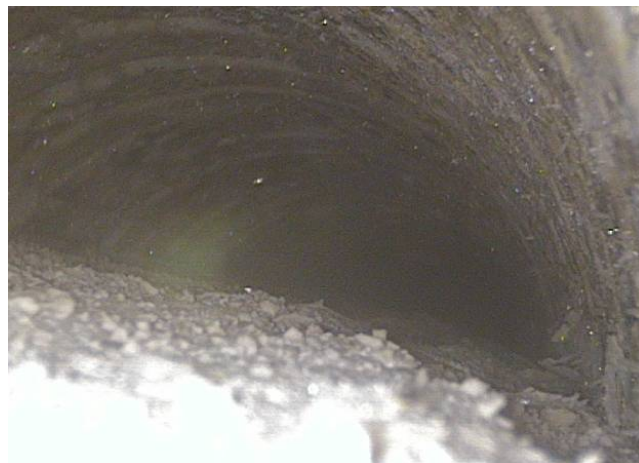
Inspection holes of the three tendons towards pier 2 in span 2 had significant voids and some corrosion. Each of the duct inspections revealed large voids present, despite being 205.5 inches (522 centimeters) from the high point of the tendon at the pier. Tendon 1 had corrosion on top of the grout and duct with bubbles of corrosion product seen on the grout surface. The grout is a white and chalky indicating a poor quality material (high in water content and segregated). Despite the large void, there are no cables visible on top of the grout level in this tendon. Figure 8.10 shows a photo taken with the borescope within the duct (accessed through the inspection

holes) taken toward the high point (towards pier 2). The grout fills the duct only to approximately half capacity. Figure 8.11 shows the same location with the direction of the borescope to be pointed towards the low point (mid span).

Structure 02027 E has indications of significant voids toward the high points in the structure. Some evidence of corrosion was also found. All repairs were sealed up with accommodations made for future access for investigation and repair. A full investigation of this structure continuing in a similar manner of accessing ducts at high points is recommended to determine areas with corrosion and voids. Remediation may include vacuum grouting the voided areas to establish a protective environment for the strand.

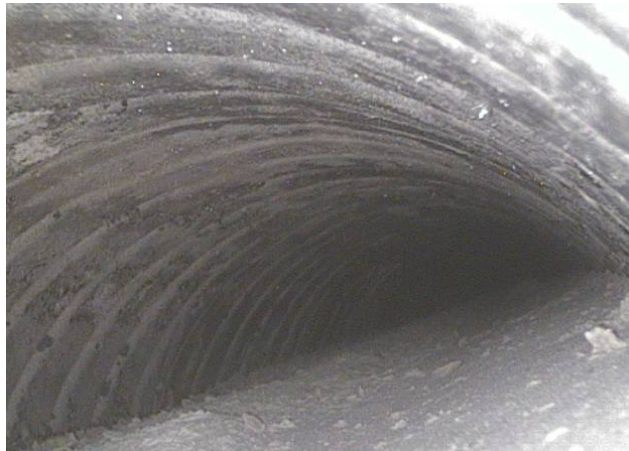
The inspection into tendon 2 showed similar results. Again the void within the duct occupies half of the total area, and the grout that is present is a white and chalky in consistency. It is likely that closer to the highpoint there is a much larger void that exposes strands. Figure 8.12 shows a photo taken with the borescope within the duct (accessed through the inspection holes) taken toward the high point (towards pier 2). Figure 8.13 shows the same location with the direction of the borescope to be pointed towards the low point (mid span).

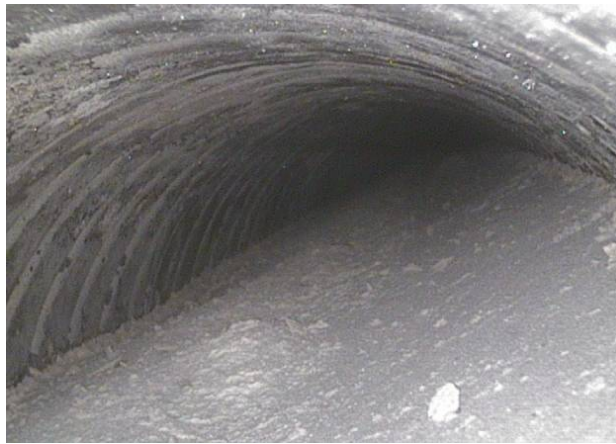
The inspection of tendon 3 showed similar results to that seen in the previous two tendons. Voids within the duct occupied a third to half of the total area, and the grout that is present is a white and chalky. Figure 8.14 shows a photo taken with the borescope within the duct (accessed through the inspection holes) taken toward the high point (towards pier 2). Figure 8.15 shows the same location with the direction pointed towards the low point (mid span).

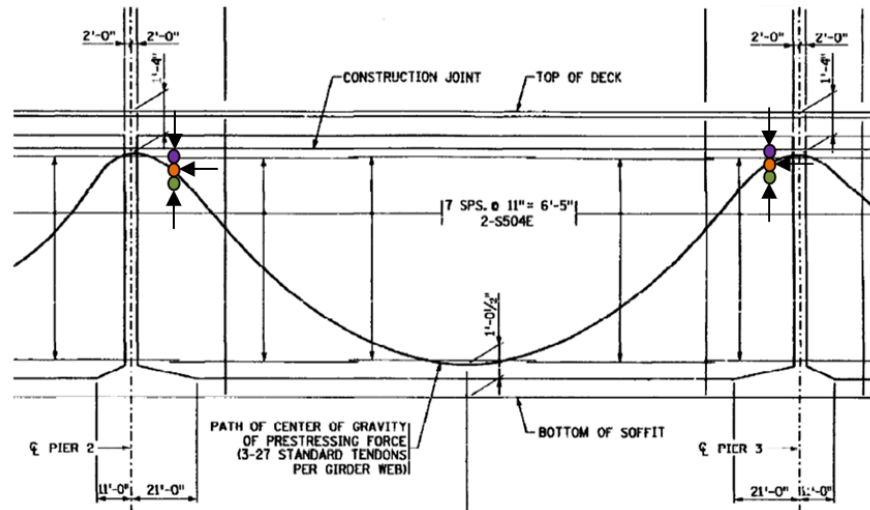
**Figure 8.16. Span 3 tendon profile of girder 5**

Inspection of span 3 focused on girder 5 from cell 4, at six different locations (high points along the tendon profile). Figure 8.16 shows the elevation view in of the tendon profile in span 3 (the tendon line represents the path of the center of gravity of the three contributing tendons). The inspection locations are highlighted in the figure (indicated by purple for tendon 1, green for tendon 2, and orange for tendon 3).

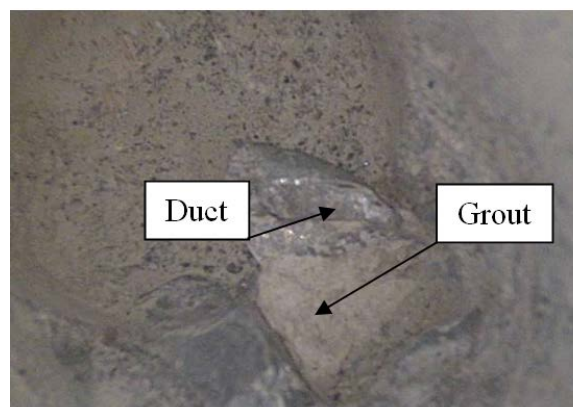
**Figure 8.17. Borescope picture of drilled hole in girder 5 of span 3**

All of the inspection locations within span 3 have similar results for each of the three tendons. Each of these spot checks had a full duct of grout that was white in color and very chalky. Figure 8.17 shows a photo taken with the borescope into the inspection hole of tendon 1, 110 inches (279.4 centimeters) from pier 2. This inspection is a representation of the findings from all inspection holes in span 3.

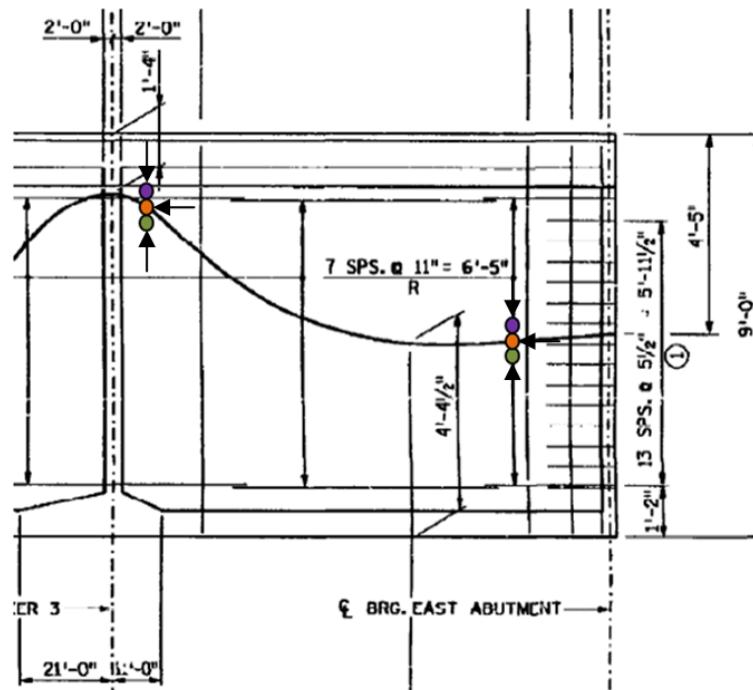
**Figure 8.18. Span 4 tendon profile of girder 4**

Each of the three tendon highpoints were examined near pier 3 and by the east abutment. Figure 8.18 shows the elevation view of the tendon profile (the tendon line represents the path of the center of gravity of the three contributing tendons) with a highlight on the inspection locations into girder 4 (indicated by purple for tendon 1, green for tendon 2, and orange for tendon 3).

The inspection locations near the east abutment show similar results for each of the three tendons. Each of these spots had a duct full of grout that was white in color and very chalky. When a screwdriver was pushed into the grout, it easily sank into the chalky grout. The inspection hole into tendon 2 and 3 exposed one wire of the post-tensioned tendon, and no visible corrosion was seen. Figure 8.19 shows a photo taken with the borescope into the inspection hole of tendon 3, 15 inches (38.1 centimeters) from the east abutment. This inspection is a representation of the findings from all inspection holes near the east abutment in girder 4 of span 4.

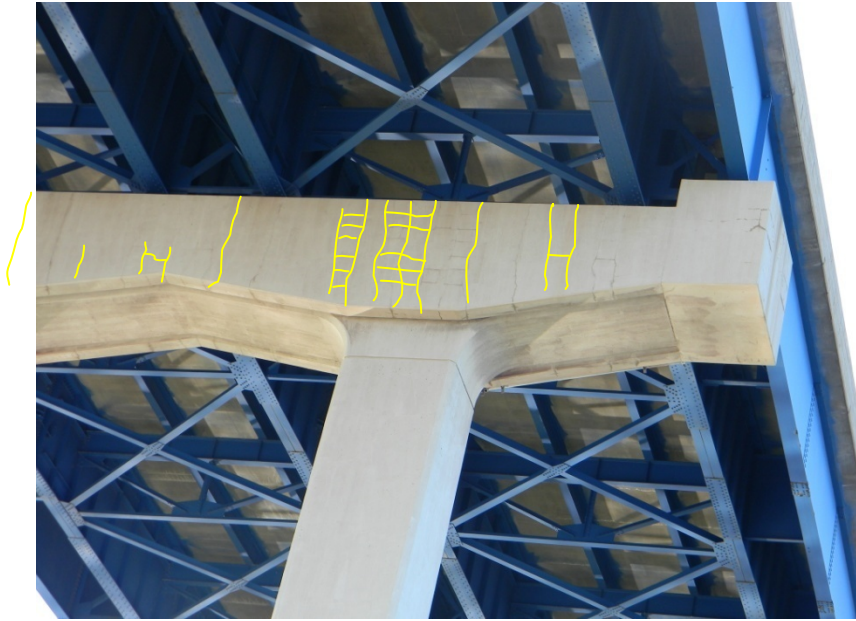
**Figure 9.4.** Longitudinal view of typical post-tensioned pier

The cracks seen in figures 9.1, 9.2, and 9.3 are typical of each of the piers in the structure. Figure 9.4 shows a longitudinal view of the pier with numerous cracks running vertically on the pier (a yellow highlight has been added to make the cracks more visible in the photo).

The pier caps should be inspected thoroughly including an invasive inspection at one of the anchorage ends. It is important to determine if the moisture present at the cracks is just surface moisture remaining in the cracked areas under humid conditions or if the moisture is trapped near the anchorage (or in a worst case scenario, the moisture is coming from the anchorage).

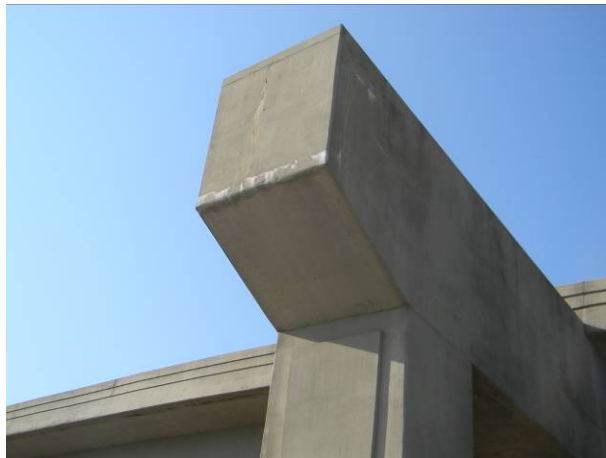
**Figure 10.1. Pier with cracking and efflorescence**

From ground level, it was observed that the straddle bent has cracking and efflorescence emitting from cracks as shown in figure 10.1. While plans were not available, the bent appears to have a pourback and thus is likely to be post-tensioned.

The interior of the superstructure box girders should be inspected with a focus on the problem areas indicated in past inspection reports. The straddle bent cap cracking should also be investigated with a comparison of the cracking to the tendon profile in the plans (or by locating the tendons with GPR). Locations near the anchor should be invasively inspected with a borescope to determine the condition of the tendon and grout.

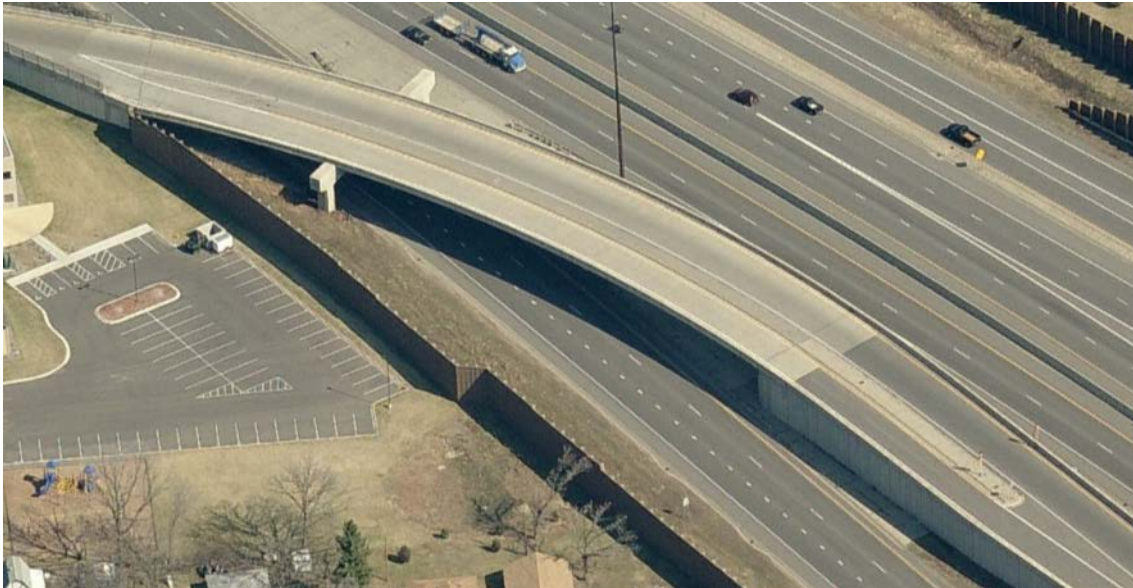
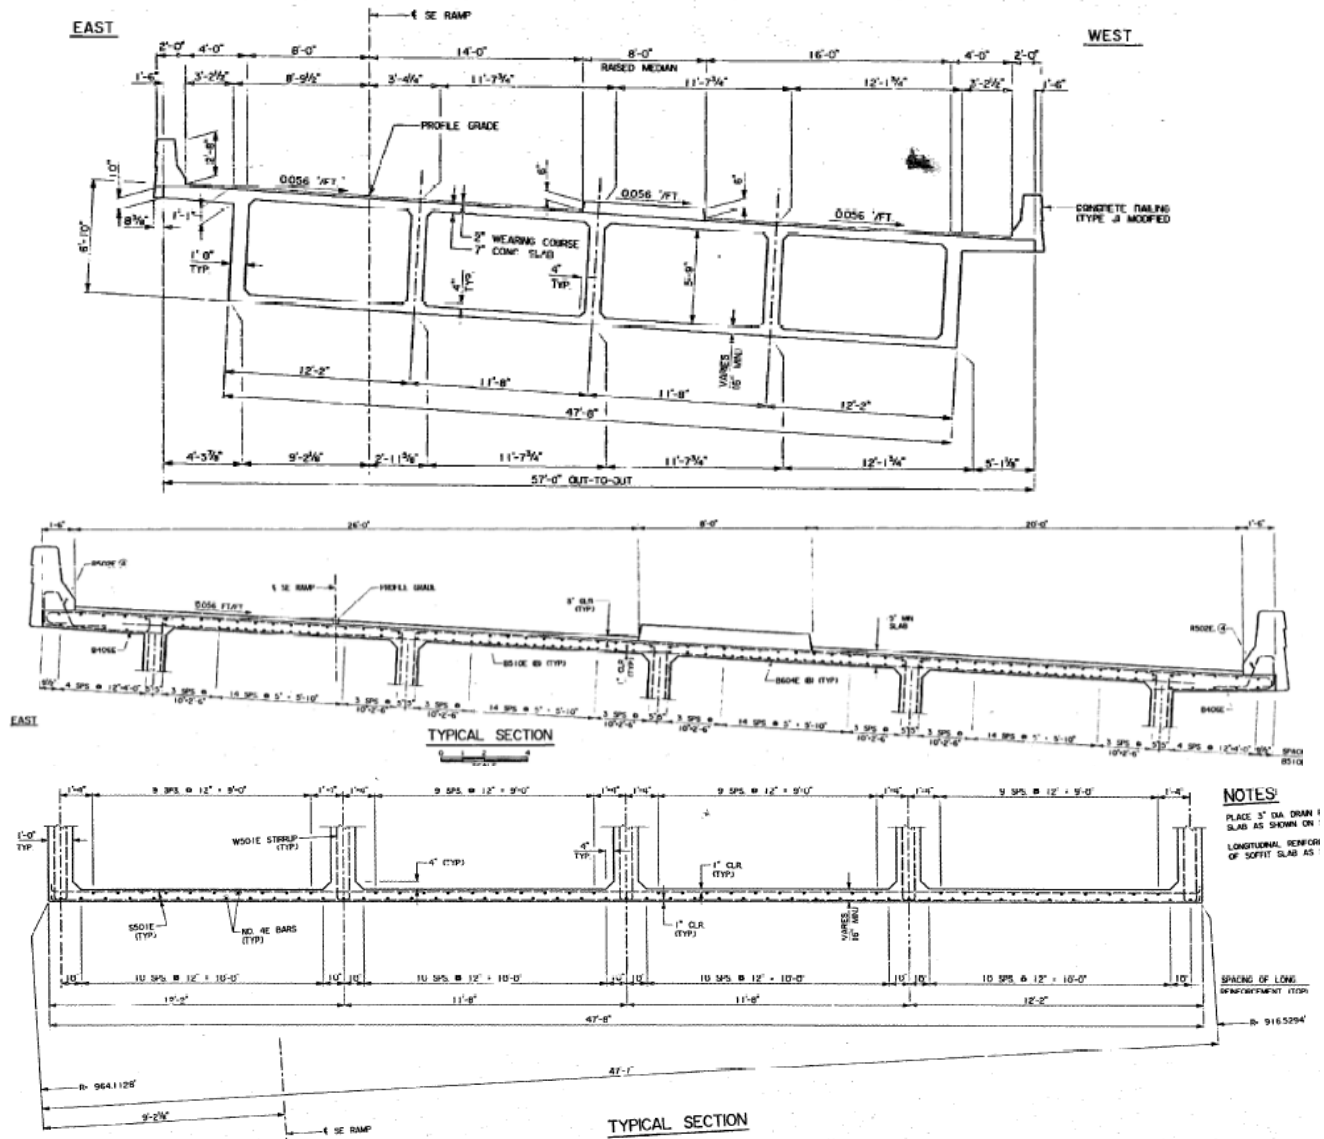
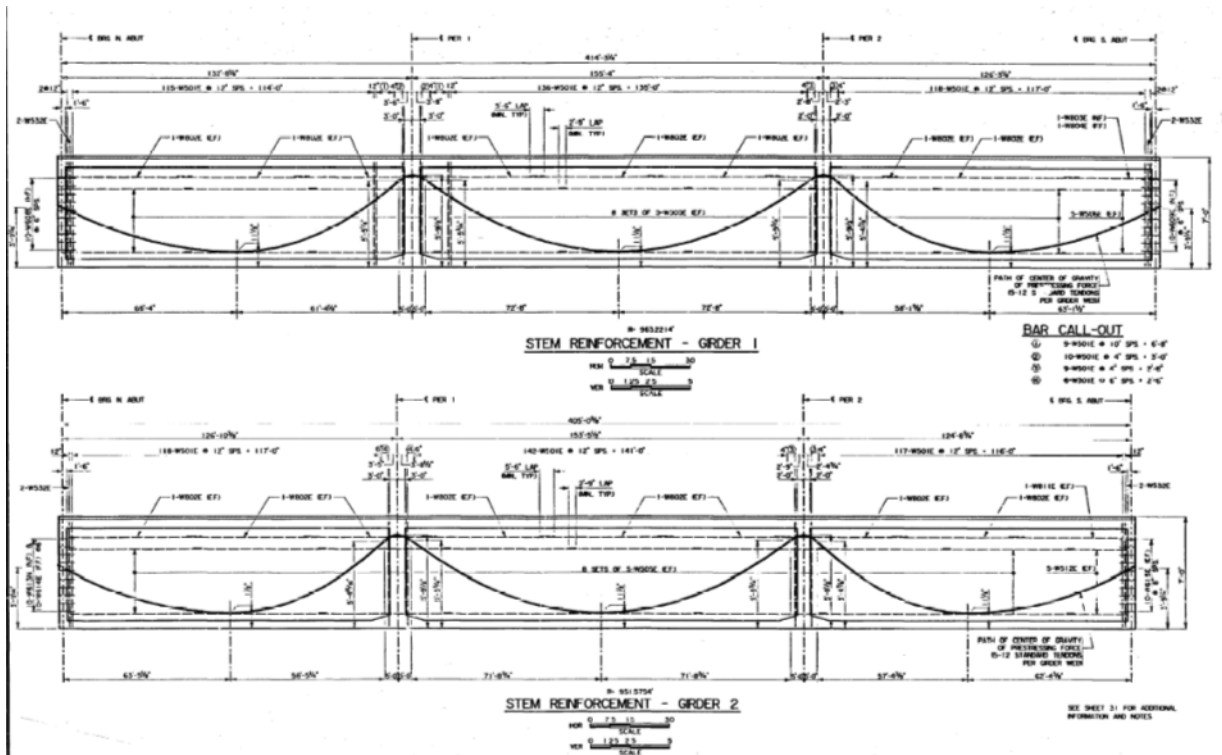
- PT pier cap #1 has vertical cracks with leaching
- Deck cracking up to 1/4" width
- Cracking inside boxes

Deck cracking of 1/4" is significant. Cracking requiring epoxy fill inside the box is also of interest as a sign of PT related problems or potential for corrosion. A full visual inspection of the box interiors is recommended for this bridge. The 2009 inspection report does not have any information specific to the PT boxes. The parabolic drape profile does not have a tall vertical rise, but this layout may be susceptible to bleed problems near intermediate high points and end anchors.

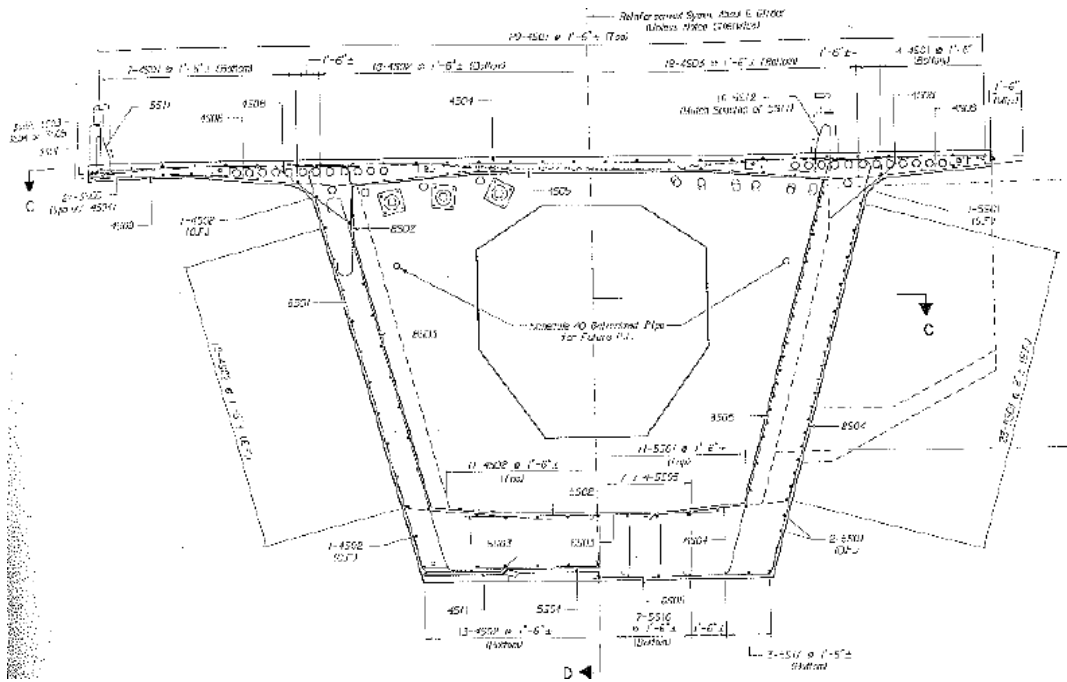
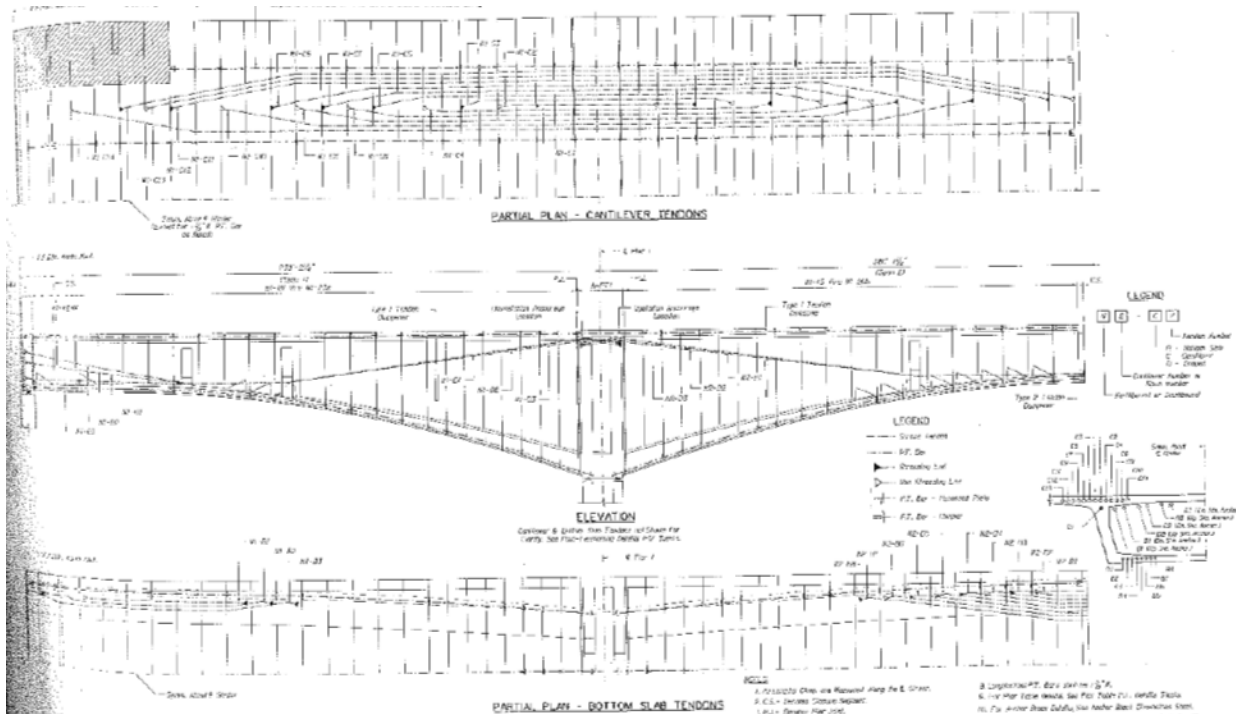
- Spalling at grout tube location on deck
- PT girders show some efflorescence in transverse joints along bottom; paint peeling in these locations
- Longitudinal cracks in top of box near south abutment cross walk
- Interior inspection of box girders in 2005 (team included Tom DeHaven of Figg)
- Anchor block joint is open 1/4"

The spalled area at the grout port to the deck should be revisited. This type of detail can allow direct ingress of moisture and chlorides to a tendon. The anchor block joint should also be visually inspected for signs of corrosion from moisture/chloride ingress. No major problems were indicated in the 2005 inspection. This bridge has a specific inspection manual from the designers (Figg Bridge) and has been inspected with one of the Figg team who has extensive segmental bridge experience on site. For this reason, the inspection recommendation under this project is lower than for other bridges of this type.

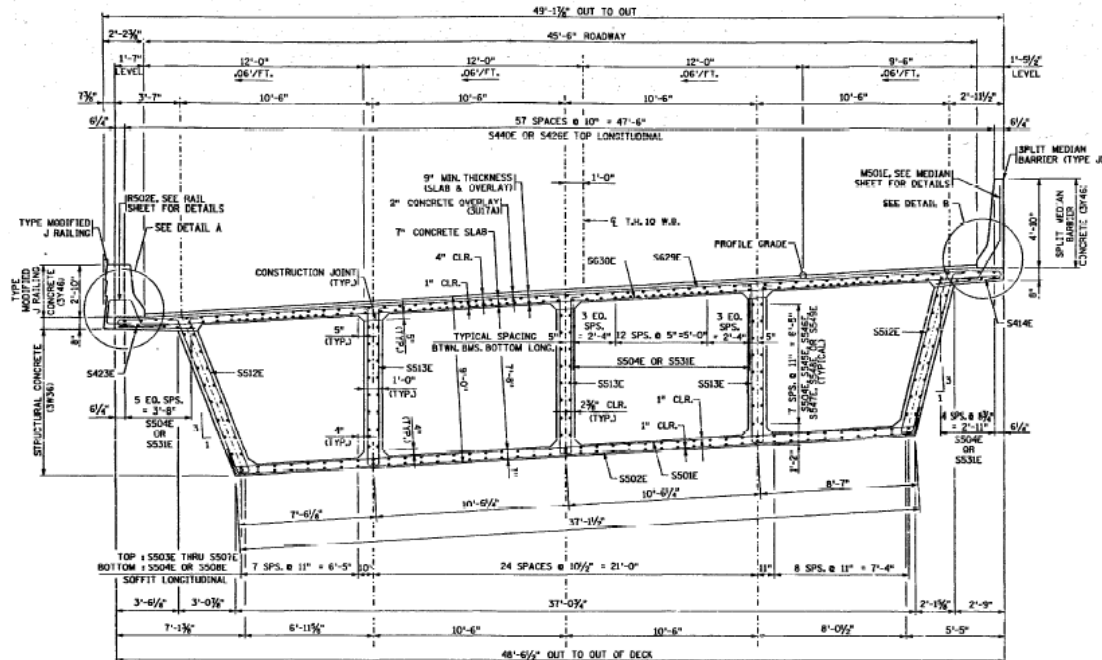
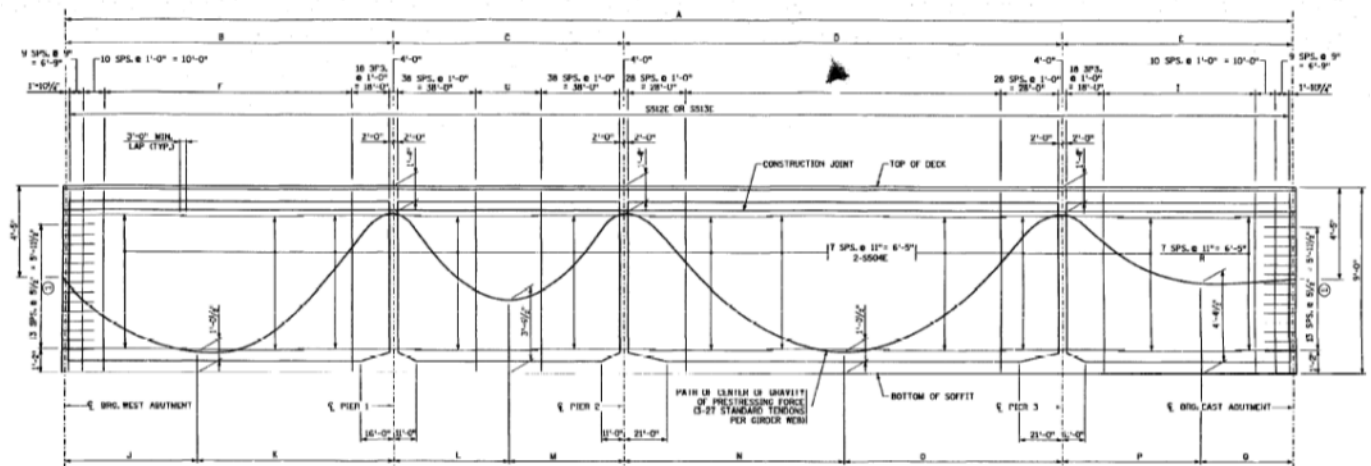
- Deck has 4 sq ft of delamination (2 sq ft spalling) at west end block; 1 sq ft spalling at east end block

This is the sister structure to 02037E. Similar concerns exist at tendon high points. No information is given in the 2009 inspection report about the PT boxes. This structure is potentially more of a concern than the eastbound structure due to grouting procedures observed on site by Mn/DOT personnel.

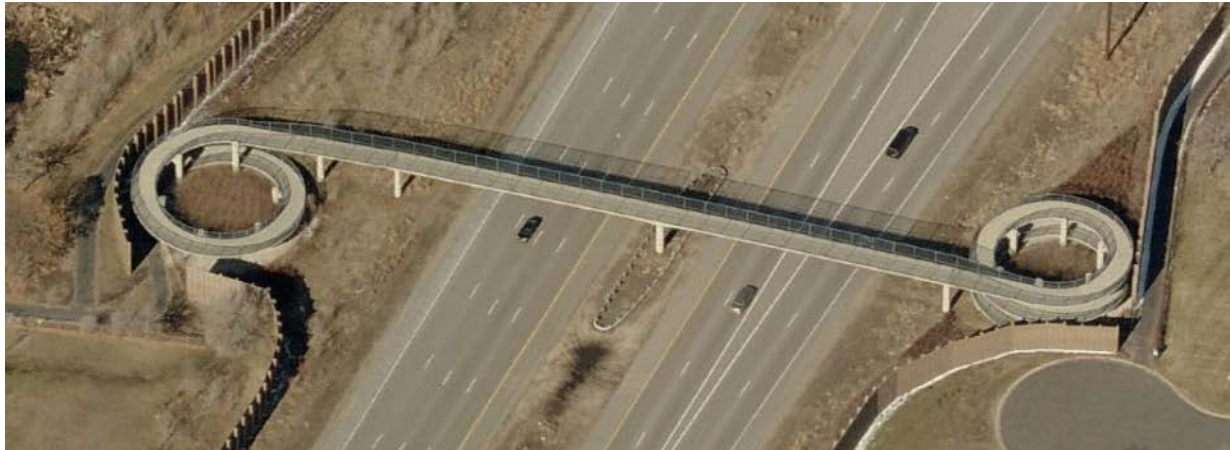
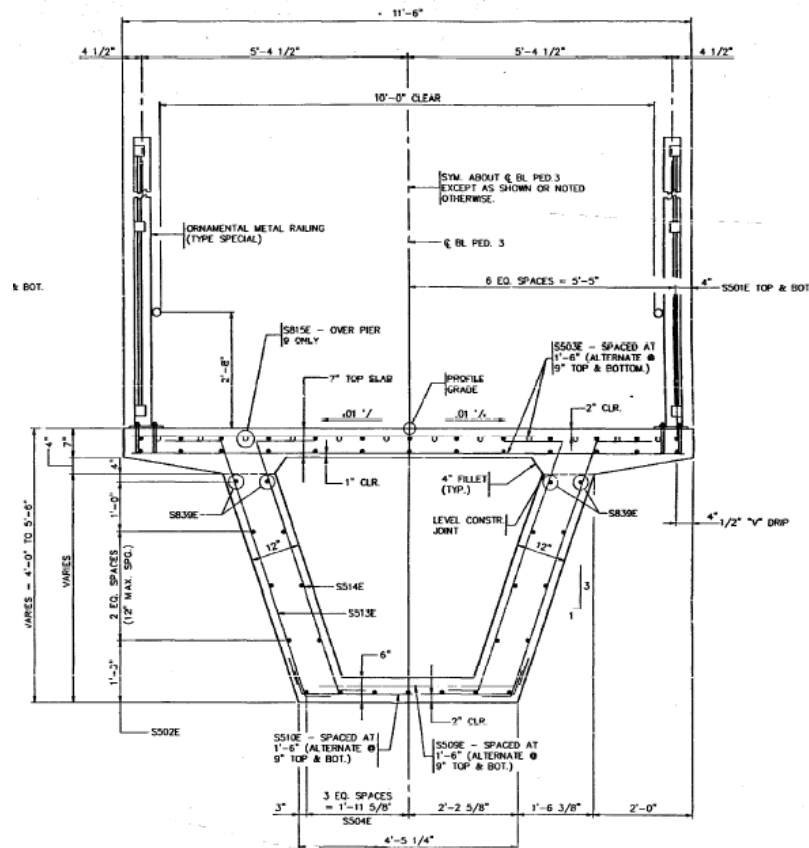
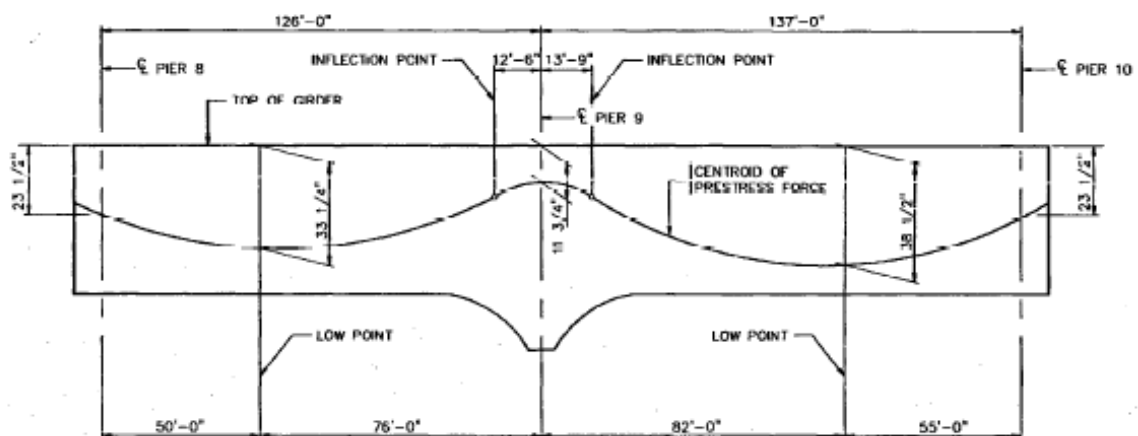
- Pier caps have 50 linear feet of vertical cracking with leaching

- Transverse cracks with leaching on underside

The inspection details for this pedestrian bridge indicate primarily cracks with leaching but no other concerns. The vertical cracking in the pier caps seems extensive from the inspection notes, so these should be monitored visually. We do not have access to the pier cap plans so we assume they are not PT. If there are PT, the pier caps should be inspected.
