# Development of Best Practices for Inspection of PT Bridges in Minnesota

Minnesota  
Department of  
Transportation

Andrea Schokker, Principal Investigator  
Department of Civil Engineering  
University of Minnesota Duluth

Research Project  
Final Report 2012-09

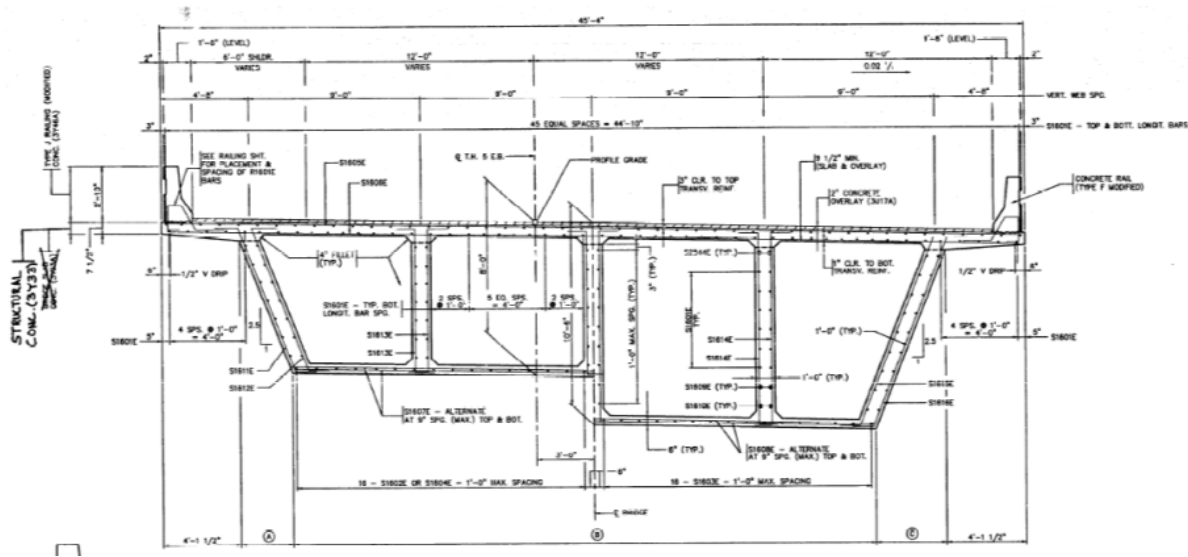
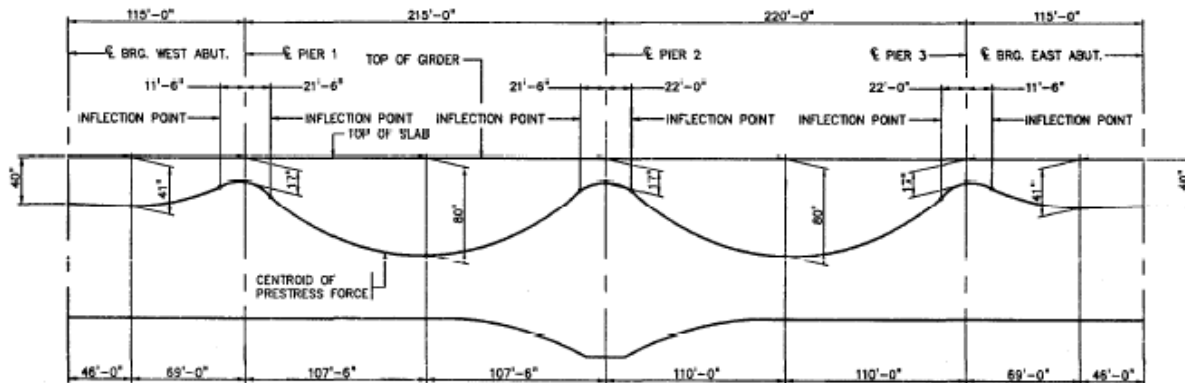
- Deck surface delamination at end block
- Deck joint seal failures
- PT box girder has location with 2 sq ft of cracking and delamination, exposed rebar
- Transverse cracking at pier 1

The bridge has a parabolic tendon profile with relatively tall vertical rise, so high points are susceptible to bleed. The tendon size is not available on the provided plans, but larger tendons will have a higher tendency to accentuate bleeding due to the wicking effect of the 7-wire strand. High points and areas near the joint seal failures should be the focus of inspection. The spalled area with exposed rebar should also be inspected for the effect on tendons in that area.

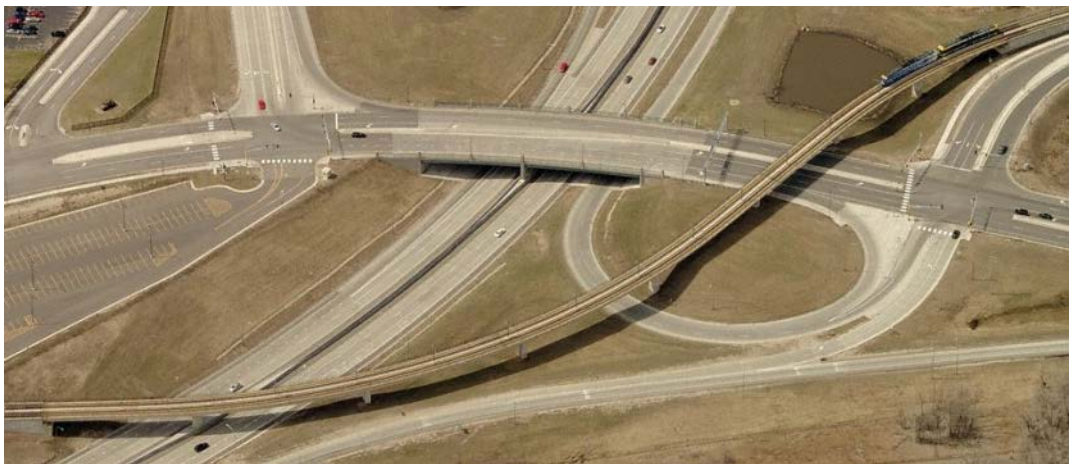
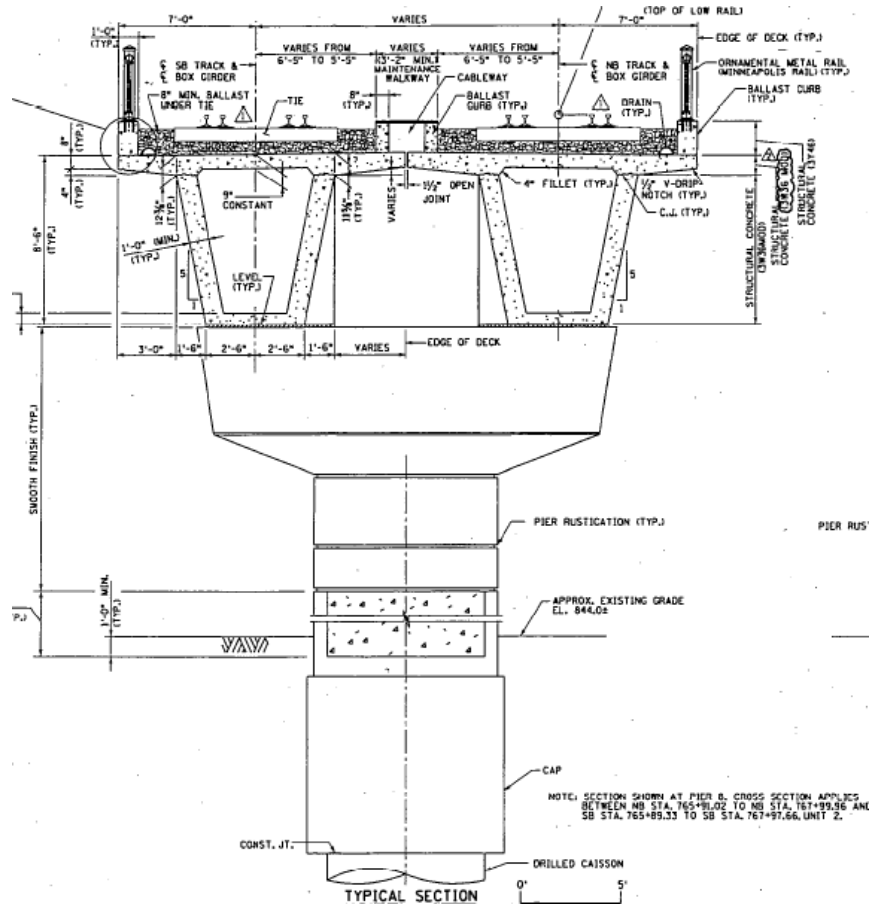
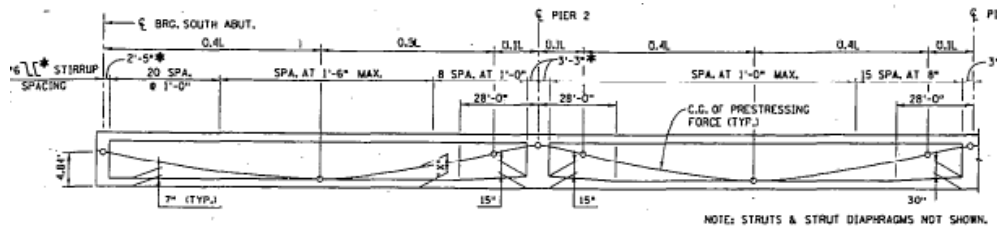
**Bridge 27262 (LRT)**

- Void in east girder north of pier #14 (9" deep) with large amount of grout on top of bottom slab that has emanated from the void
- 11" void in span 11 with grout on bottom slab in numerous locations in this area
- Minor cracking with efflorescence in soffit slab
- 4 ft long horizontal cracks around the center web access openings
- Horizontal cracking in W fascia web of the N intermediate diaphragm in span 14

possibility of blowouts/leaks during construction and the likelihood that the structure is not fully grouted. These areas should be more thoroughly inspected beyond visual inspection.

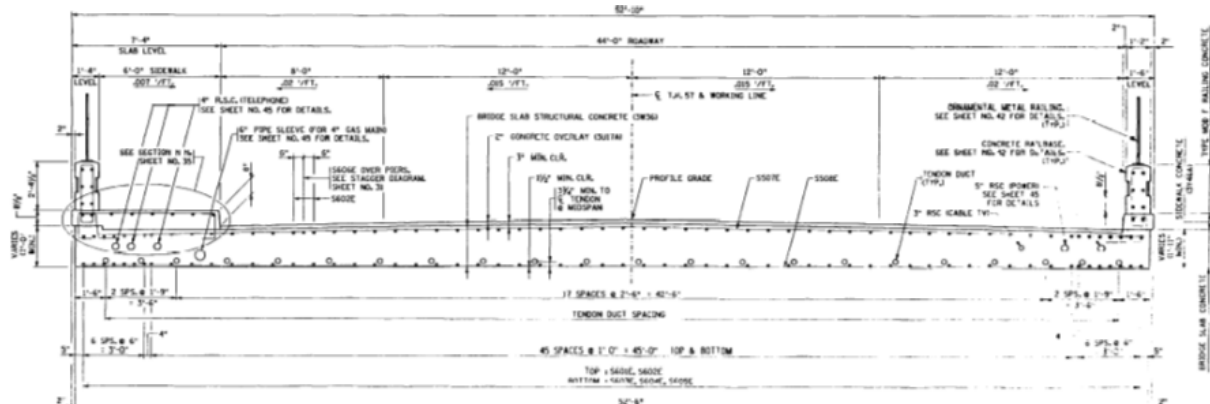
- 2 longitudinal cracks on underside of concrete deck extending out from both abutments near centerline

As detailed in the inspection notes, this PT slab bridge appears to be in good condition. Visual inspection near cracking locations as related to PT is recommended along with visual inspection of anchorage areas where possible.

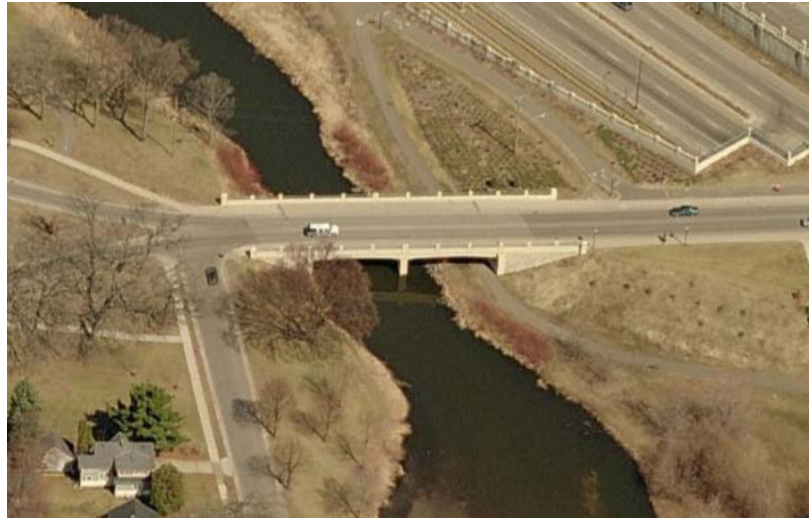
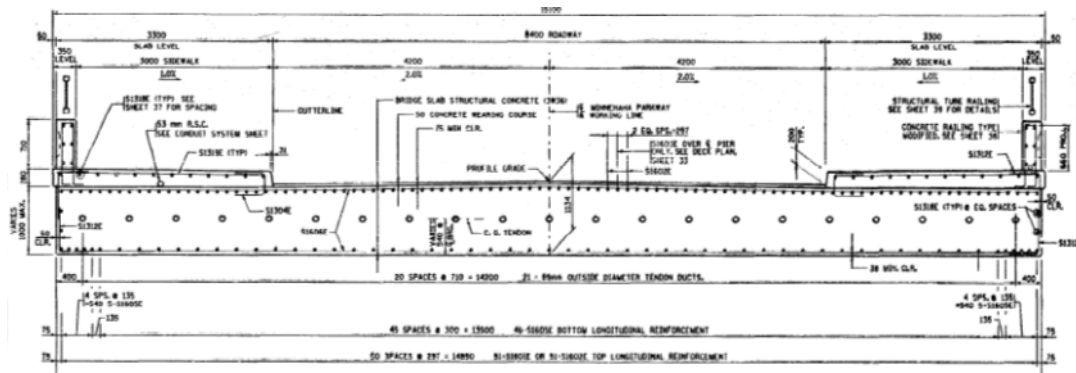
- Fine sized map cracking in deck

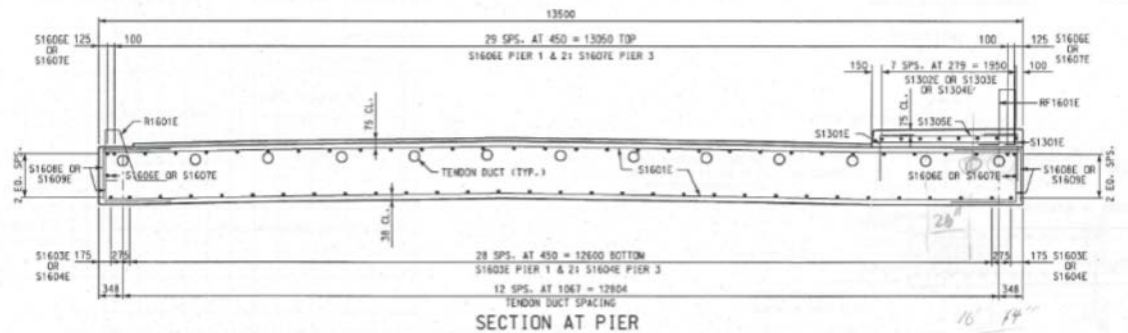
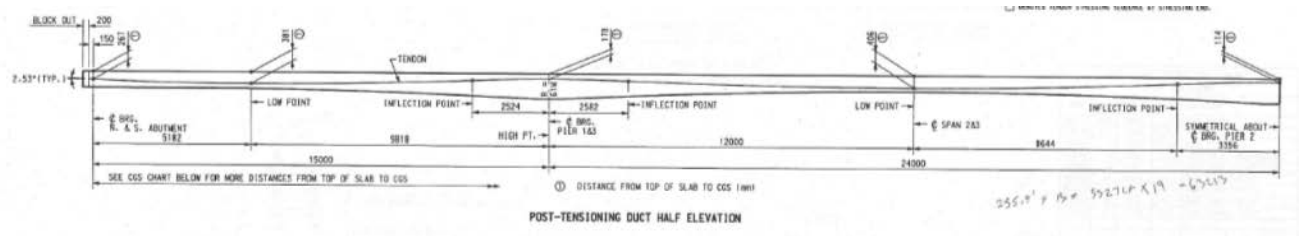
- Some fine transverse and longitudinal cracks in overlay
- Fine longitudinal cracks in underside of slab at centerline in all spans
- Minor areas of honeycombing in the underside of the N span

This PT slab span has some cracking and honeycombing on the underside that should be visually inspected in relation to the location of PT tendons and PT anchorage.

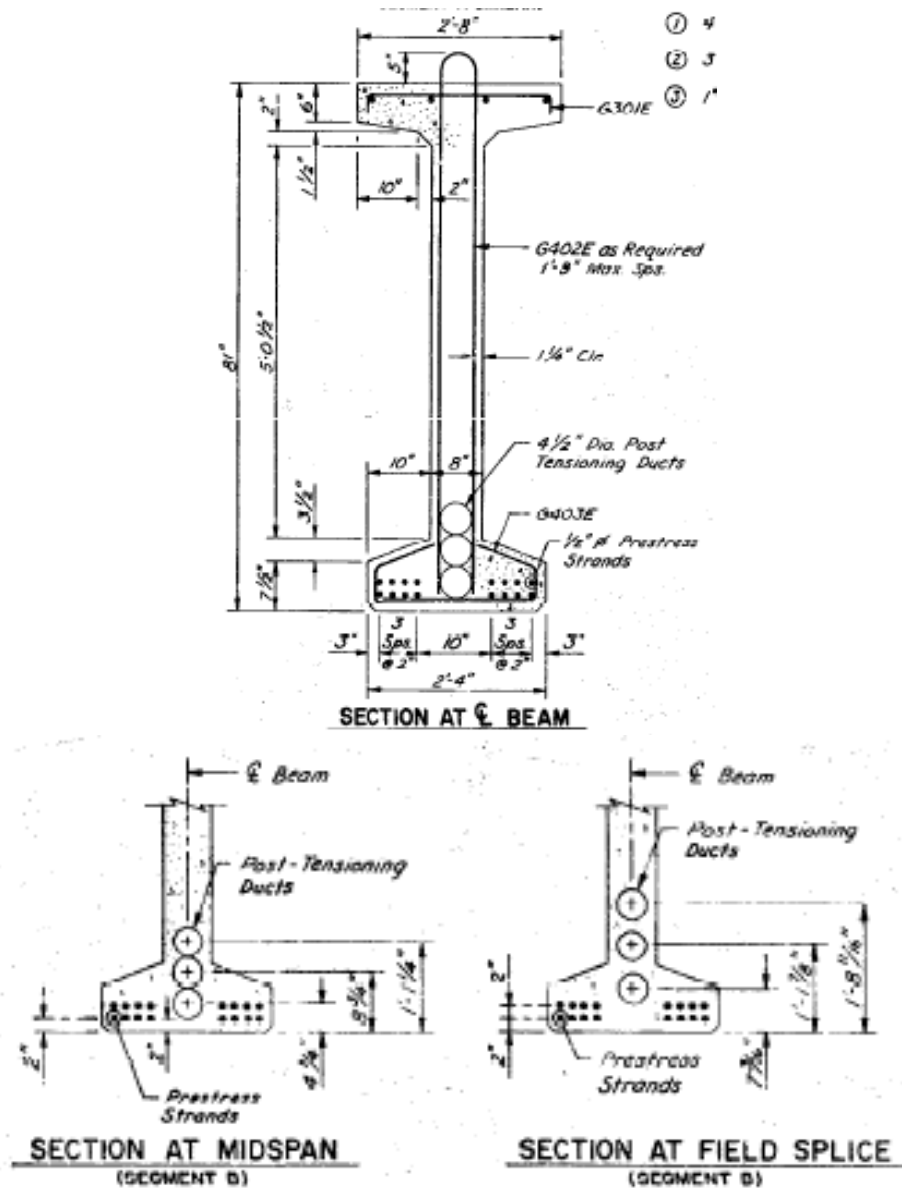
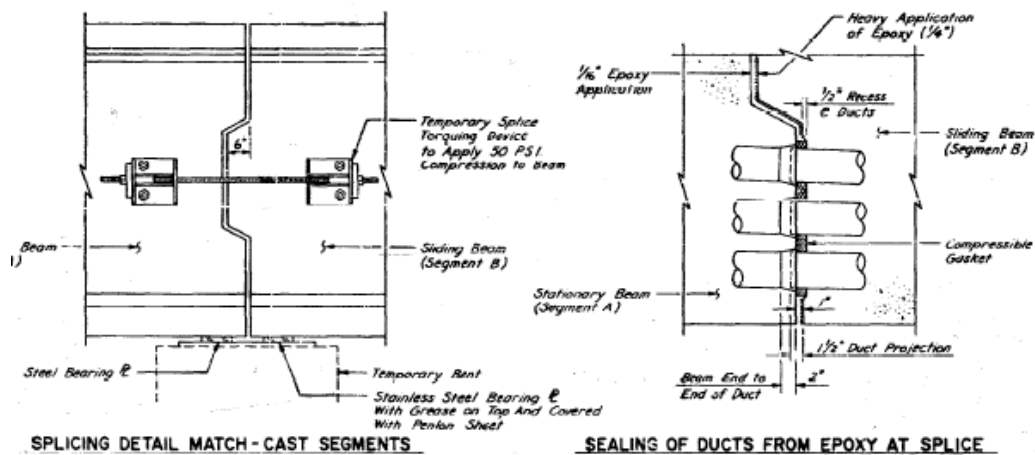
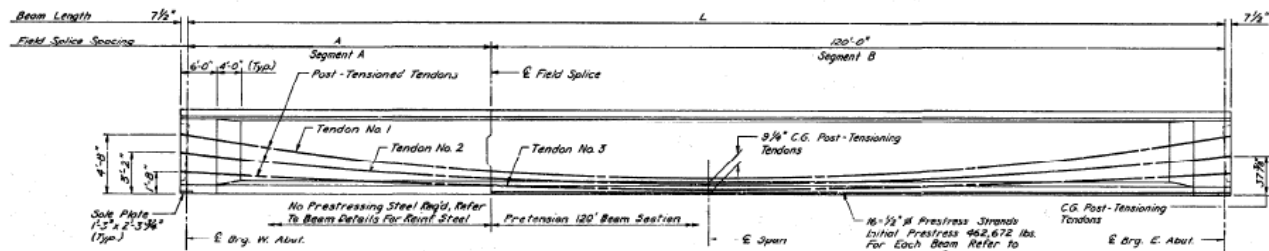
- Overlay delamination and scaling near end block (not likely to be related to PT for this type of system)
- Joint failures

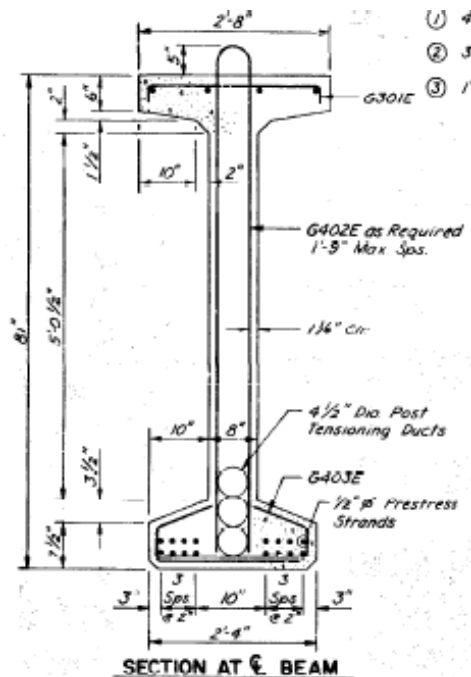
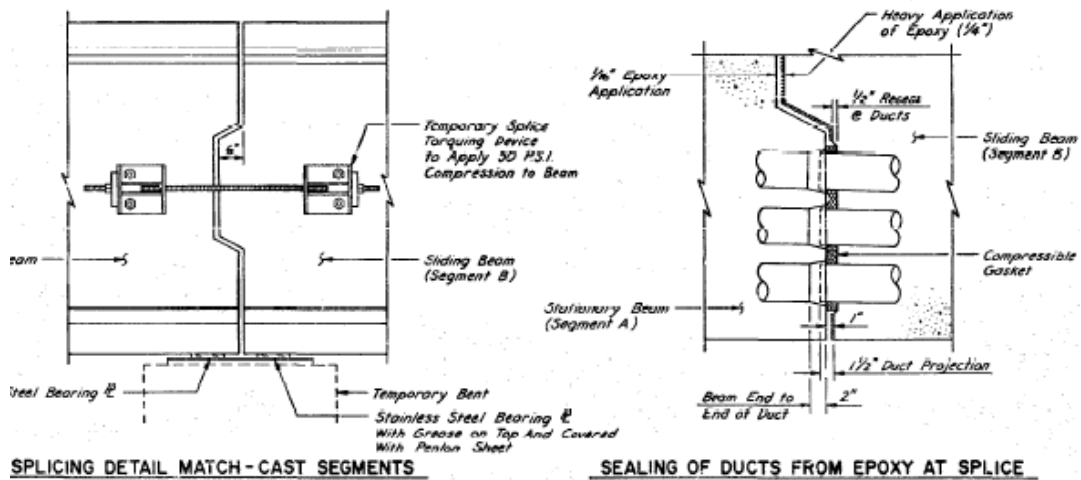
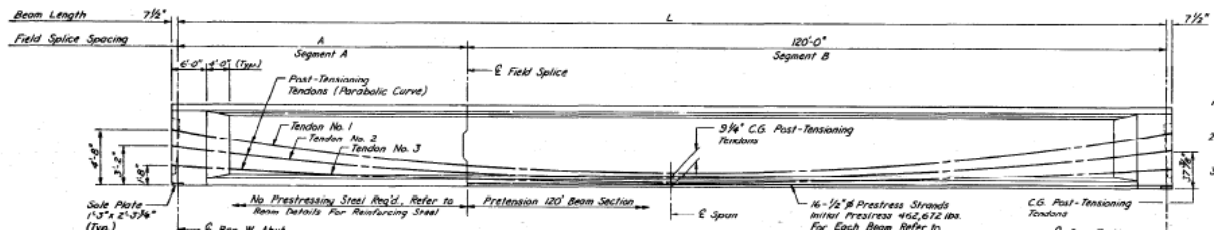
- Overlay delamination and scaling near end block (not likely to be related to PT for this type of system)
- Joint failures

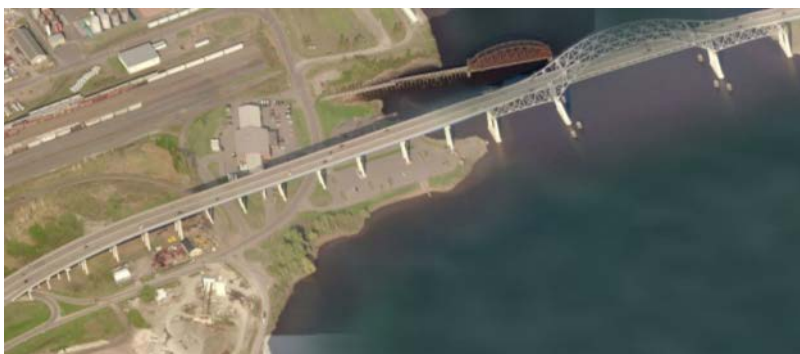
- PT pier caps had shrinkage cracking that was repaired shortly after construction; nearly identical cracks visible on each pier cap

The PT components in this bridge are the PT pier caps. The inspection notes do not indicate any problem areas related to the PT other than the recorded cracking. End anchorage protection should be visually inspected during routine inspections. The end protection for the anchorages as shown in the plans indicate good protection. Plastic end caps are recommended for current construction, but were not typically used at the time of this construction. Metallic caps (that were typically removed) were often used. Indications of cracking, efflorescence and/or rust staining would be indicators of the need for a more detailed inspection. The overall recommendation for inspection of this bridge related to PT is low, however it has been given an “8” based on the reported cracking in the piers. A visual inspection should be done on this bridge under this project contract specific to the PT pier caps.
