# Evaluation of Corrugated HDPE Pipes Manufactured with Recycled Content

**August 2025**

Final Report 2025-32

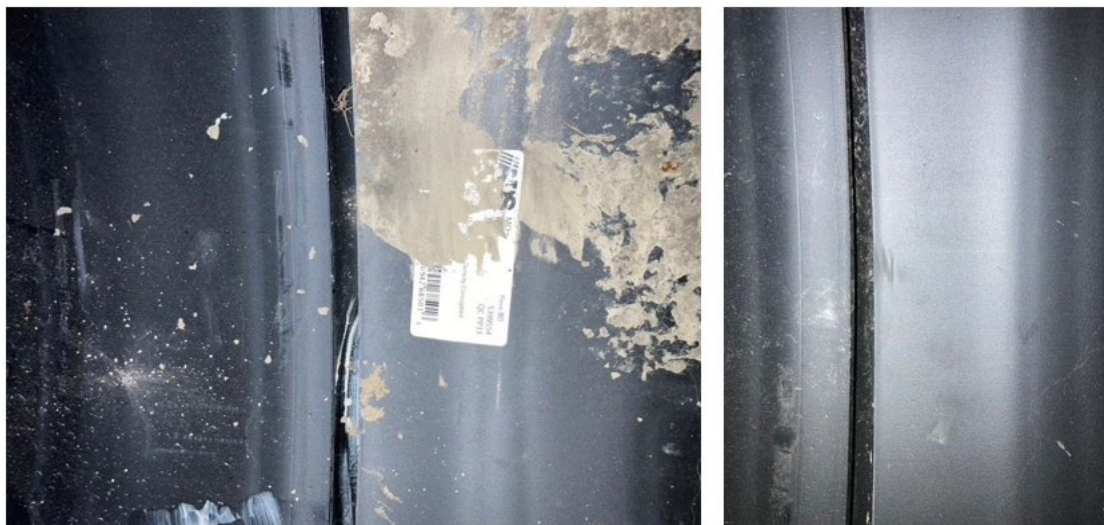
**Figure 2.16 Inspection of joint gaps to ensure proper seating of joints**

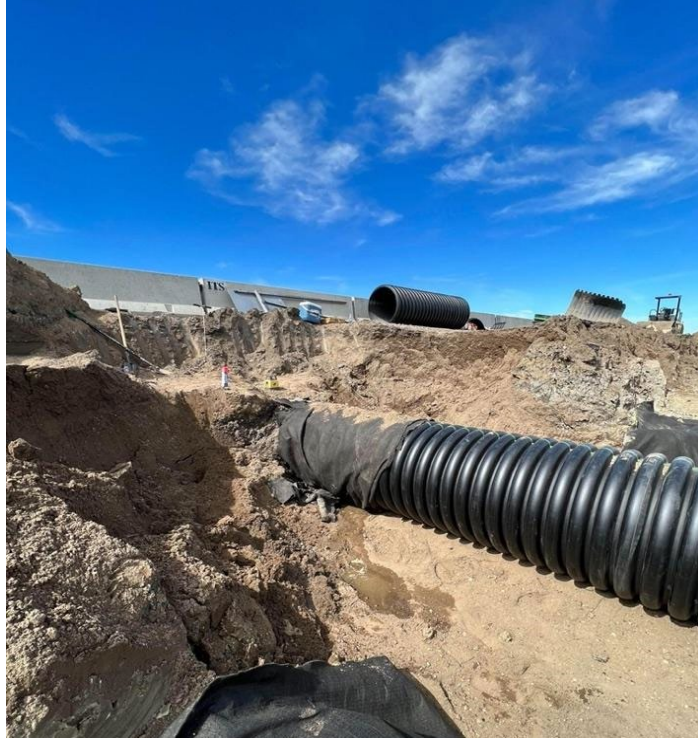
The split coupler that was used to connect the existing M 294 R recycled pipe underneath the eastbound lanes to the M 294 R pipe underneath the westbound lanes was wrapped in geotextile fabric to mitigate soil migration into the joint, as shown in Figure 2.19.

**Figure 2.19 Split coupler joining pipe underneath westbound lanes to that previously installed underneath eastbound lanes**

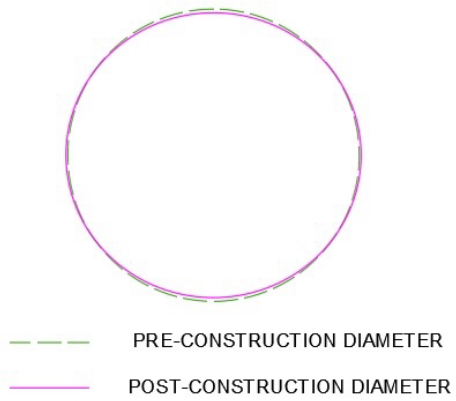
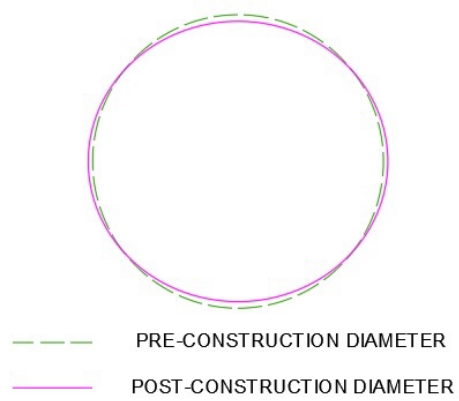
**Figure 2.23 Illustration of culvert deflection prior and post construction**

In-situ deflection measurements of the westbound instrumented pipes were taken using a Bosch BLAZE digital measuring tape, which is accurate to 1/32 of an inch. To ensure the measurements were taken in the same location prior and post-installation, markers were lightly etched into the sides of the culvert. Table 2.2 shows the initial vertical, horizontal, and diagonal measurements of each pipe, both before and after construction, as well as the calculated deflections. As demonstrated in the table, the deflections were below MnDOT's required 5% limit. Figure 2.23 depicts a visual comparative analysis of the deflection experienced prior to and post-installation.

| Virgin HDPE Pipe (AASHTO M 294 V) | | | |
|---|---|---|---|
| Diagonal | 35.94 in. | 36.38 in. | 1.2 |

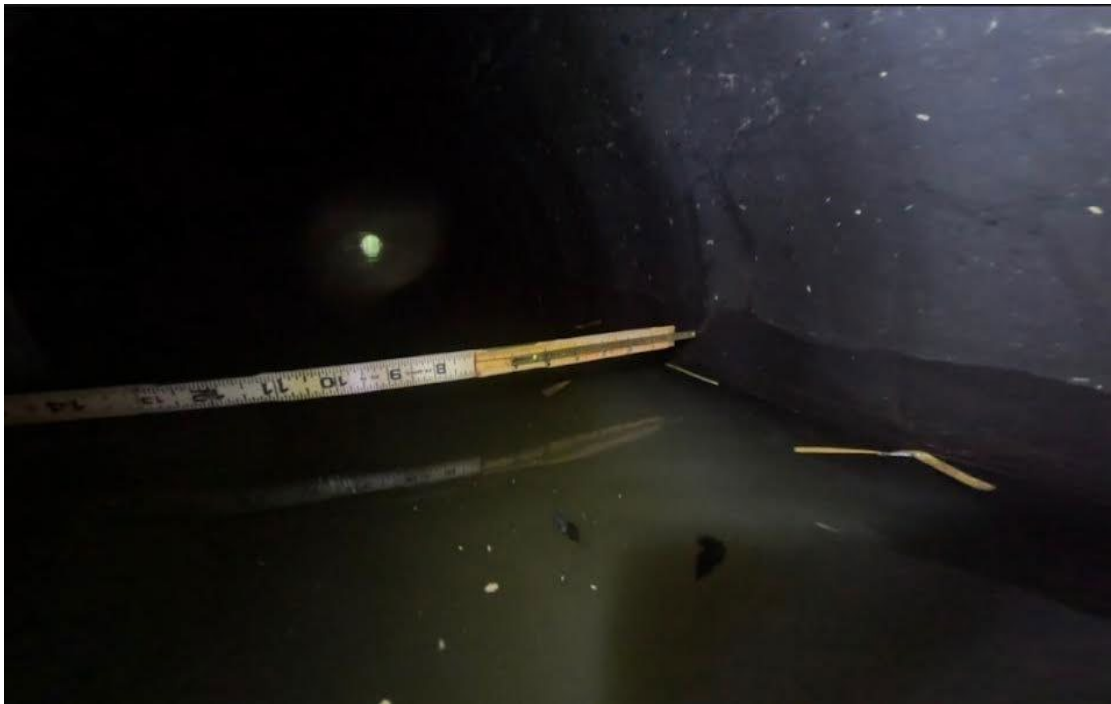
The pipes were again inspected on July 19, 2023. Figure 3.8 shows an image of the pipe inlet at the time of inspection. Again, the water levels were very high, but the pipes were deemed marginally safe enough to enter. Due to the previously-mentioned issues with the instrumentation, physical measurements were taken using a Lufkin wooden ruler with brass extensions, allowing a more accurate measurement than the tape measure used on the June 12 inspection. Figures 3.9 and 3.10 show the process used to measure the horizontal and vertical diameters, respectively. A summary of the data is shown in Table 3.1.

**Figure 3.9 July 19, 2023, horizontal measurement using Lufkin wooden ruler with brass extends**

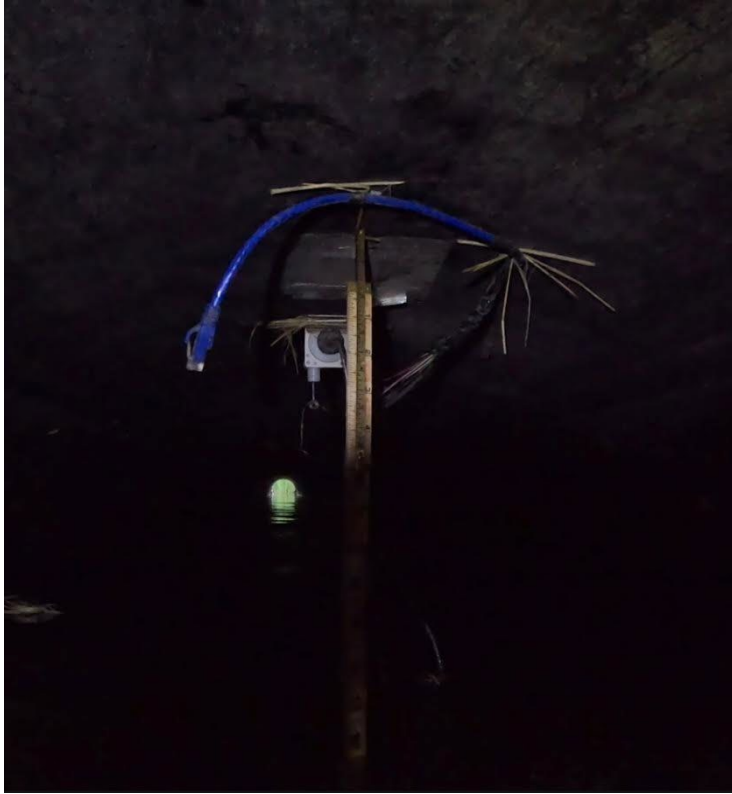
**Figure 3.10 July 19, 2023, vertical measurement using Lufkin wooden ruler with brass extends**
